## PIT REMEDIATION AND CLOSURE REPORT

| Operator: <u>Conoco Inc.</u> | | Telephone: <u>505-324-5813</u> | |
| Facility Or: <u>San Juan 28-7 #32</u> | | | |
| Location: | Unit or Qtr/Qtr Sec | <u>L</u> Sec <u>19</u> T <u>28N</u> R <u>7W</u> County <u>Rio Arriba</u> | |

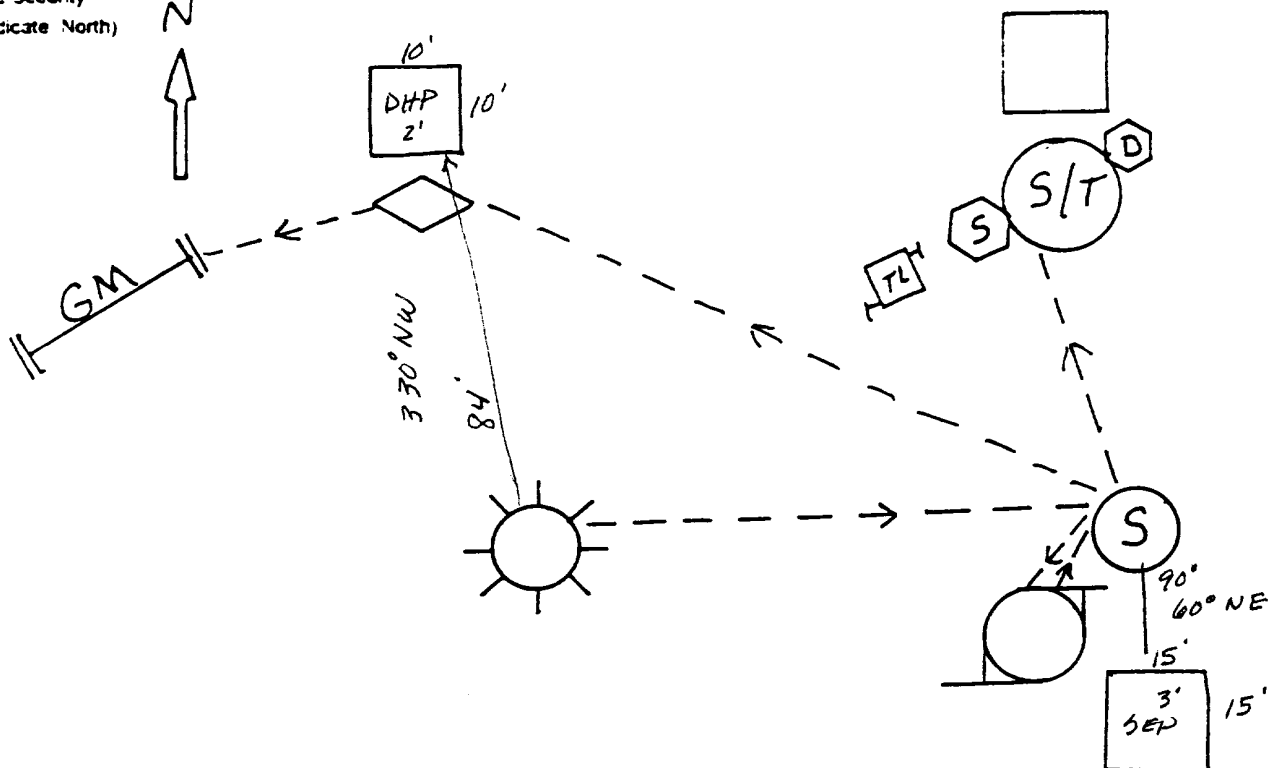
Site Security  
(Indicate North)

Load line valves :  
Sealed during Production

Drain line valves :  
Sealed during Production

Production Line valve:  
Sealed during sales
