| <b>PIT REMEDIATION AND CLOSURE REPORT</b> | | |

| Operator: <u>Conoco Inc.</u> | | Telephone: <u>505-324-5837</u> | |
| Facility Or: <u>San Juan 28-7 #193</u> | | | |
| Location: | Unit or Qtr/Qtr Sec | Unit M Sec | 28 T <u>27</u> N R <u>7</u> County Rio Arriba |

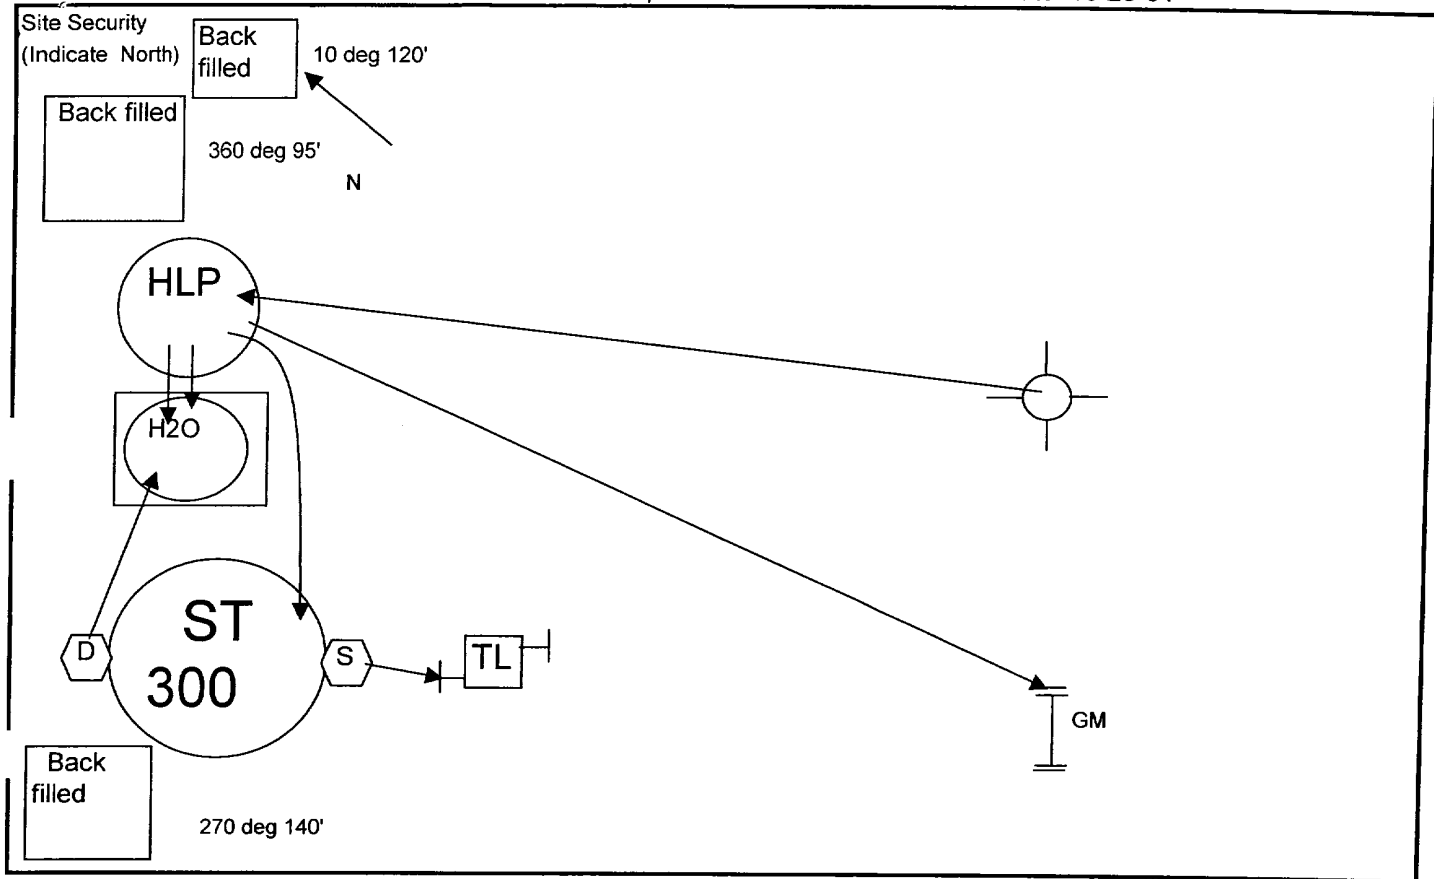
Lease Name: San Juan 28-7 # 193

Load line valves :  
Sealed during Production

Drain line valves :  
Sealed during Production

Production Line valve:  
Sealed during sales
