# FIELD PIT SITE ASSESSMENT FORM

**EPFS**  
**EL PASO FIELD SERVICES**

# ORIGINAL PIT LOCATION

## FIELD SERVICES LABORATORY ANALYTICAL REPORT PIT CLOSURE PROJECT - Soil

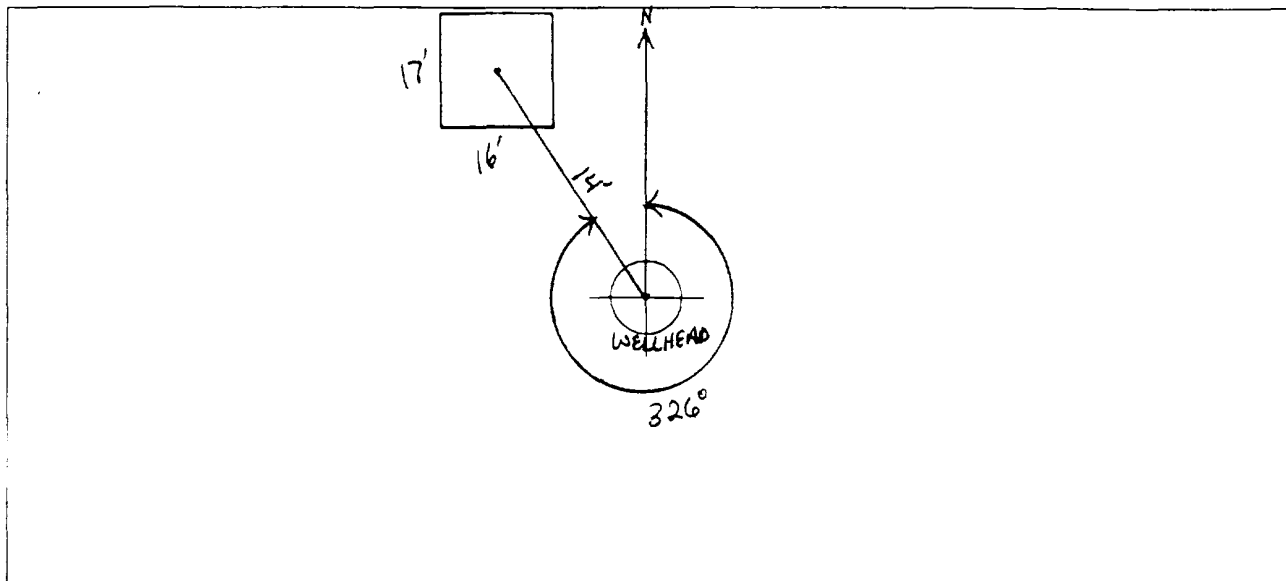
ORIGINAL PIT LOCATION

Original Pit : a) Degrees from North 326° Footage from Wellhead 14'  
b) Length : 17' Width : 16' Depth : 4'
