Risk TPA

PIT REMEDIATION AND CLOSURE REPORT

Operator: <u>Conoco Inc.</u>		Telephone: <u>505-324-5813</u>	
Address: <u>3315 Bloomfield Hwy - Farmington, NM 87401</u>			
Facility Or: <u>Hammond WN Fed-8</u>			
Well Name _____			
Location:	Unit or Qtr/Qtr Sec	<u>B</u> Sec	<u>34</u> T <u>27N</u> R <u>08W</u> County San Juan
Pit Type:	Separator <u>X</u>	Dehydrator _____	Other _____
Land Type:	BLM <u>X</u> State _____	Fee _____	Other _____
Pit Location: (Attach diagram)	Pit dimension:	length <u>21'</u>	width <u>21'</u> depth <u>3'</u>
	Reference:	wellhead <u>X</u>	other _____
	Footage from reference:	<u>75'</u>	
	Direction from reference:	<u>60</u> Degrees	East of _____ North _____ West <u>X</u> South

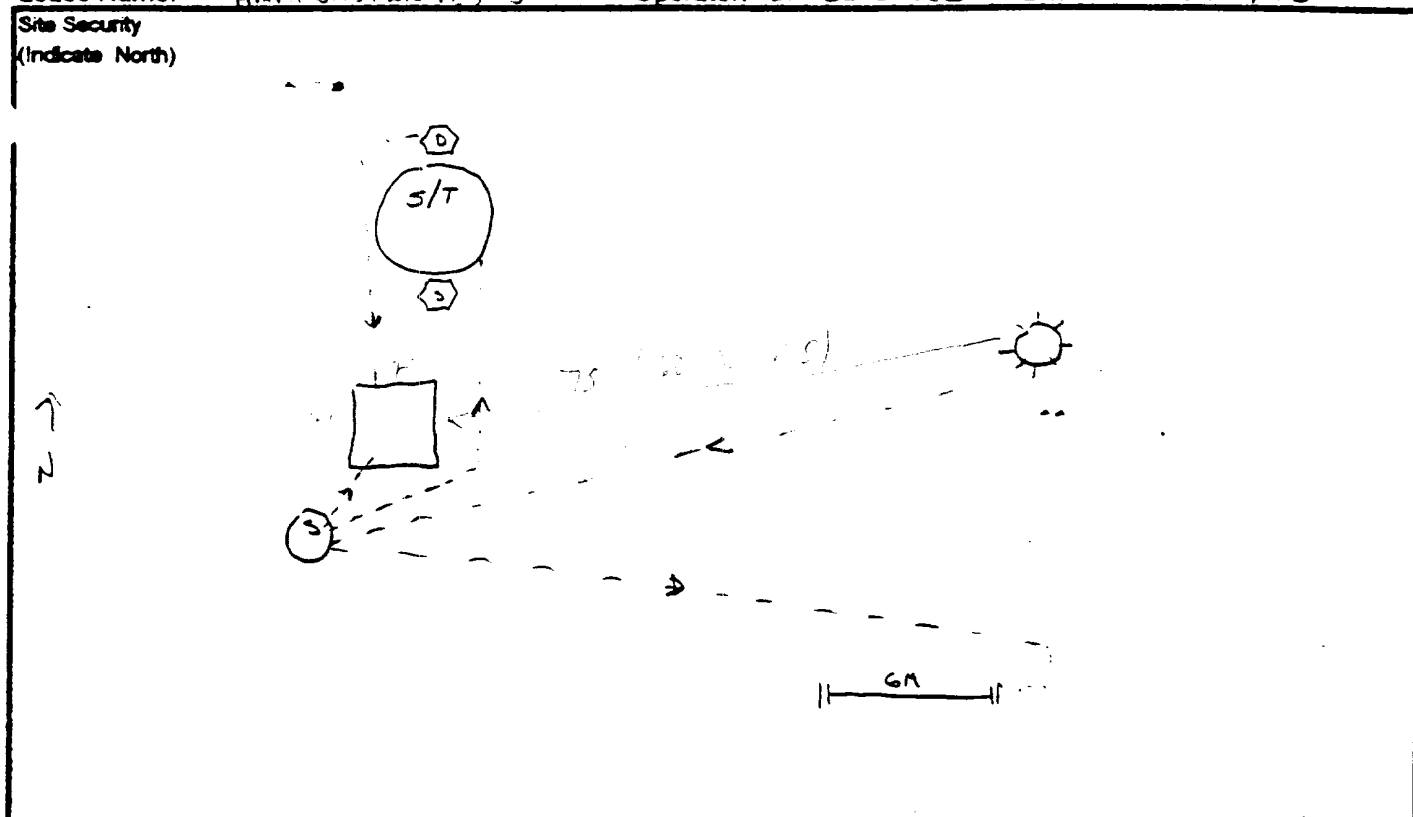
Site Security
(Indicate North)

Load line valves :
Sealed during Production

Drain line valves :
Sealed during Production

Production Line valve:
Sealed during sales
