Final Pit: Sample location Deepest part of pit. Sampled with a backhoe.  
Closure Sampling: \_\_\_\_\_  
(if multiple samples, attach sample results and diagram of sample locations and depths) Sample depth 1 ft below pit bottom (bedrock)  
Sample date 11-18-93 Sample time \_\_\_\_\_

PHILLIPS PETROLEUM PIT ASSESSMENT SUMMARY  
REVISED DATE: NOVEMBER 22, 1993

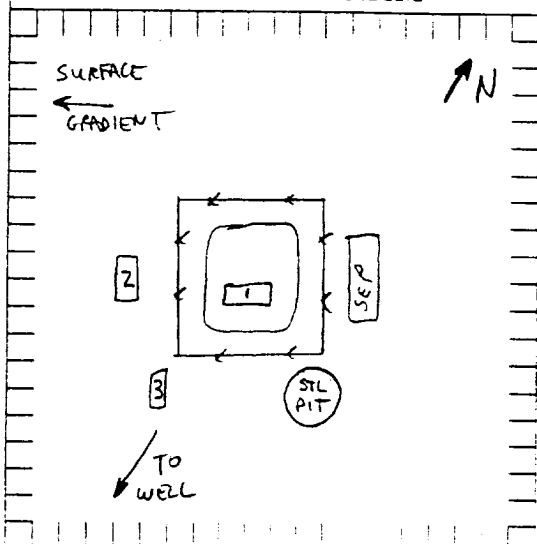
# SITE DIAGRAM

Initial assessment of the pit showed the soils to be clean at  
bedrock which was 1 foot below the pit bottom.

SURFACE CONDITIONS: EARTHEN PIT - FENCED 25' x 25' - NO SURFACE STAINING

T1: PIT DUG INTO SANDSTONE  
WET, BROWN/GRAY SILTY-SANDY-CLAY-  
SLIGHT ODR.
