## PIT REMEDIATION AND CLOSURE REPORT

Operator: Phillips Petroleum Company Telephone: (505) 599-3460  
Address: 5525 Hwy. 64, NBU 3004, Farmington, NM 87401  
Facility Or: San Juan 29-6 Unit #73A  
Well Name B  
Location: Unit or Qtr/Qtr Sec NW NW Sec 20 T 29N R 6W County Rio Arriba  
Pit Type: Separator X Dehydrator      Other Condensate Tank  
Land Type: BLM X, State     , Fee     , Other

FIELD REPORT: SITE ASSESSMENT

PROJECT. PIT ASSESSMENT

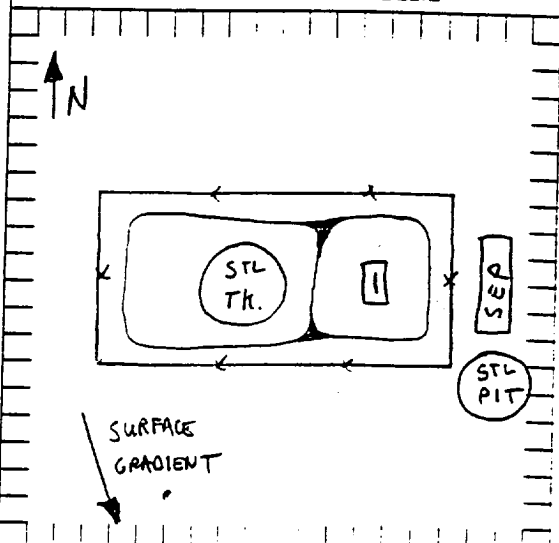
# SITE DIAGRAM

SURFACE CONDITIONS: EARTHEN PIT - FENCED 30' x 60' - DRY - NO SURFACE STAIN

FIELD NOTES & REMARKS: PIT IS LOCATED APPROXIMATELY 55 FEET N.20°W. OF WELLHEAD.

T1: MOIST, BROWN, SAND - NO ODOR?

| TEST HOLE LOGS: | | | |
|---|---|---|---|
| 4 | CL | GRA | 3.8 |
| 7 | SP | GRA | 5 |
| 8 | TD=6.5 | | |
