Meter Number:90546 L& GAS INSPECTORLocation Name:SAN JUAN 29-6 #13A Location: TN-29 RG-06 SC-06 UL-D 2 - Federal

RATIONALE FOR RISK-BASED CLOSURE OF PRODUCTION PITS LOCATED OUTSIDE OF THE VULNERABLE ZONE IN THE SAN JUAN BASIN

FIELD PIT SITE ASSESSMENT FORMEL PASOF

FIEL PIT REMEDIATION/CLOSULE FORM

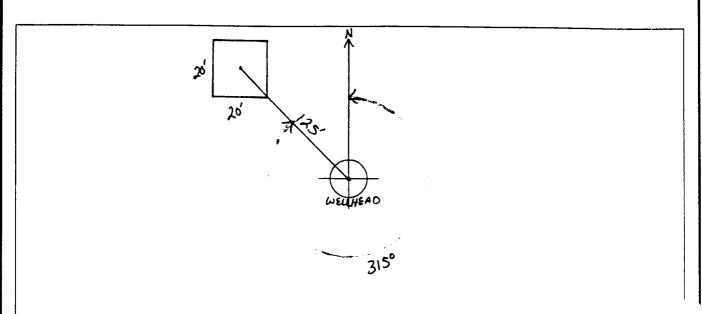
ORIGINAL PIT LOCATION

Original Pit: a) Degrees from North 315° Footage from Wellhead 125'

b) Length : <u>20'</u> Width : <u>20'</u> Depth : <u>4'</u>

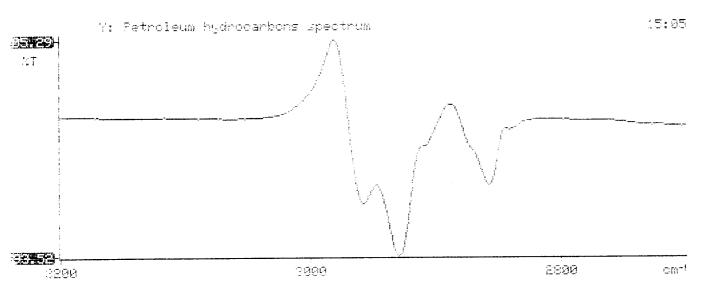
****************** Test Method for Oil and Grease and Petroleum Hydrocarbons * in Water and Soil Perkin-Elmer Model 1600 FT-IR Analysis Report ******************

Sample identification 745461

Initial mass of sample, g 1.160

Volume of sample after extraction, ml 03.000

Petroleum hydrocarbons, ppm 124,541

Net absorbance of hydrocarbons (2930 cm-1)
