Meter Number:89725 Location Name: STATE GAS COM A #1A Location:TN-29 RG-09

RATIONALE FOR RISK-BASED CLOSURE OF PRODUCTION PITS LOCATED OUTSIDE OF THE VULNERABLE ZONE IN THE SAN JUAN BASIN

FIELD PIT SITE ASSESSMENT FORM ELPASOFIELD SERVICES

FIELD PIT REMEDIATION/CLOS_RE FORM

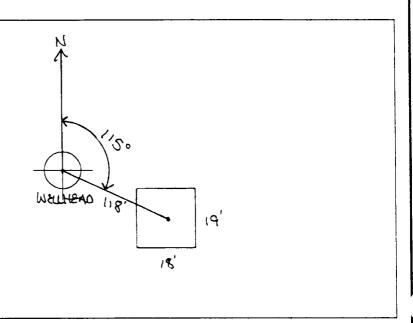
ORIGINAL PIT LOCATION

Original Pit : a) Degrees from North 115° Footage from Wellhead 118'

b) Length : ________ Width : ________ Depth : __________
