**OIL CONSERVATION DIVISION**

**PIT REMEDIATION AND CLOSURE REPORT**

| Facility Or: | <u>Federal C-1</u> | | | | |

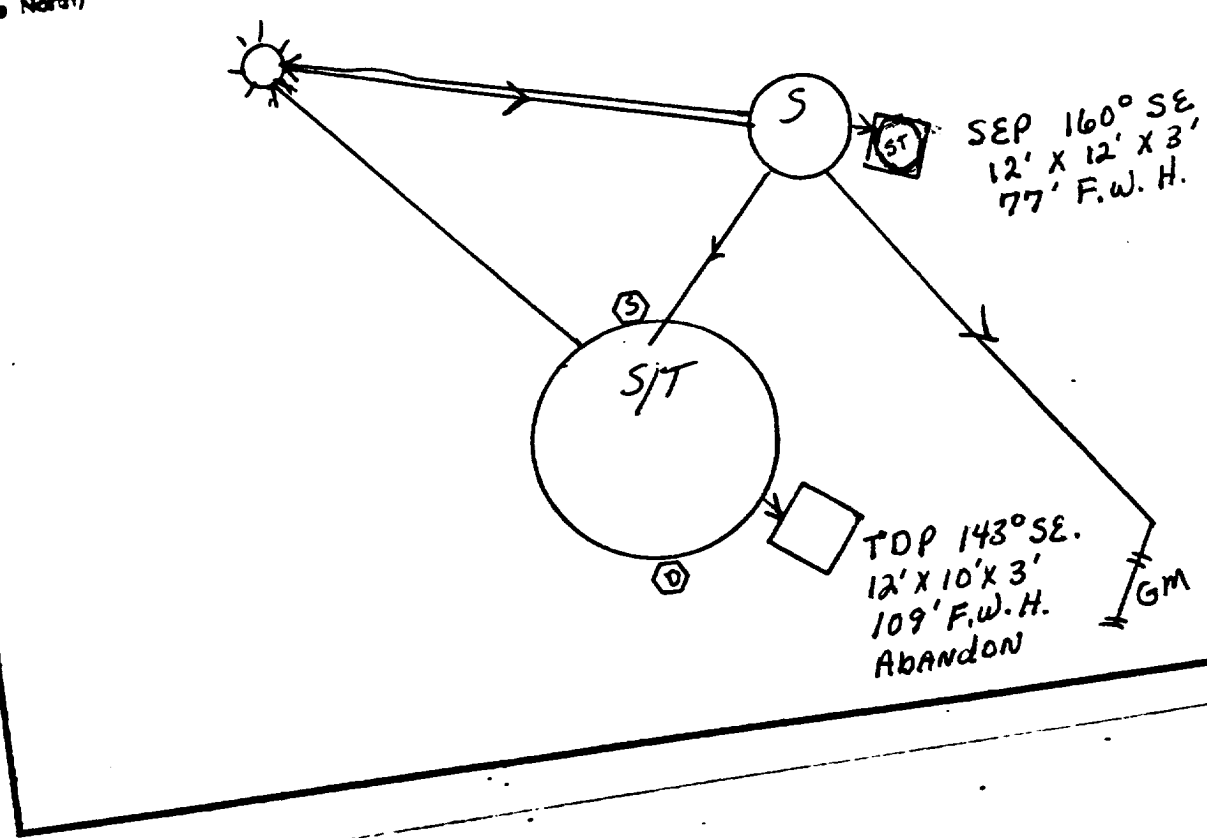
Lease Name: Federal C1  
Site Security  
(Indicate North)

Lease Name: Federal C1  
Federal/ Indian Lease No: NMSE 078138  
CA No.: 7940001810  
Unit: F  
Legal Description: Sect: 28 TP: 30N R: 11W  
County: SAN JUAN, NM

Load line valves :  
Sealed during Production

Drain line valves :  
Sealed during Production

Production Line valve:  
Sealed during sales
