gan, gan, dagan e camera — e m. e gaganese	1.40	
Sundry Notic	ces and Reports on Wells	- :34 - 33 	
1. Type of Well GAS JAN 1	型 (V) (E) () () () () () () () ()	5.	Lease Number NM-03202 If Indian, All. or Tribe Name

Pertinent Data Sheet - San Juan #10

SAN JUAN #10

BLANCO MESAVERDE/PICTURED CLIFFS UNIT M, SEC 10, T30N, R10W, SAN JUAN COUNTY, NM

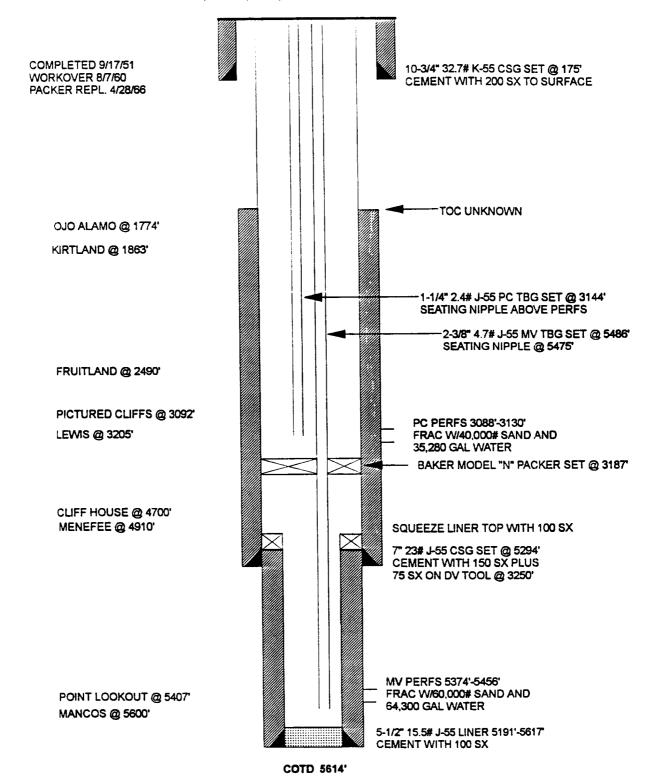
AS OF 7/12/95

Csg Size	Wt. & Grade	Depth Set	Cement	Top/Cement
10 3/4"	32.7# K-55	175'	200 sxs	to surface
7"	23# J-55	5294'	150 sxs	TOC unknown
			75 sxs on DV Tool @ 3250'	TOC unknown
5 1/3" Liner	15.5# J-55	5191'-5617'	100 sxs	Liner Top

Tubing Record: MV- 2 3/8" 4.7# J-55 tubing set at 5486'. Seating Nipple @ 5475'. Baker Mode: "N" Packer set @ 3187'. PC- 11/4" 2.4# J-55 tubing set at 3144'. Seating Nipple above perfs.
