Meter Number: 73839
Location Name: JOHN SCHUMACHER #2
Location: TN-30 RG-12
SC-08 UL-M
2 - Federal
NMOCD Zone: OUTSIDE
Hazard Ranking Score: 00

**RATIONALE FOR RISK-BASED CLOSURE OF PRODUCTION PITS
LOCATED OUTSIDE OF THE VULNERABLE ZONE
IN THE SAN JUAN BASIN**

FIELD PIT SITE ASSESSMENT FORM **EL PASO FIELD SERVICE**

FIELD PIT REMEDIATION/CLOSURE FORM

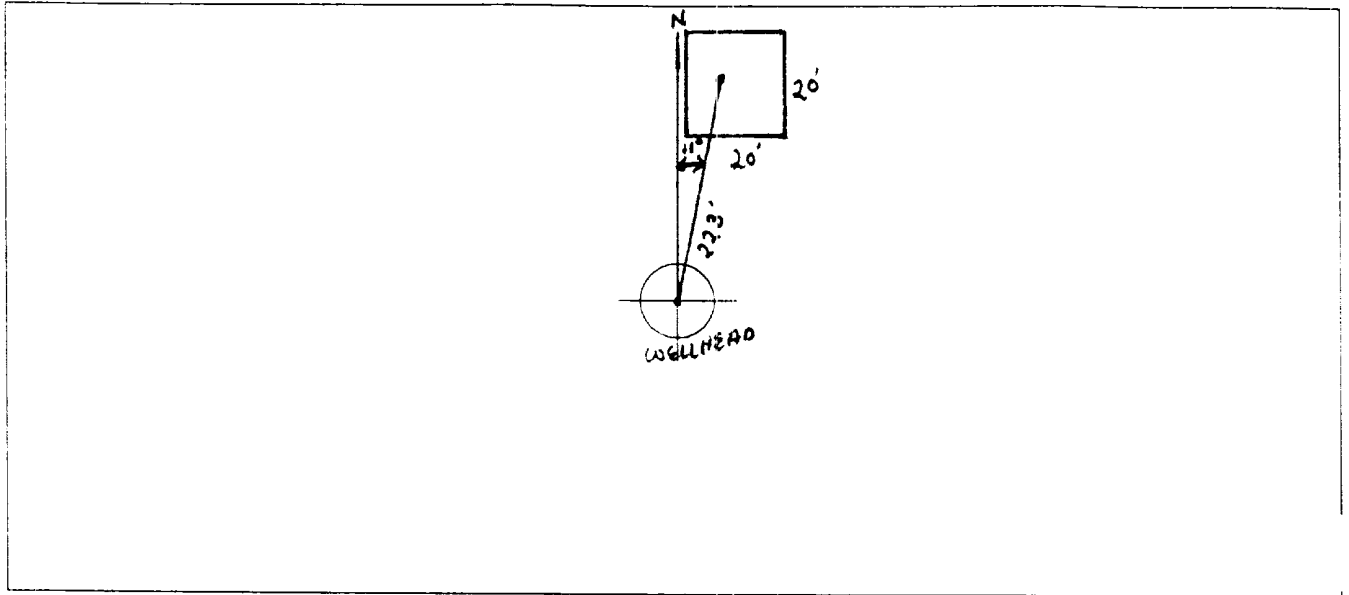
ORIGINAL PIT LOCATION

Original Pit : a) Degrees from North 11° Footage to Wellhead 223'
 b) Degrees from North _____ Footage to Dogleg _____
 Dogleg Name _____
 c) Length : 20' Width : 20' Depth : 2'

STARTED TAKING PICTURES AT 9:17 A.M.
END DUMP

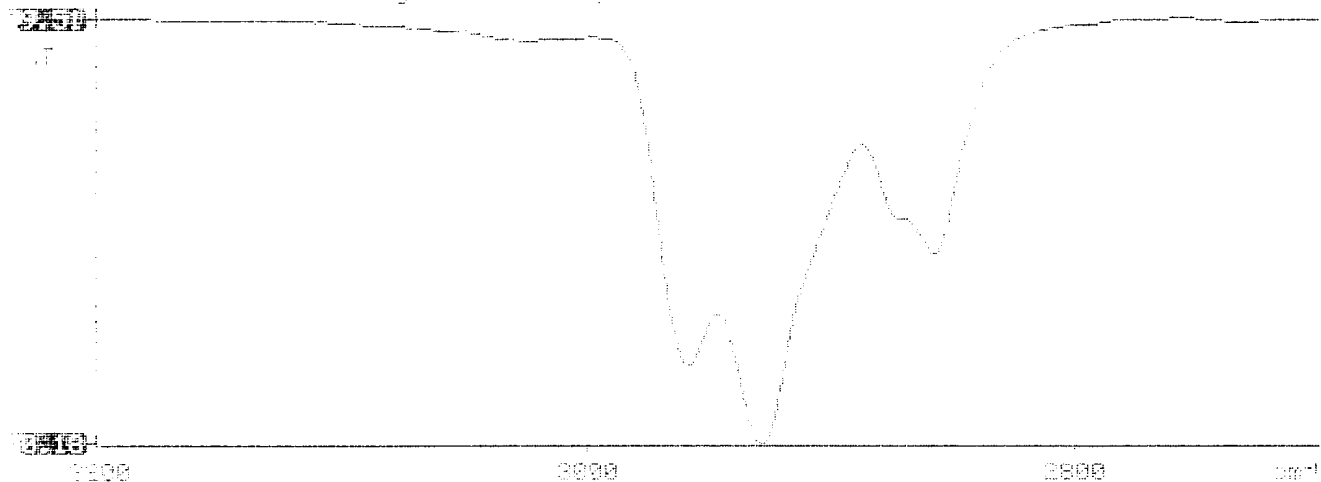
Petroleum hydrocarbons spectrum

Petroleum hydrocarbons, ppm
1711.791
Net absorbance of hydrocarbons (2930 cm⁻¹)
0.07
