## PIT REMEDIATION AND CLOSURE REPORT

| Operator: <u>Conoco Inc.</u> | | Telephone: <u>505-324-5813</u> | |
| Facility Or: <u>Bruington LS 5</u> | | | |
| Location: | Unit or Qtr/Qtr Sec | <u>    </u> C <u>    </u> Sec | <u>5</u> T <u>30</u> N R <u>11</u> W County <u>San Juan</u> |

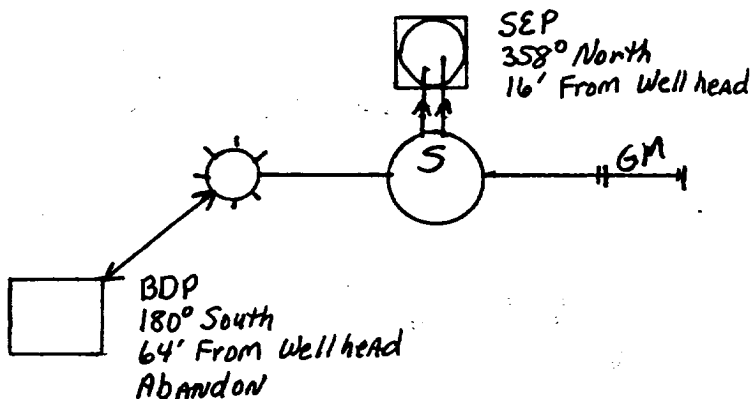
Site Security  
(Indicate North)

Load line valves :  
Sealed during Production

Drain line valves :  
Sealed during Production

Production Line valve:  
Sealed during sales

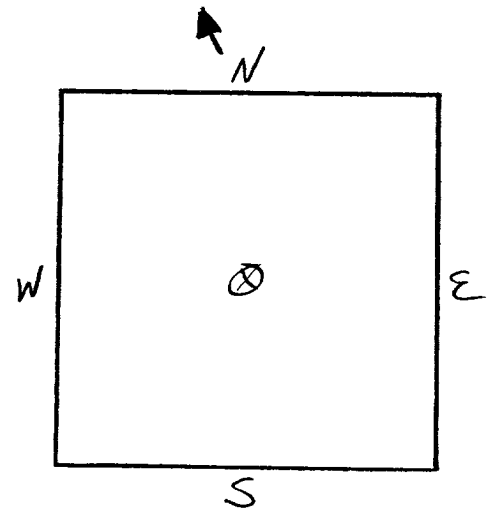
Bruington LS 5

SEP 12'x12'x3'

358° North 16' From WH. to  
CENTER of Pit.

Center of Pit.

Time. 1305  
PPM. 478

⊗ Sample Taken  
Bottom of Pit 3' IN

| General Description Of Remedial Action: | | <u>Sample taken -- till bottom of pit 1' -- back fill with clean soil</u> | |

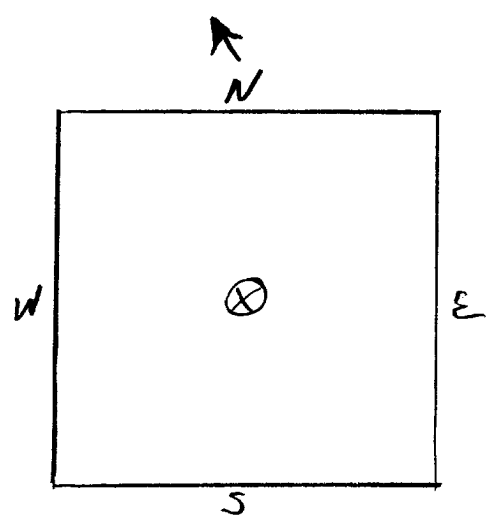
Bruington LS 5

BDP 12'x12'x3'

180° South, 64' From WH  
to center of Pit.

Center of Pit.

Time. 1300  
PPM. 8

⊗ Sample Taken  
3' IN From Bottom of Pit
