*J-33-32N-6W*  
**WELLBORE DIAGRAM**  
**ROSA UNIT #90A MV**

LOCATION: SURFACE 2025'FNL, 1875'FEL  
TD: 2033'FSL, 2109'FEL  
TD: NW/4 SE/4 SEC. 33, T32N, R6W  
SAN JUAN, Co., NM  
ELEVATION: 6365' GR  
KB: 12'

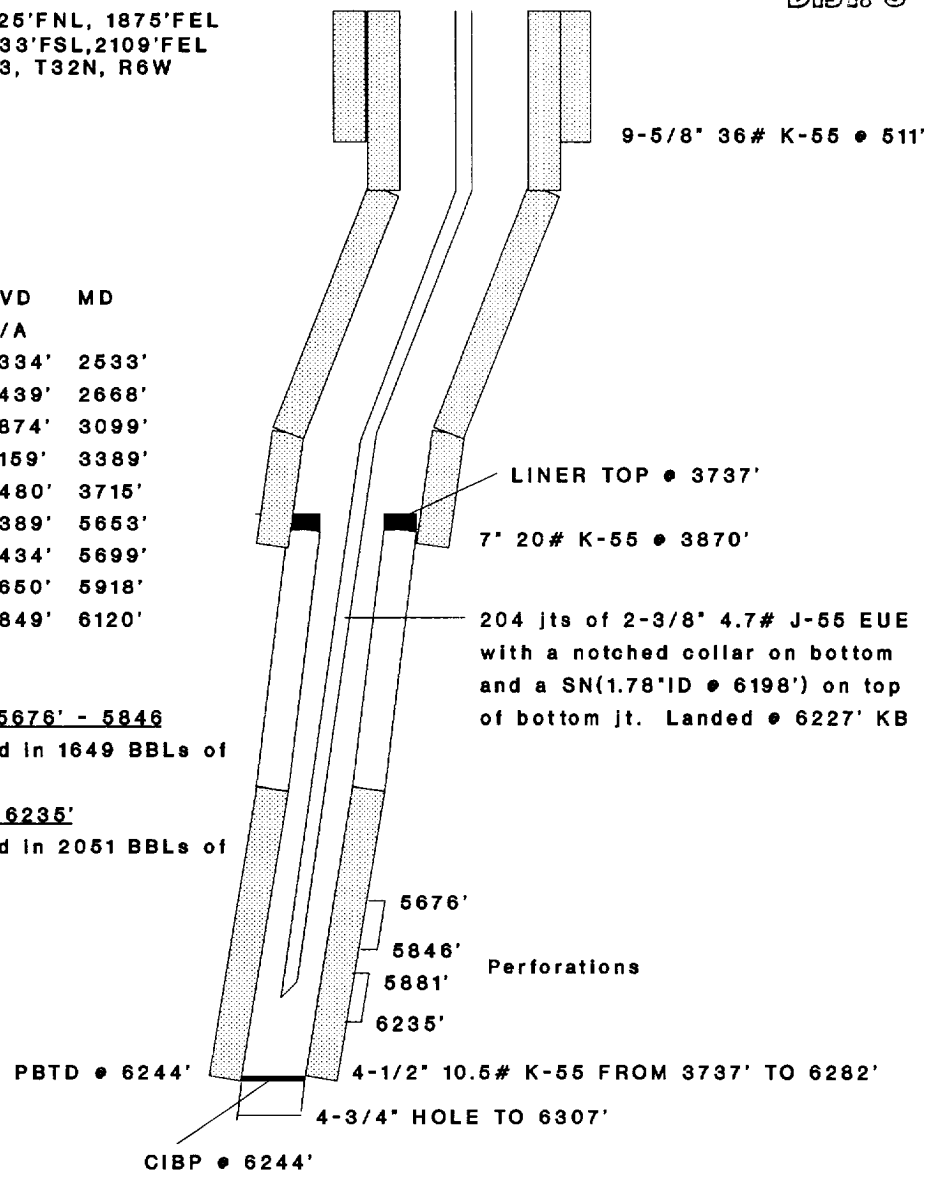
Cliff House/Menefee: 5676' - 5846  
65,000# of 20/40 sand in 1649 BBLs of slick water.  
Point Lookout: 5881' - 6235'  
74,500# of 20/40 sand in 2051 BBLs of slick water.

| HOLE SIZE | CASING | CEMENT | VOLUME | TOP OF CMT |
|---|---|---|---|---|
| 12-1/4" | 9-5/8" 36# | 265 SX | 315 CU.FT. | SURFACE |
| 8-3/4" | 7" 20# | 700 SX | 1218 CU.FT. | SURFACE |
| 6-1/4" | 4-1/2" 10.5# | 245 SX | 424 CU.FT. | 5430'(CBL) |
