Closure Report

Site Name:	Bass Federal #5 Battery
Company:	Chevron USA
Legal Description:	U/L N, Section 30, T20S, R33E
County:	Lea County, NM
GPS Coordinates:	N 32.53852° W 103.70440°

Chevron
Bass Federal #5 Battery

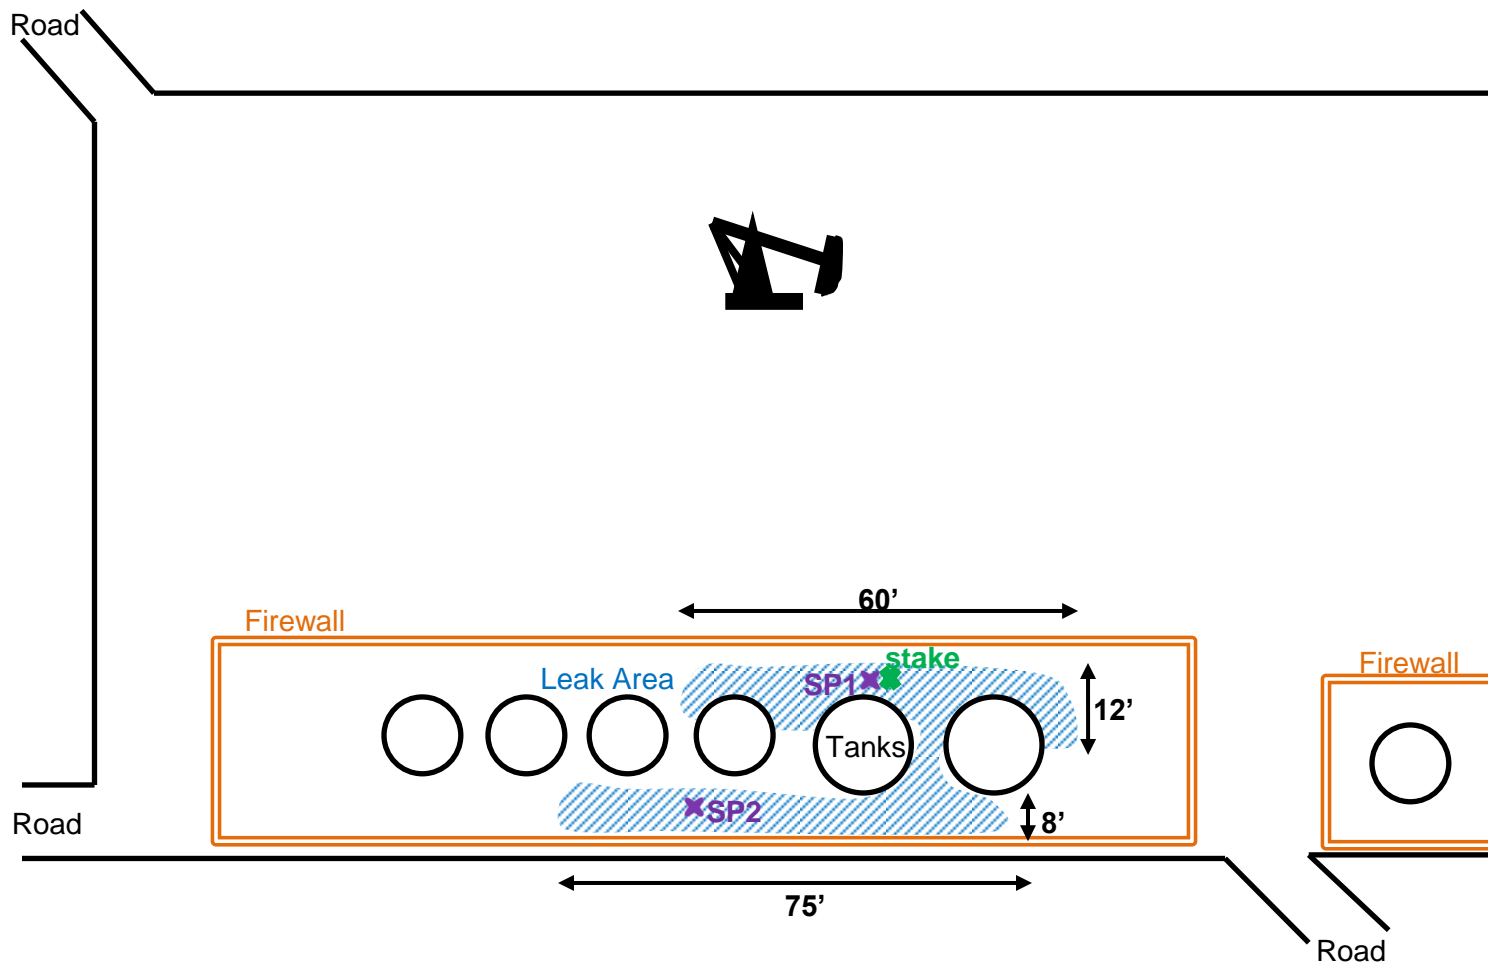
U/L N, Section 30, T20S, R33E
Lea County, NM
N 32.53852° W 103.70440°
API# 30-025-34550

BBC International, Inc.	
Chevron	
Bass Federal #5 Battery	
Date: 04/30/2015	DRWG by: K. Purvis
NOT TO SCALE	File: Chevron 2015

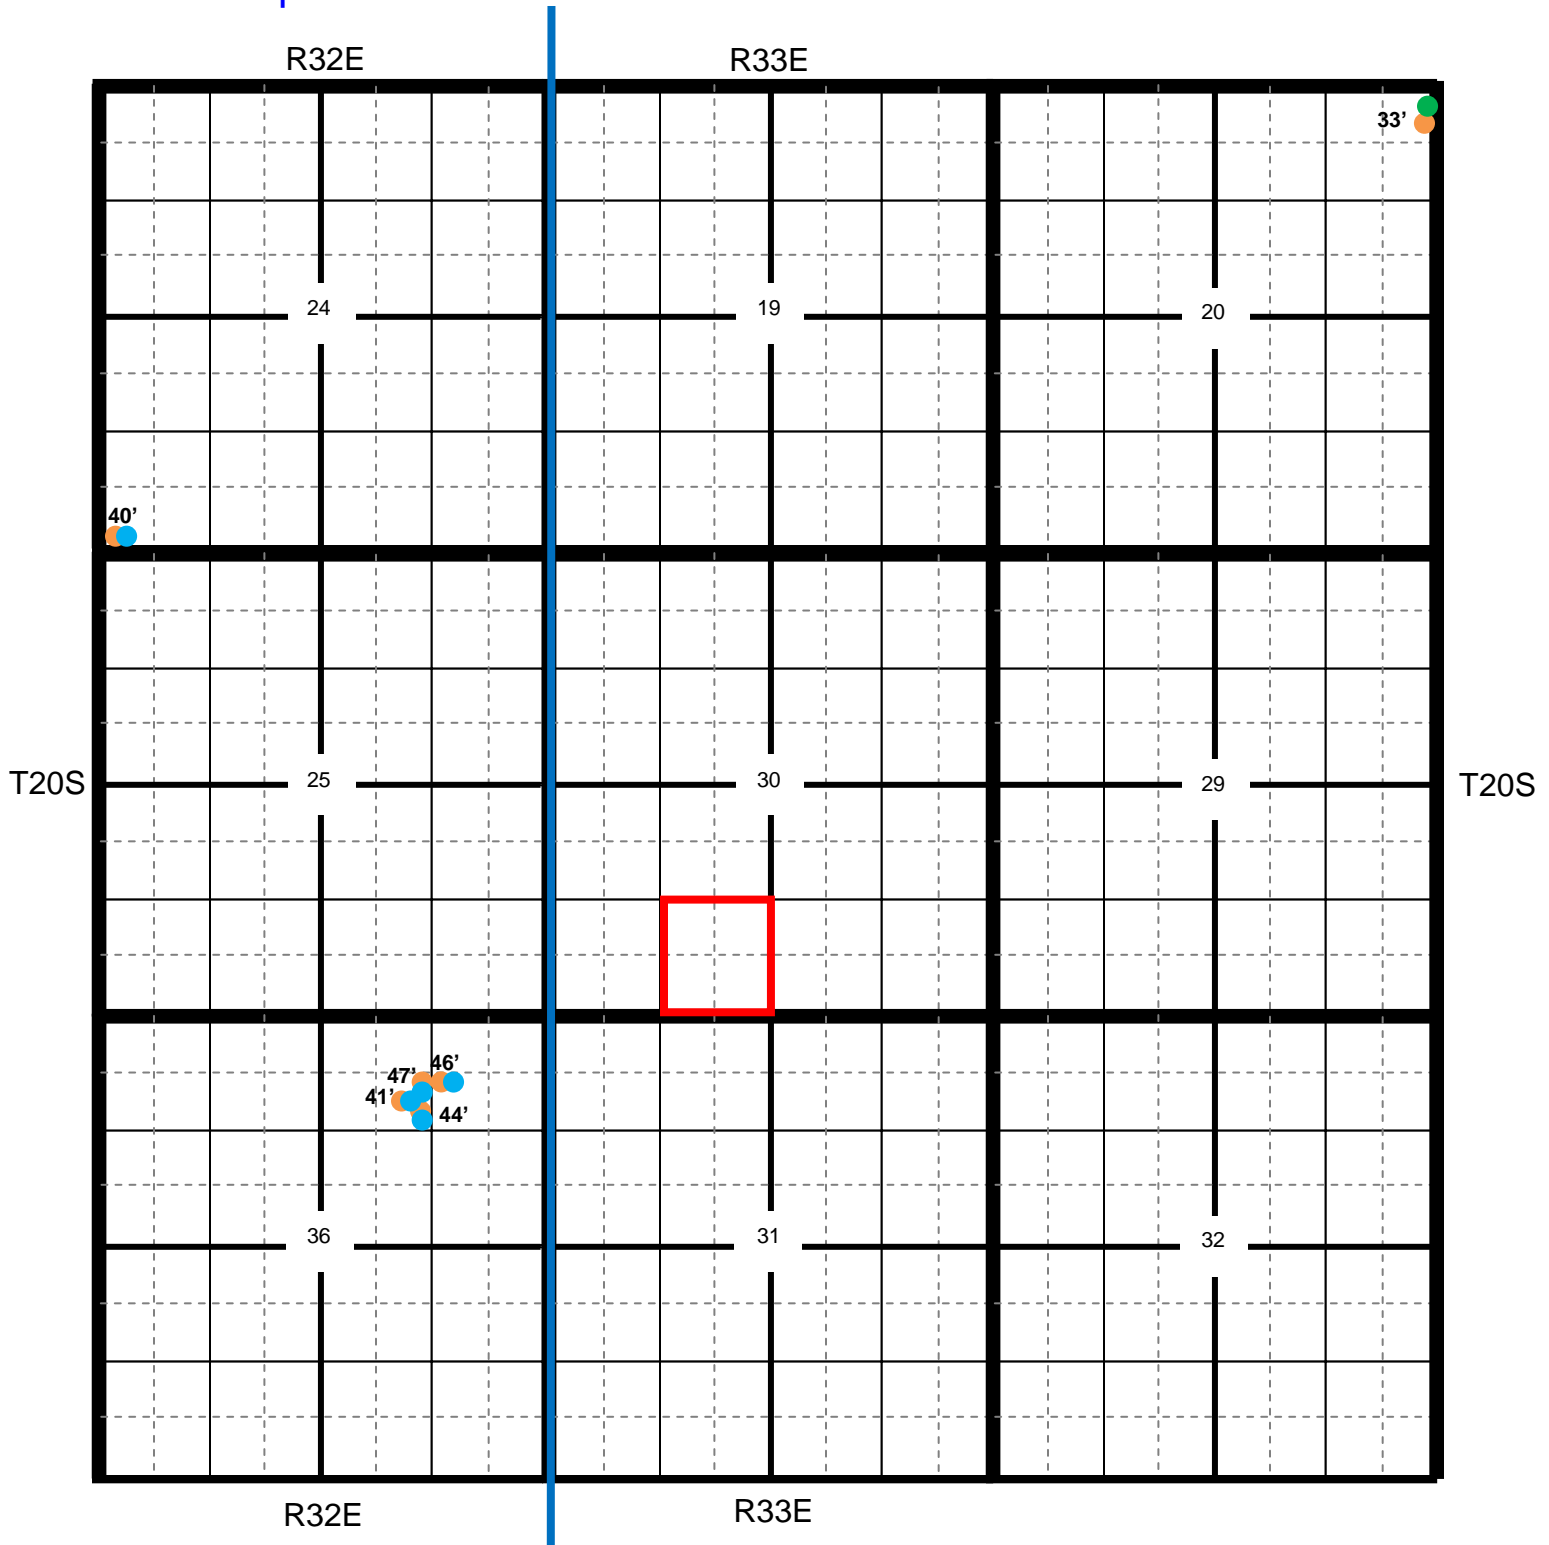
Groundwater Plot

Trend Map 50'-75'

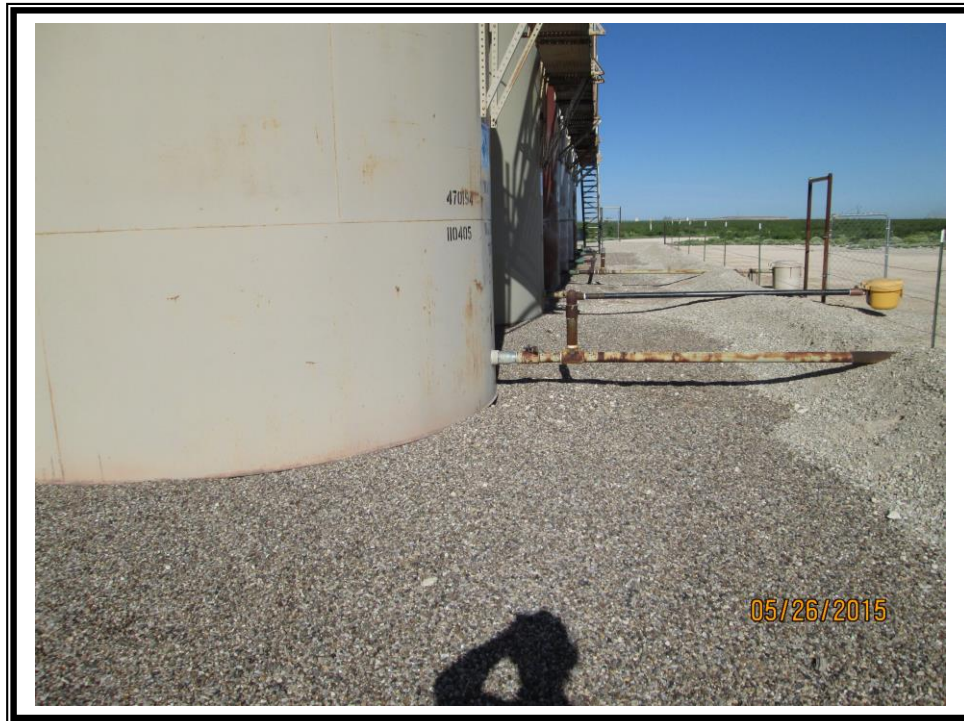
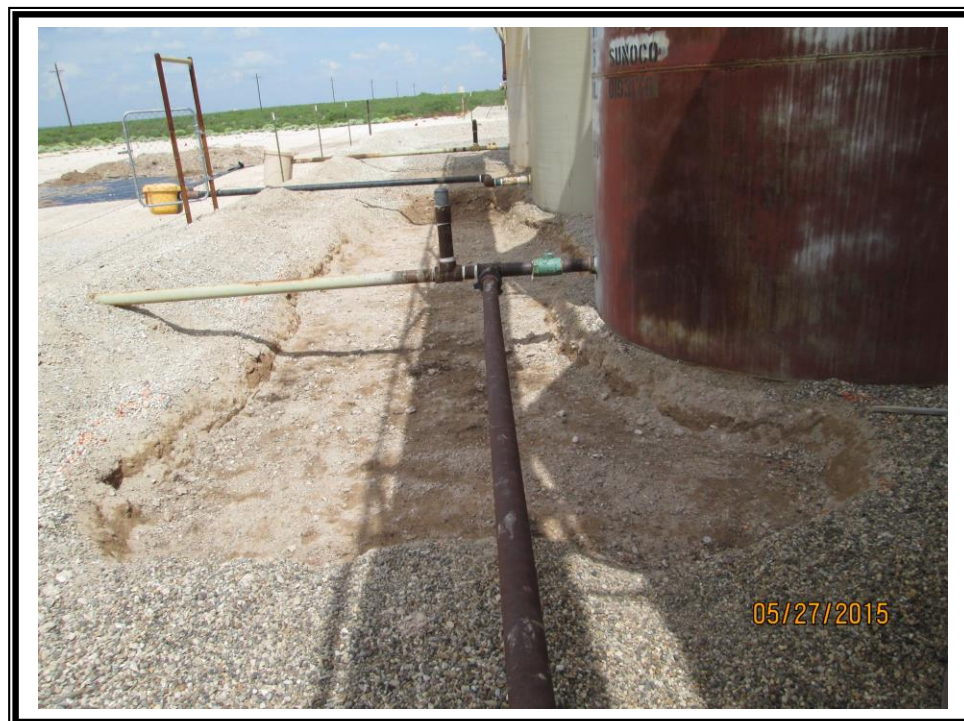
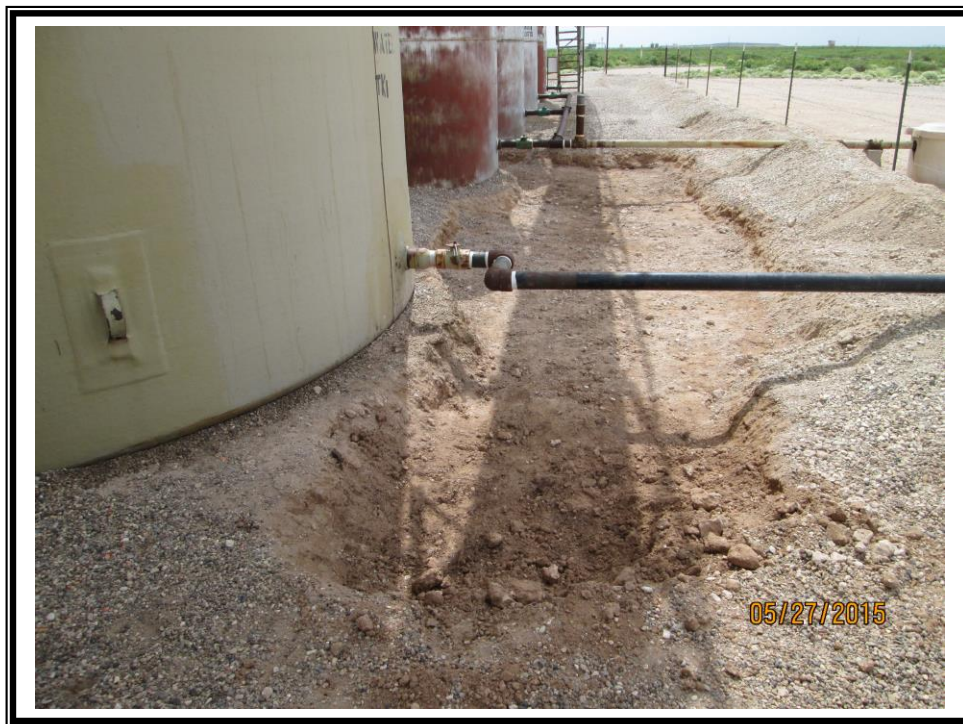
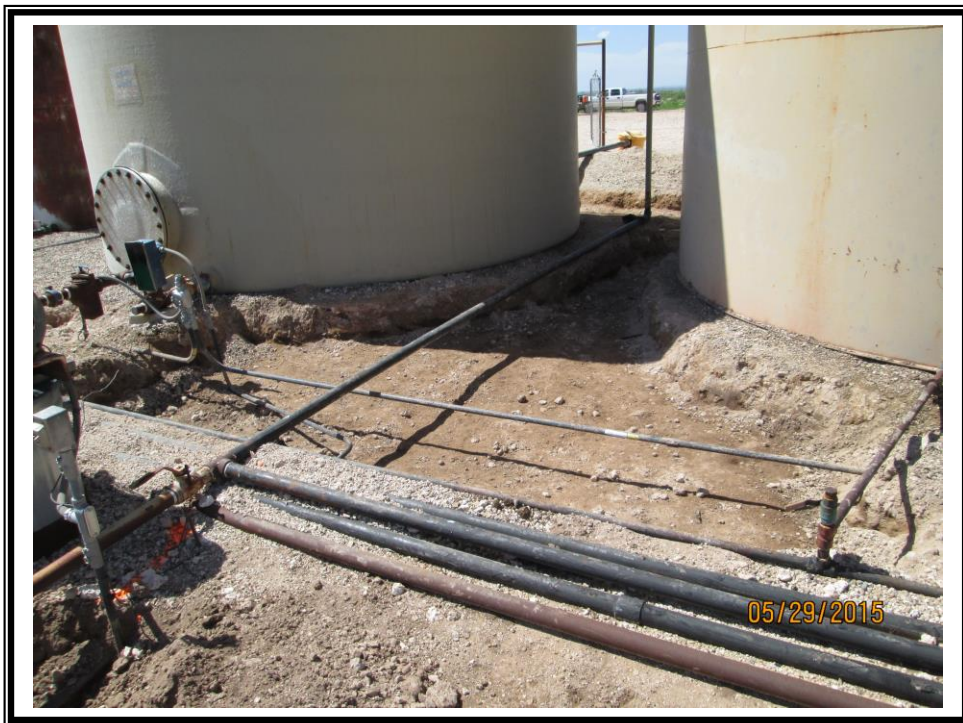
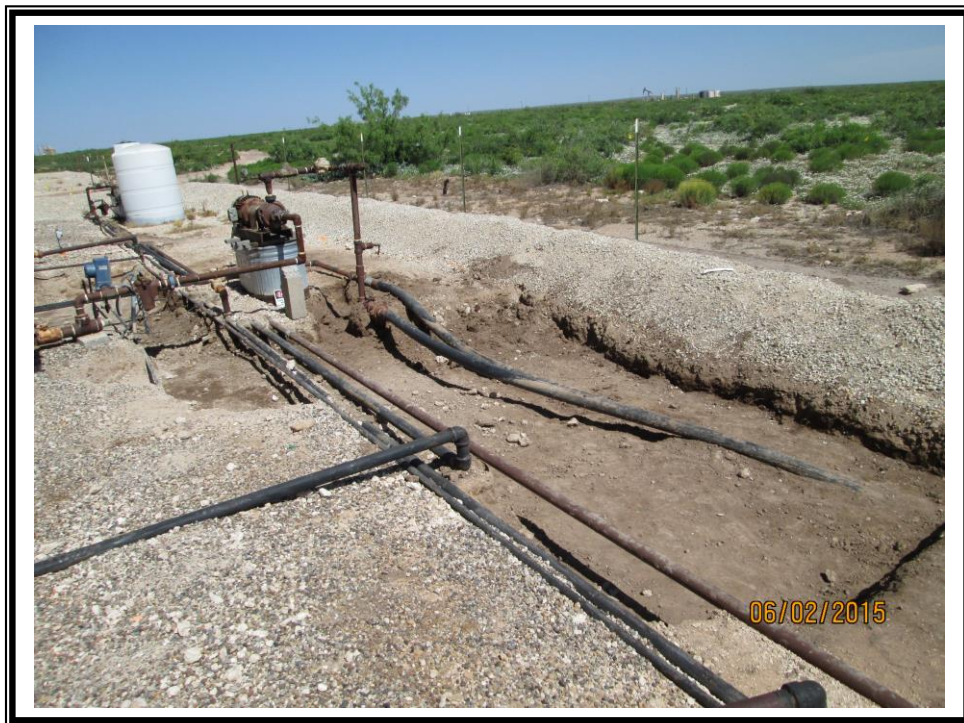
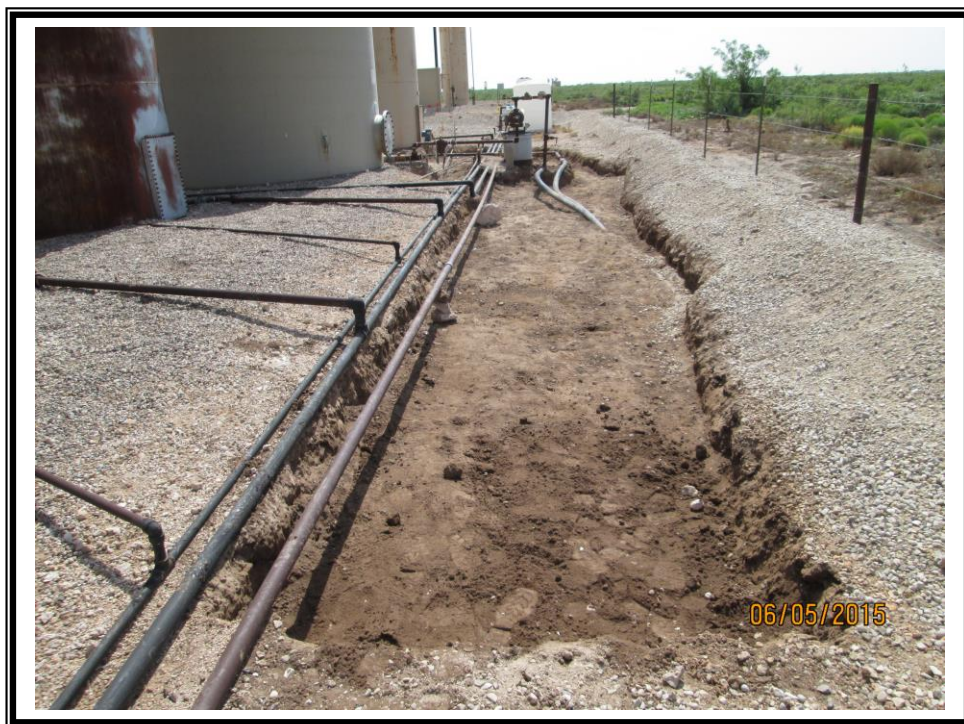
I have attached the corrected remediation packet. The drawing was corrected (my apologies), the initial C-141 has the correct surface owner on it, and I included some pictures of the spill area inside the battery. These pictures are some of the area that is being excavated. I hope this meets your request. If you need anything else, please let me know.

I have attached the materials that we used in our discussion on May 19th concerning the remediation plan for the illegal dumping spill that occurred inside Chevron's Bass Federal #5 Battery. As you recall, it was agreed that 1 foot of impacted soil would be hand excavated in the spill area and then backfilled with clean soil.
