Closure Report

Site Name:	SHU #172 Injection line
Company:	Oxy Permian Ltd.
Legal Description:	NE ¼, Section 9, T19S, R38E
County:	Lea County, NM
GPS Coordinates:	N 32.68019° W 103.147789°

Date of Release:	07/11/2015
Type of Release:	Produced water
Source of Release:	Stress/fatigue of a 4" fiberglass injection line
Volume of Release:	150 bbls
Volume Recovered:	0 bbls

Remediation Parameters:	Surface scrape the areas around SP1, SP2, SP3, & SP4. No action is required in the trench area near sample points SP5, SP6, & SP7. Backfill the site with clean soil.	
Remediation Activities:	11/13/2015 to 11/16/2015	
Plan Sent to OCD:	08/17/2015	Email from Cliff Brunson to Kellie Jones
OCD Approval of Plan:	08/18/2015	Email from Kellie Jones to Cliff Brunson
Plan Sent to BLM:	n/a	n/a
BLM Approval of Plan:	n/a	n/a

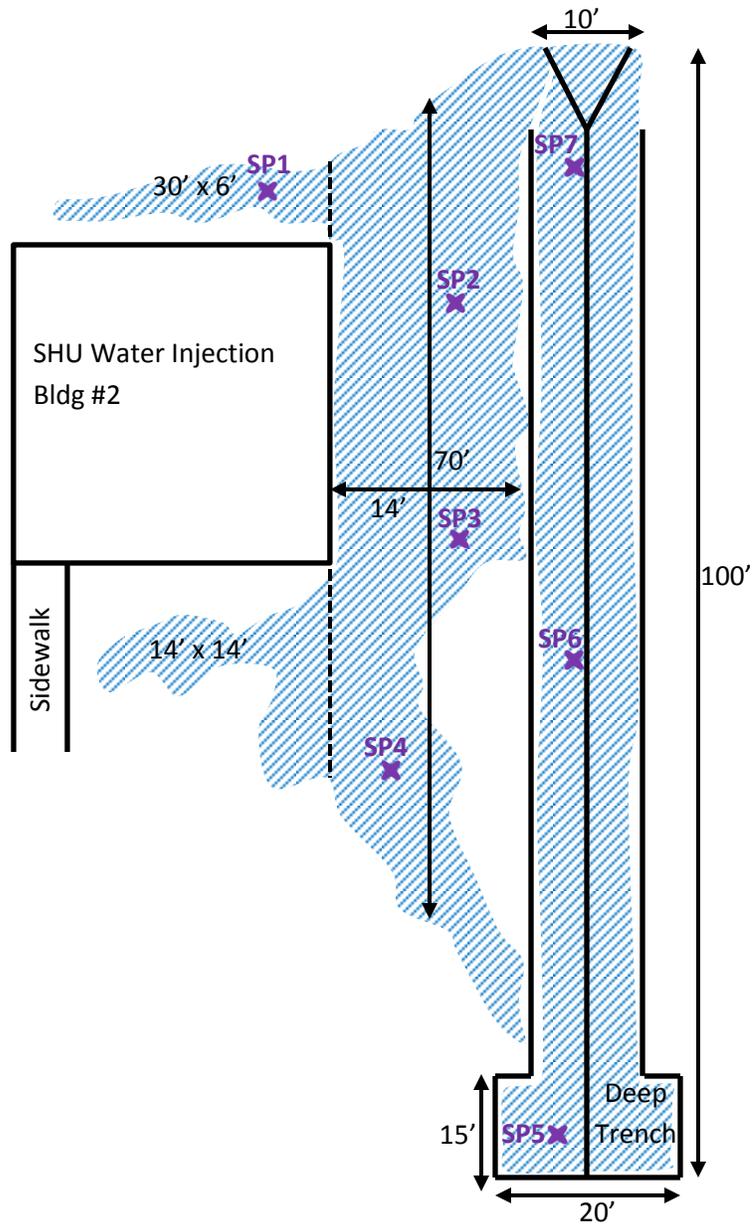
Oxy

SHU #172 Injection line

NE ¼, Section 9, T19S, R38E

Lea County, NM

N 32.68019° W 103.147789°

API# 30-025-28543

BBC International, Inc.

Oxy SHU #172 Injection line

Date: 07/15/2015

DRWG by: K. Purvis

NOT TO SCALE

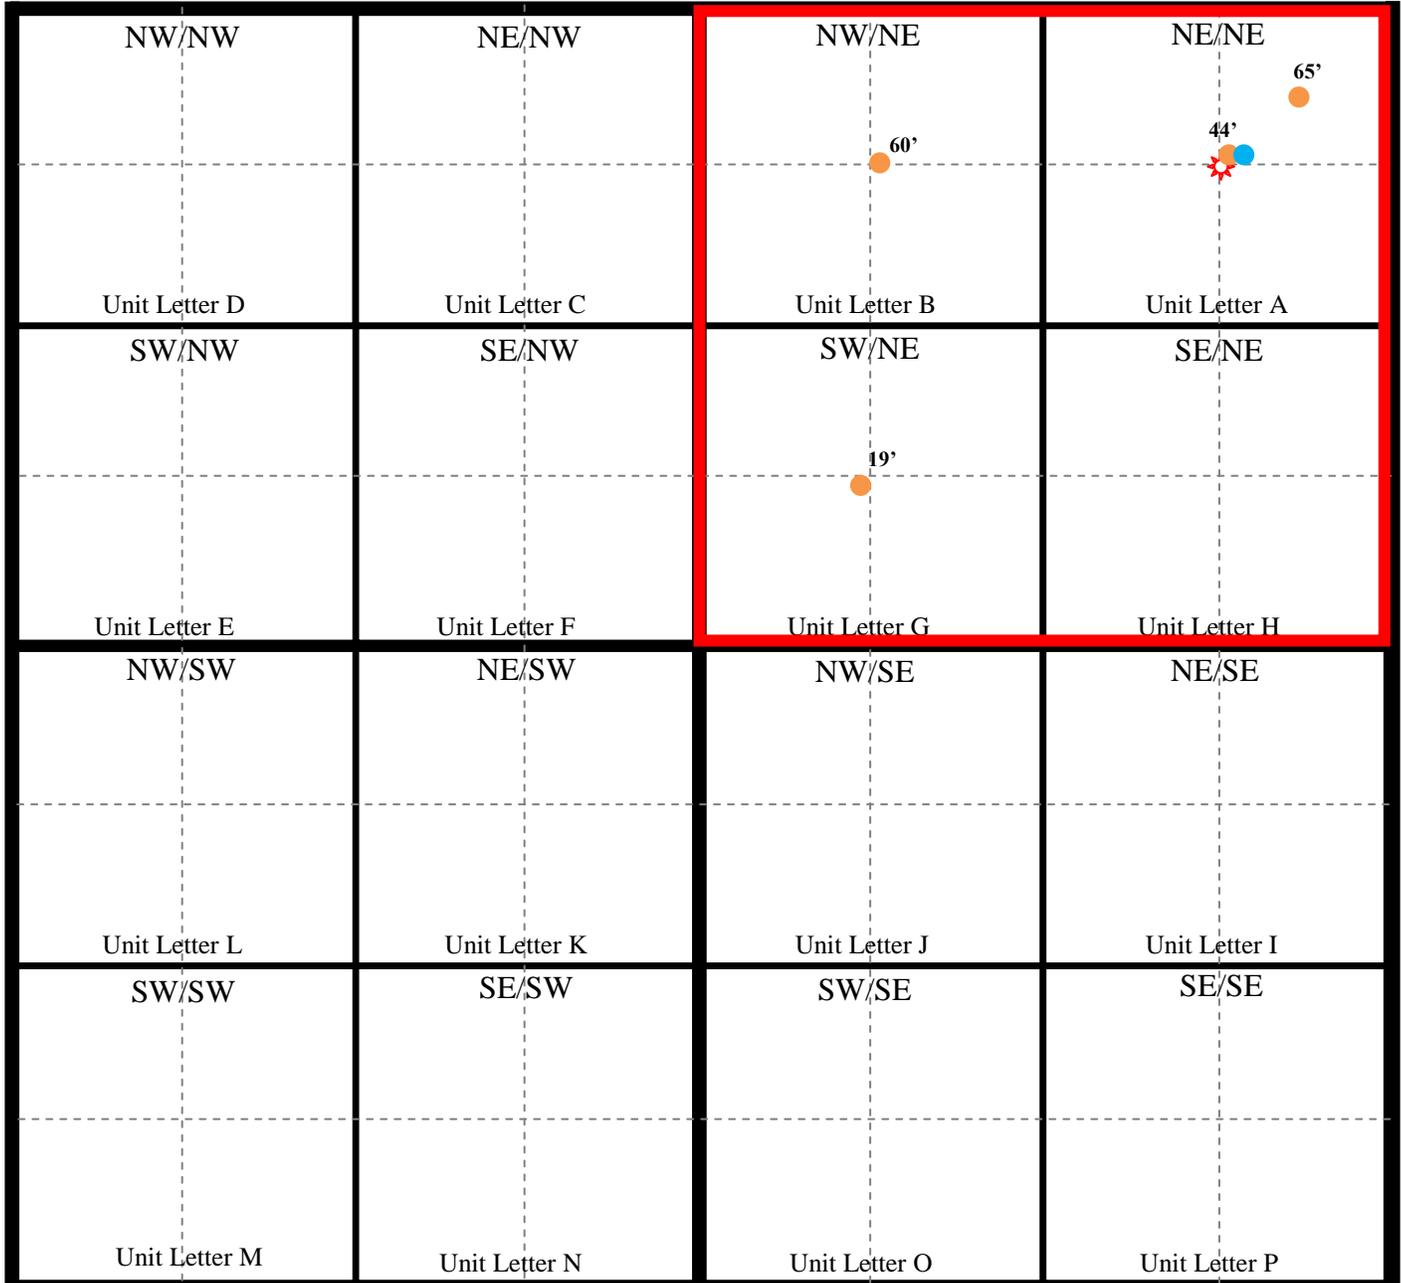
Trend Map 25'-75'

Oxy SHU #172 Injection line

County: Lea Unit Letter: NW ¼ Section: 9 Township: 19S Range: 38E

✳ Location
 ● OCD
 ● USGS
 ● SEO
 ● All Databases
