Release Notification and Corrective Action

Name of Company	John H. Hendrix Corporation	Contact	Carolyn Doran Haynes
Address	P. O. Box 3040, Midland, TX 79702	Telephone No.	432-684-6631
Facility Name	Jennings A Federal Battery	Facility Type	Production Lease Facility
Surface Owner	Federal	Mineral Owner	Federal
			API No. 30-025-27940

Jennings A Federal Battery Release Site 06-13-18 before clean-up

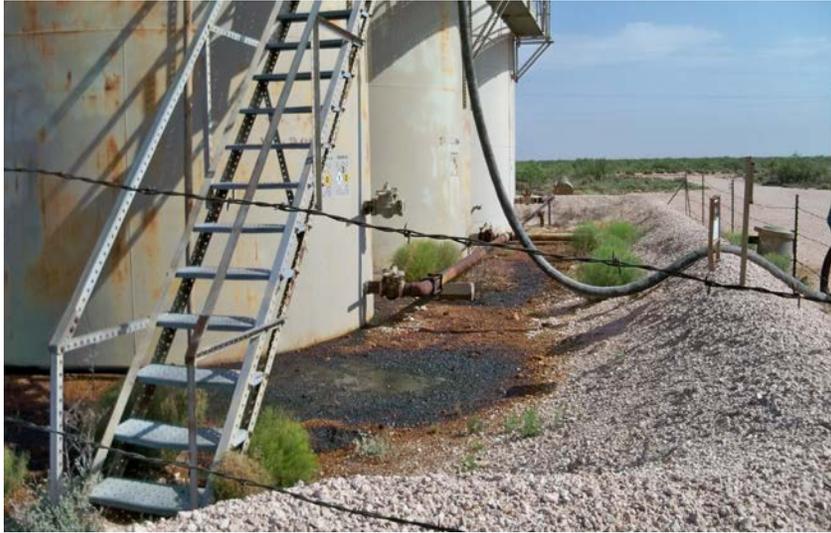
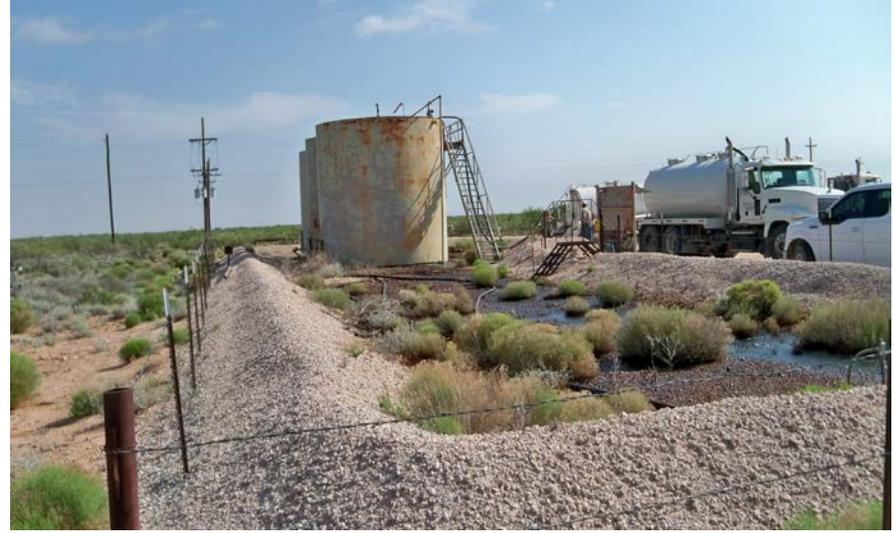
Production oil tank failed from leak under thief hatch. Tank will be opened, cleaned and repaired or replaced as warranted. All released fluid remained within the facility berm area. Volume is unknown, but by last tank gauge, 150-200 bbls.

The area affected is approximately 80' x 20', all within the facility berm. Oil stained surface soils to 3-6" below surface. (This finding argues that the release was actually much less than 150-200 bbls.) The impacted soils will be scraped-up, staged and hauled to Sundance or remediated on site. Any residual impact left in place will naturally attenuate until facility abandonment. The facility area will be returned to operation when all the repairs are complete. A final C-141 will be submitted upon completion. Photos attached.
