Release Notification

Site Name: Rojo 26 Oil Dump Valve Failure	Site Type: Tank Battery
Date Release Discovered: 8/16/2022	API# (if applicable) Nearest well:

Location Rojo 14Y-17H / Rojo 26 Oil Dump Valve Failure API # Spill Date 8/16/2022

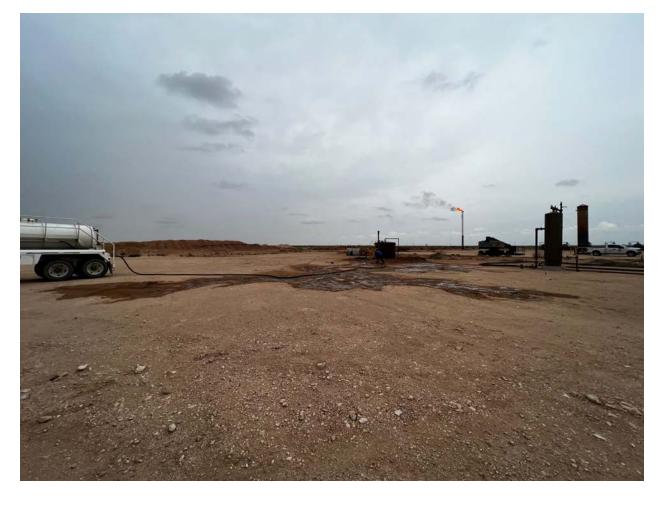
Rojo 14Y-17H Tank Battery Rojo 26 Oil Dump Valve Failure

Oil Dump Controller Malfunction. Oil dump valve was replaced, and the snap controller did not seat properly causing oil to overflow from the Rojo #26H separator to the compressor catch tank. Catch tank overflowed for less than 30 minutes, releasing 10 BO onto the caliche well pad. Recovered 8 BO with vacuum truck. Spill volume calculation is included.
