**Re: Site Assessment, Remediation, and Closure Report**  
**Burton Flat Deep Unit 61H**  
**API No. 30-015-43136**  
**GPS: Latitude 32.5076509 Longitude -104.1585985**  
**UL -- J, Sec. 2, T21S, R27E**  
**Eddy County, NM**  
**NMOCD Ref. No. NAPP2300160892**

Pima Environmental Services, LLC. (Pima) has been contracted by Devon Energy Production Company, LP (Devon) to perform a spill assessment, remediation activities, and submit this closure report for a crude oil release that occurred at the Burton Flat Deep Unit 61H (Burton). The initial C-141 was submitted on January 11, 2023 (Appendix C). This incident was assigned Incident ID NAPP2300160892 by the New Mexico Oil Conservation Division (NMOCD).

**NAPP2300160892:** On January 1, 2023, a stainless tubing for the Murphy had come apart causing fluid released onto the pad. The released fluids were calculated to be approximately 6.9 barrels (bbls) of crude oil. A vacuum truck was able to recover 1 bbls of standing fluid.

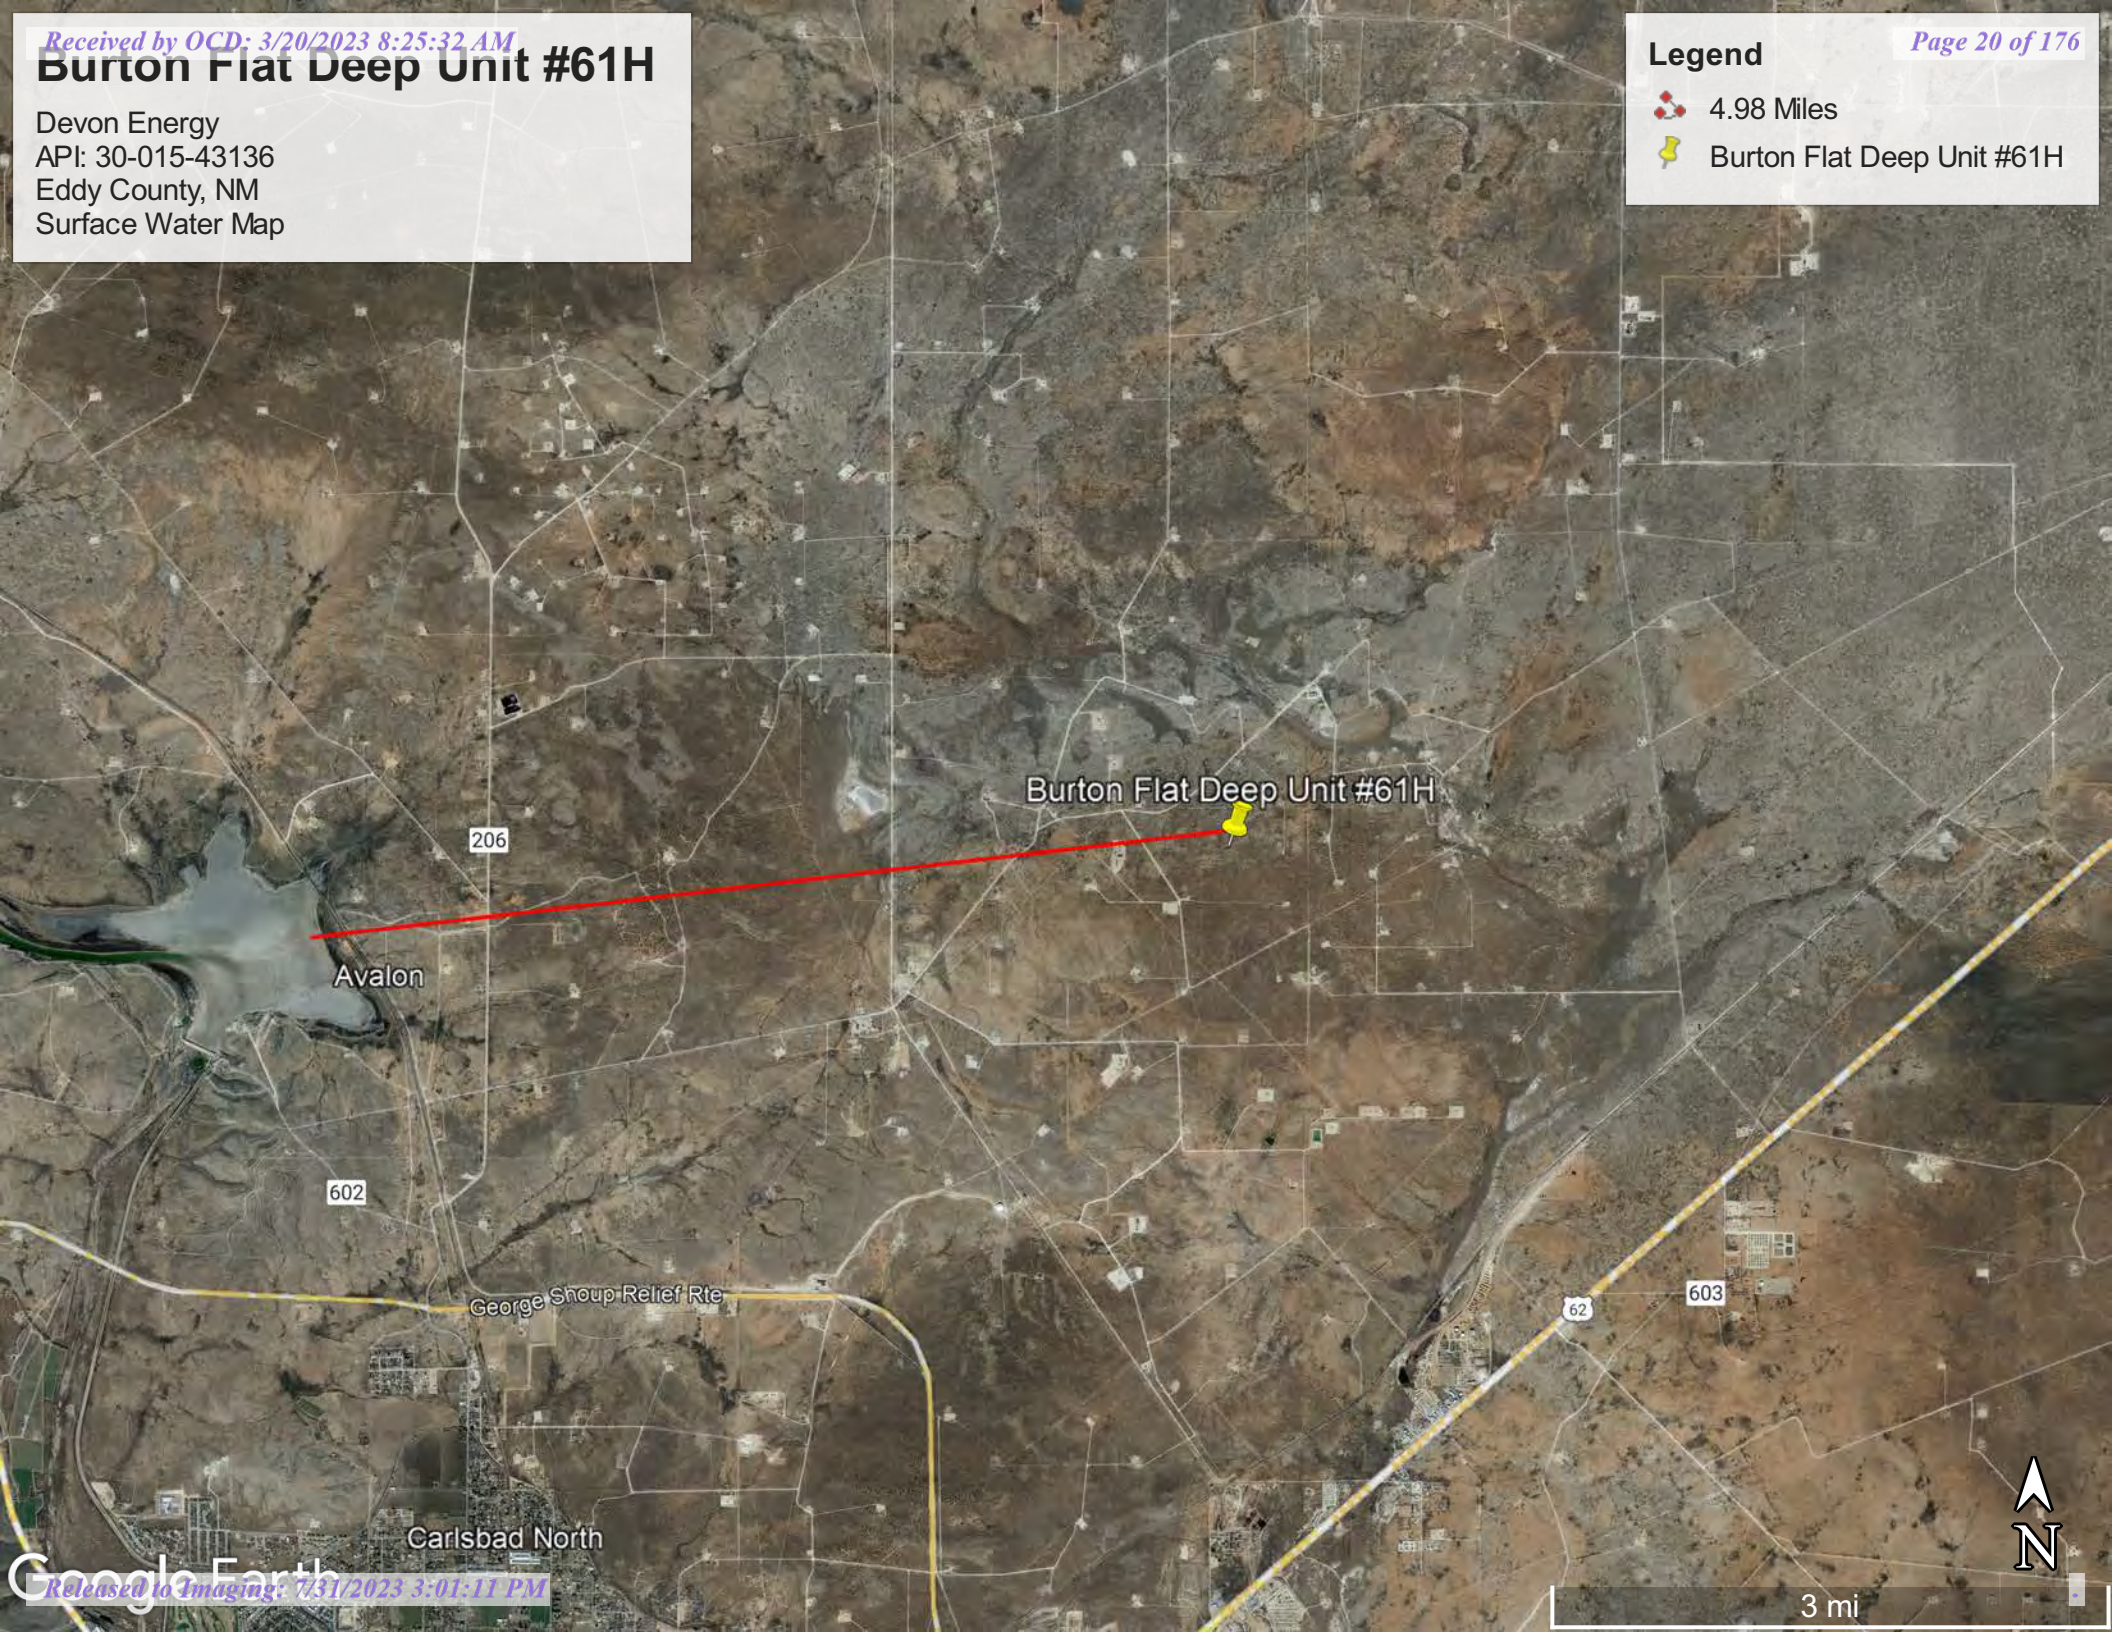
Burton Flat Deep Unit #61H

On March 3, 2023, after sending a 48-hour notification (Appendix C), Pima returned to the site to collect confirmation samples of the excavation. The results of this sampling event can be found in the following table. A Confirmation Sample Map can be found in Figure 5.
