2022 Annual Report

Maljamar E&P (AP-115-1)
Lea County, New Mexico

#212C-HN-02006
January 25, 2023

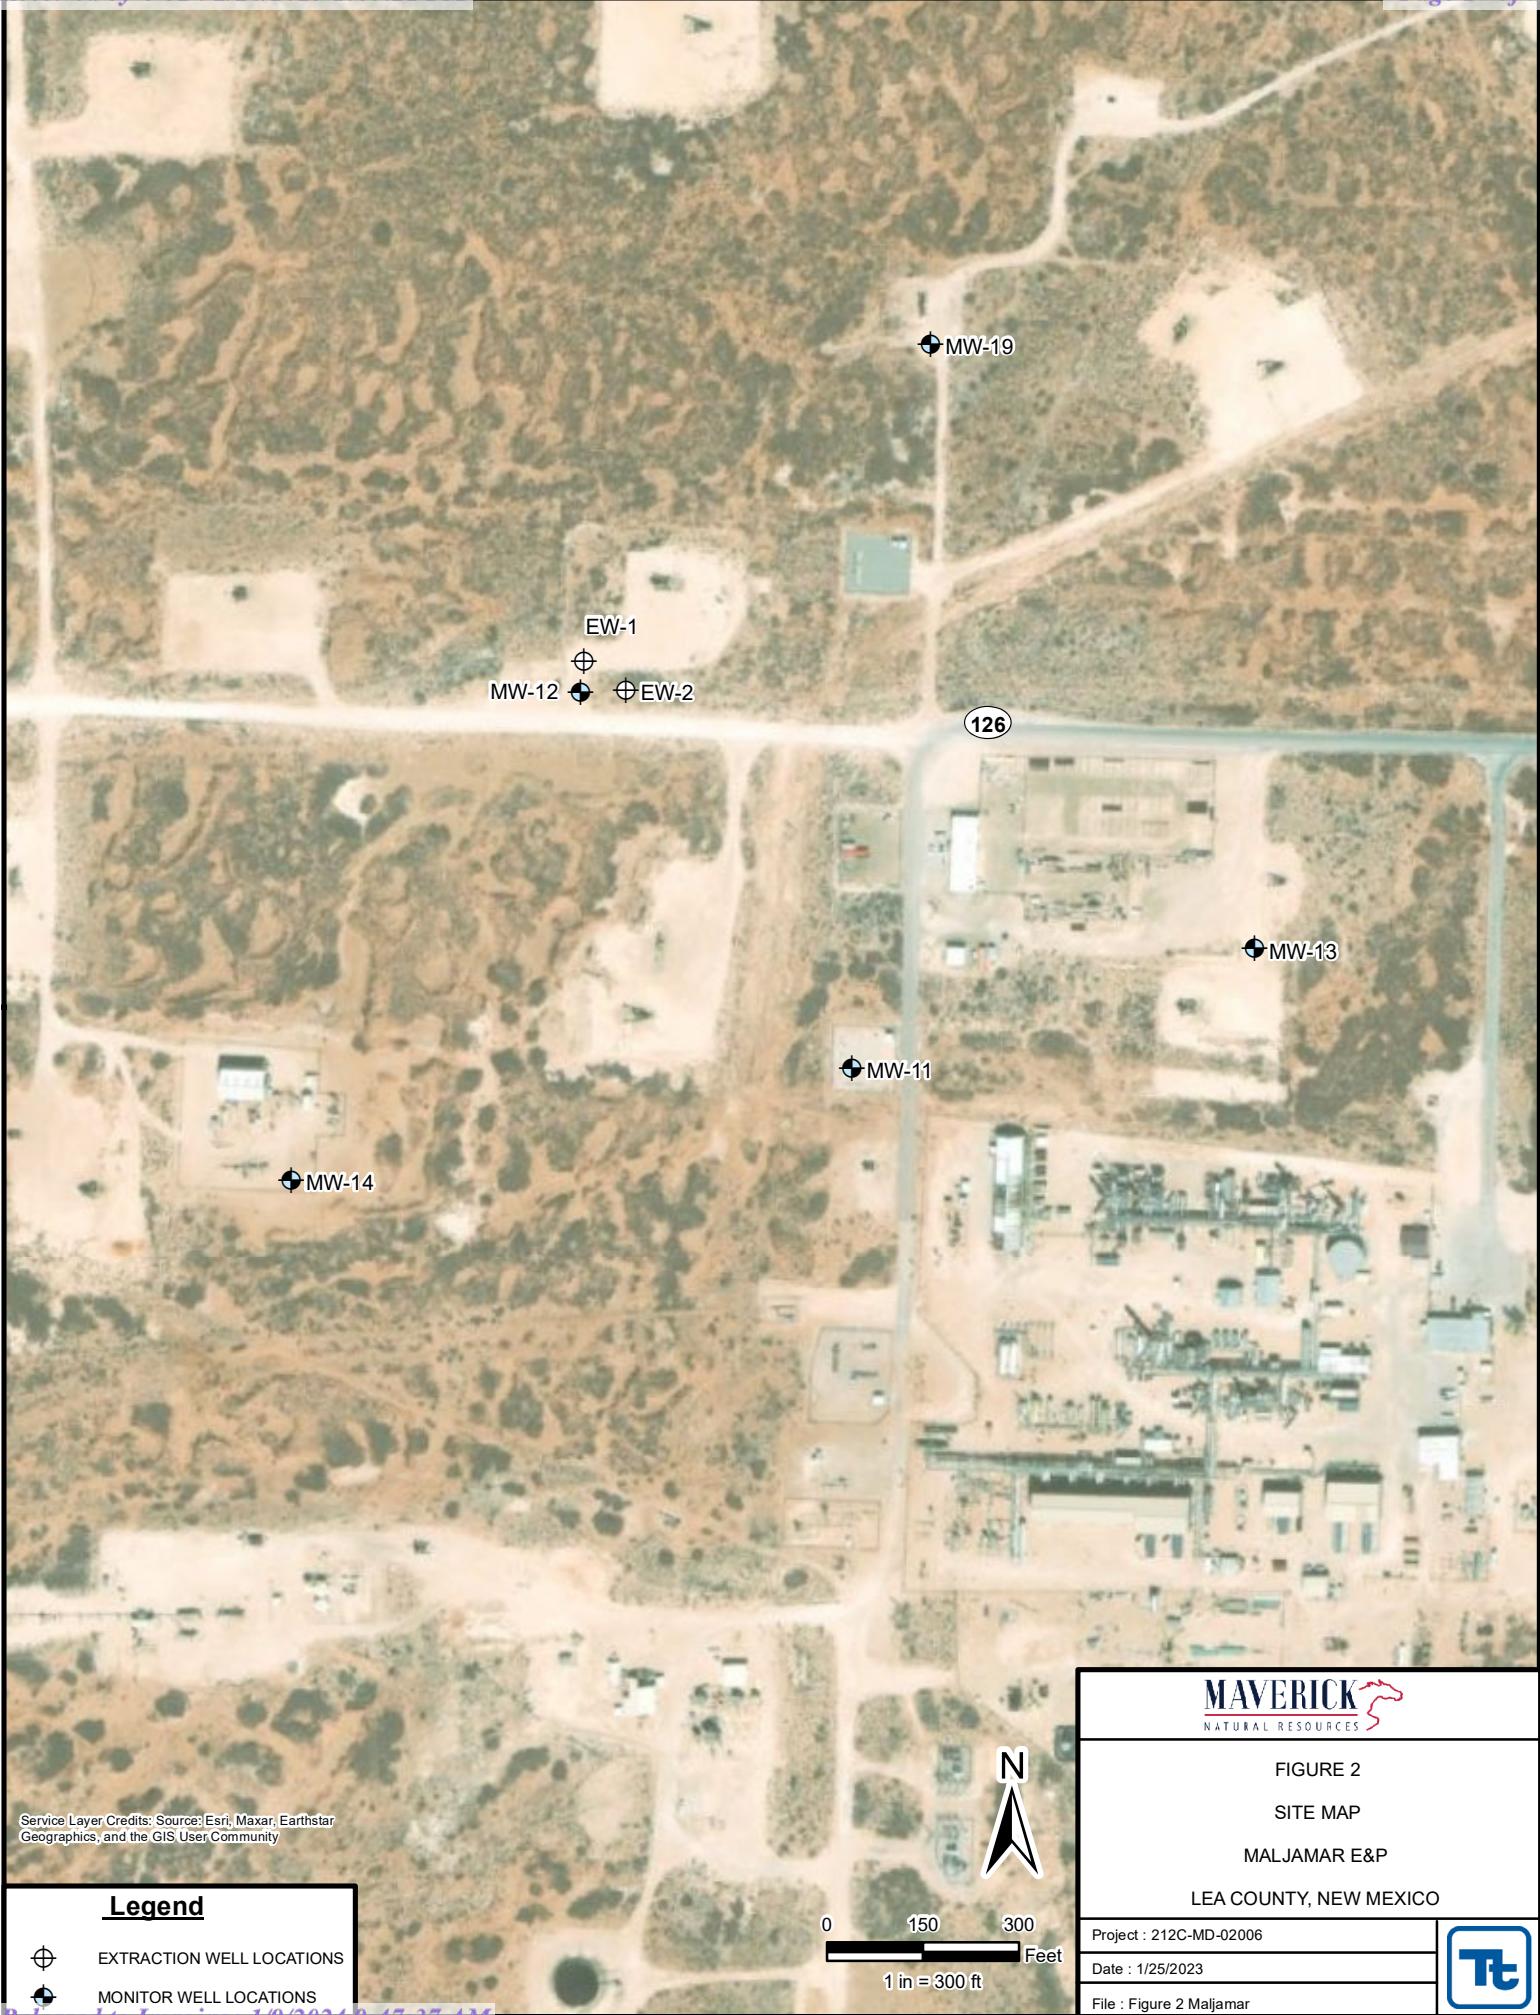
On October 17, 2014, a letter was submitted to the NMOCD listing wells that would be managed by COP following the split of ConocoPhillips upstream and downstream assets. Groundwater monitoring wells managed as part of this Site included MW-11, MW-12, MW-13, MW-14, and MW-19, and extraction well EW-1. Based on the distance from the Site, MW-18 and MW-20 were considered to be unrelated and would no longer be monitored. A map of the extraction and monitor wells is shown in **Figure 2**.

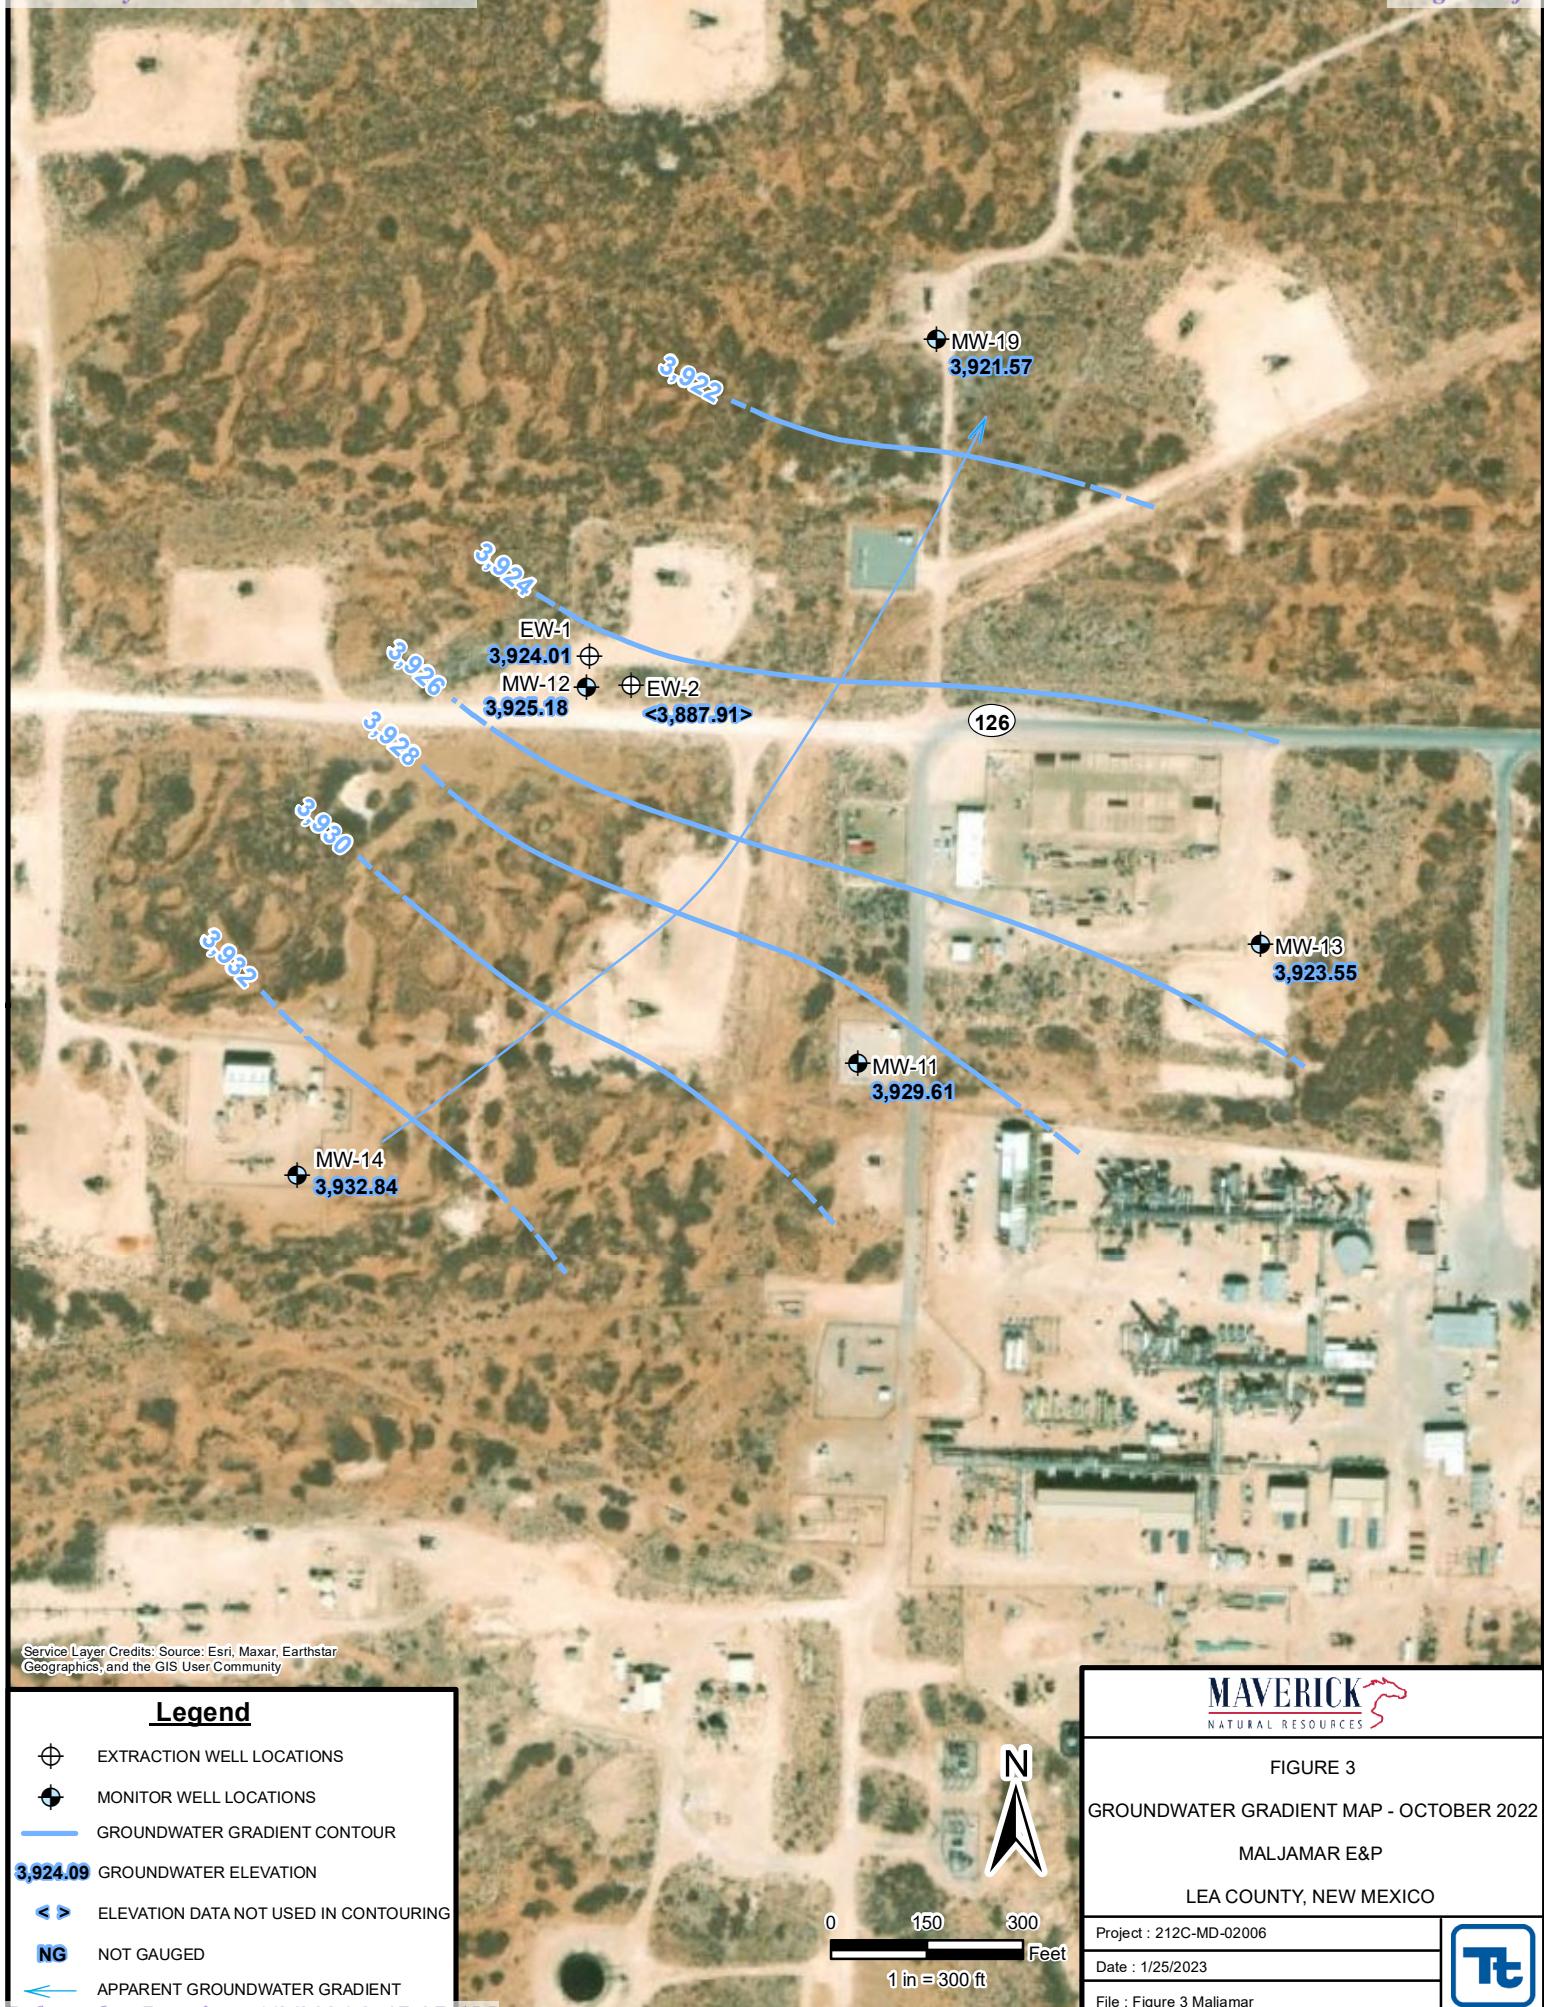
In 2022, groundwater elevations ranged from 3,921.57 feet above mean sea level (AMSL) in MW-19 to 3,932.84 feet AMSL in MW-14. Groundwater elevations and the groundwater potentiometric surface map are presented in **Figure 3**. Groundwater flow at the Site was shown to flow to the northeast with an approximate hydraulic gradient of 0.00689 feet per foot in 2022, generally consistent with historical groundwater flow direction and gradient.

As discussed above in **Section 3**, Apparent groundwater flow at the Site appears to historically have been affected by groundwater extraction from EW-1 and EW-2 in combination with the pinch out of the groundwater-bearing zone to the northeast and northwest. Based on the COC concentration distributions and groundwater investigations conducted at the unrelated Maverick MCA 357 site approximately 0.6 miles south the true groundwater flow direction at the site is anticipated as to the south.

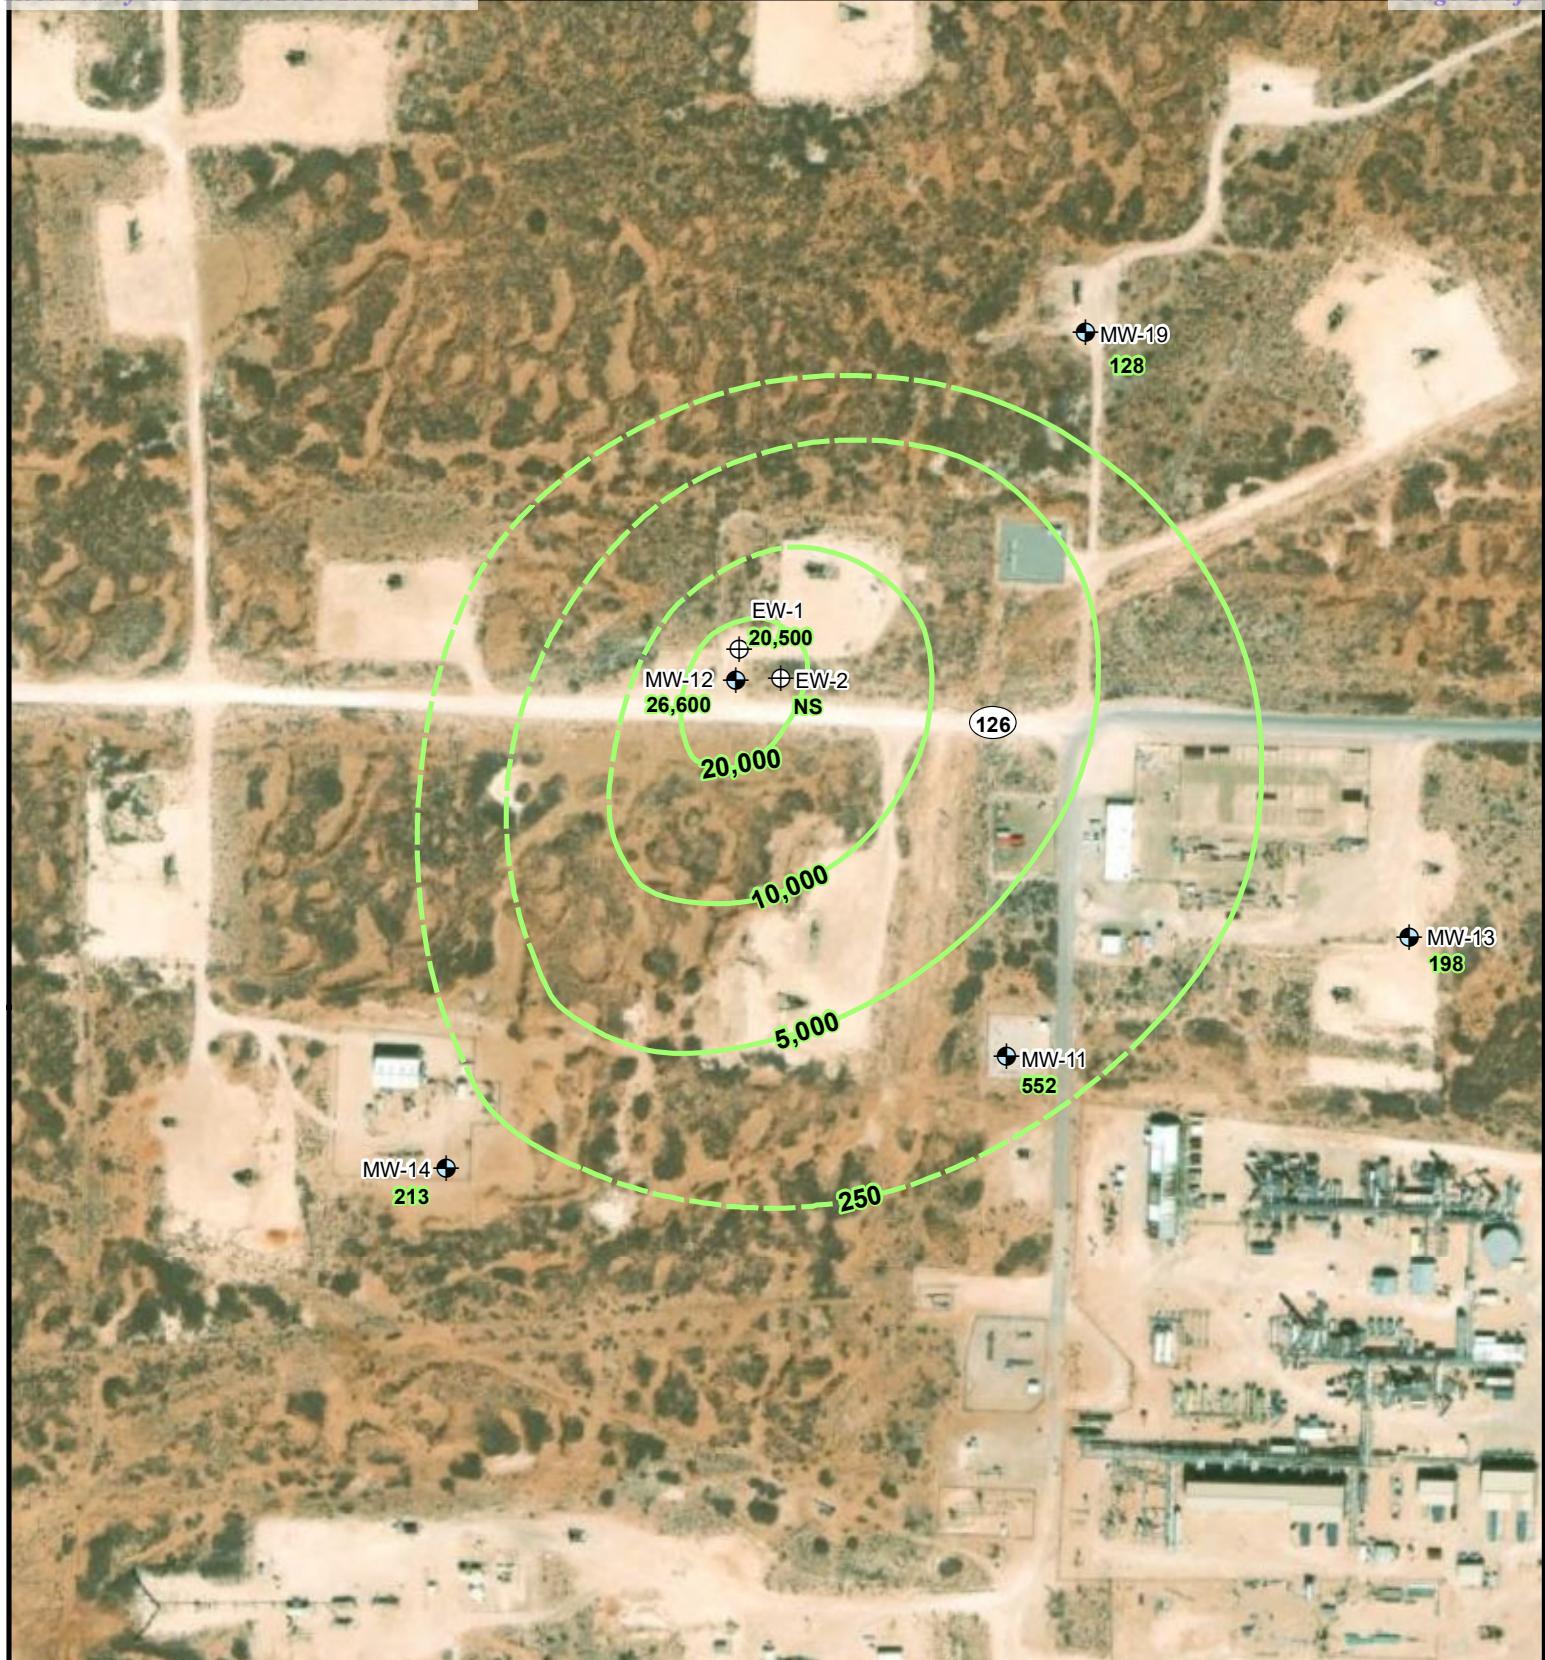
FIGURE 4
CHLORIDE CONCENTRATION MAP - OCTOBER 2022
MALJAMAR E&P
LEA COUNTY, NEW MEXICO
Project : 212C-MD-02006
Date : 1/25/2023
File : Figure 4 Maljamar

- Chloride was reported in EW-1 (20,500 mg/L), MW-11 (552 mg/L), and MW-12 (26,600 mg/L) at concentrations greater than the NMWQCC standard of 250 mg/L;
- Sulfate was reported in MW-12 (933 mg/L) and MW-14 (790 mg/L) at concentrations greater than the NMWQCC standard of 600 mg/L; and
- TDS was reported in EW-1 (44,900 mg/L), MW-11 (1,290 mg/L), MW-12 (45,900 mg/L), and MW-14 (1,400mg/L) at concentrations greater than the NMWQCC standard of 1,000 mg/L.

Chloride concentrations appear to be generally stable or decreasing in the majority of the wells. In particular, concentrations are decreasing over time in the wells with the highest chloride concentrations. No NMWQCC standard exceedances were reported in MW-19 during 2022. **Table 2** presents a summary of the groundwater analytical results screened against NMWQCC Groundwater Quality Standards. The laboratory analytical report and chain-of-custody documentation are provided in **Appendix A**, chloride, sulfate, and TDS concentration maps are provided in **Figures 4 through 6**, and chloride concentration trend graphs are presented in **Appendix B**.
