**Re: Reclamation Report  
Mesa B 22-25 Tank Battery (Mesa B East)  
Incident Number nAPP2209078912  
Lea County, New Mexico**

Ensolum, LLC (Ensolum), on behalf of BTA Oil Producers, LLC (BTA), has prepared the following *Reclamation Report* for the Mesa B 22-25 Tank Battery (Mesa B East) (Site). This *Reclamation Report* documents the Site history, reclamation activities completed to date, and proposes a vegetation monitoring plan.

BTA Oil Producers, LLC  
Reclamation Report  
Mesa B 22-25 Tank Battery (Mesa B East)

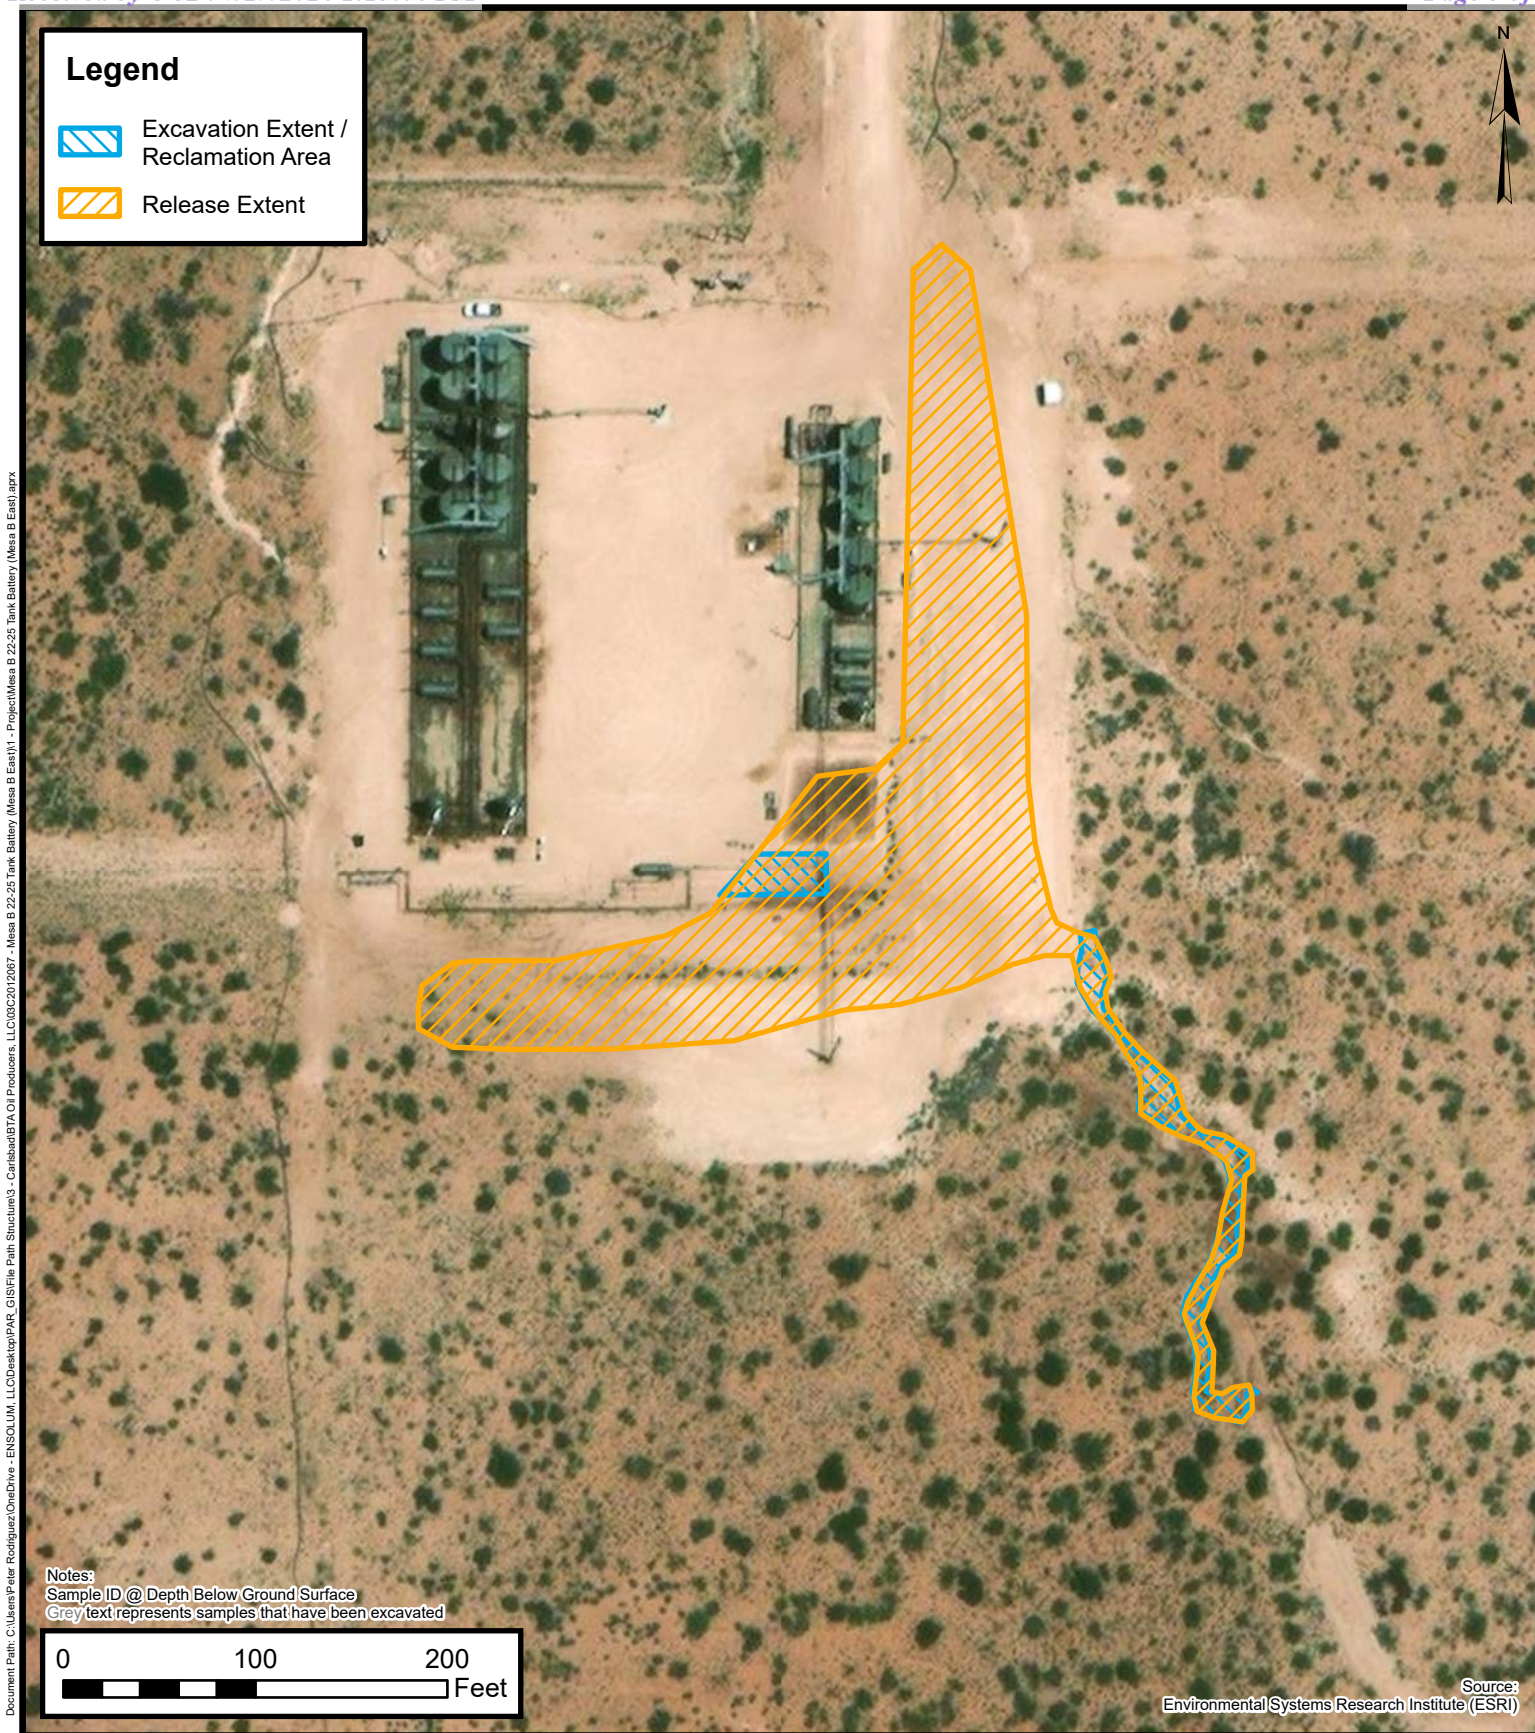
FIGURE

was restored to its original condition. The excavation area on-pad was backfilled with caliche, the pasture excavation was backfilled with locally procured topsoil. Following backfill activities, the disturbed area was graded and contoured to match the surrounding topography. The excavation extent and reclamation area are shown on the attached Figure 1.

## Excavation Extent / Reclamation Area

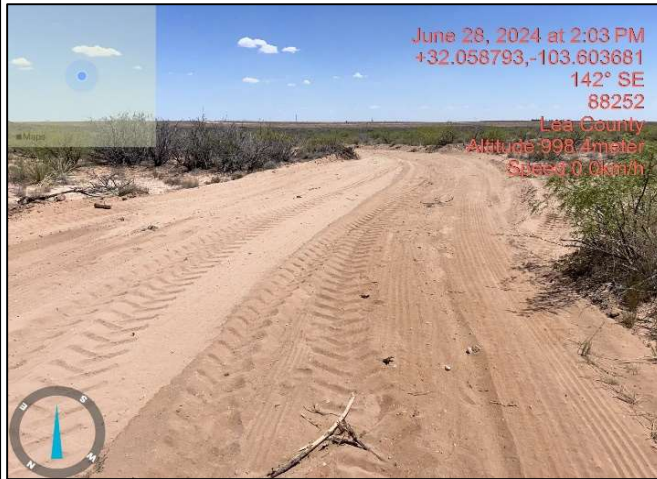
Photograph: 1 Date: 6/28/2024  
Description: Backfilling activities  
View: Southeast

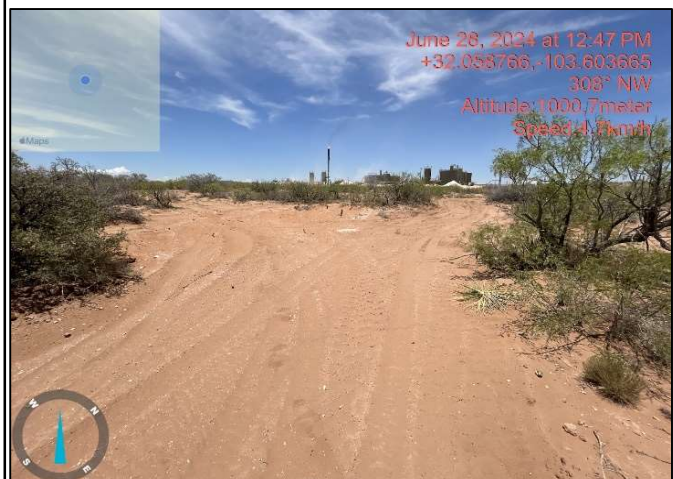
Photograph: 2 Date: 6/28/2024  
Description: Backfilling activities  
View: Northwest

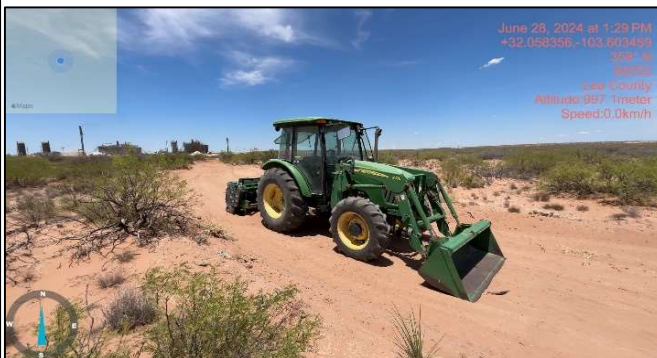
Photograph: 3 Date: 6/28/2024  
Description: Reseeding activities  
View: North

On June 28, 2024, the Site was seeded with BLM seed mix #1 for loamy sites at the rate specified in pounds of pure live seed (PLS) per acre.

The seed mix was doubled and distributed with a broadcast seed spreader and harrowed in. Photographs of the backfilled excavation and seeding of the reclaimed excavation area are provided in Appendix B.

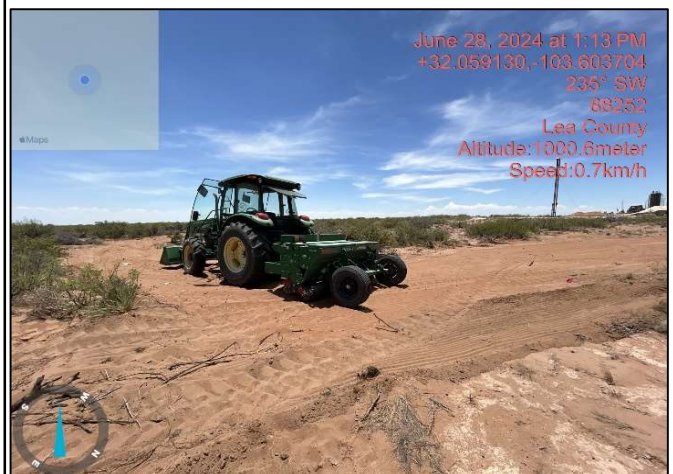
Photograph: 4 Date: 6/28/2024  
Description: Reseeding activities  
View: Southwest
