**Re: Closure Request
MCA Unit #392
Incident Number nJXK1519747622
Lea County, New Mexico**

Ensolum, LLC (Ensolum), on behalf of Maverick Permian, LLC (Maverick), has prepared this *Closure Request* to document site assessment and soil sampling activities performed at the MCA Unit #392 release (Site). The purpose of the Site assessment and soil sampling activities was to assess for the presence or absence of impacted soil resulting from a historical release of crude oil and produced water at the Site. Based on the Site assessment activities and soil sample laboratory analytical results, Maverick is requesting closure for Incident Number nJXK1519747622.

Maverick Permian, LLC
Closure Request
MCA Unit #392

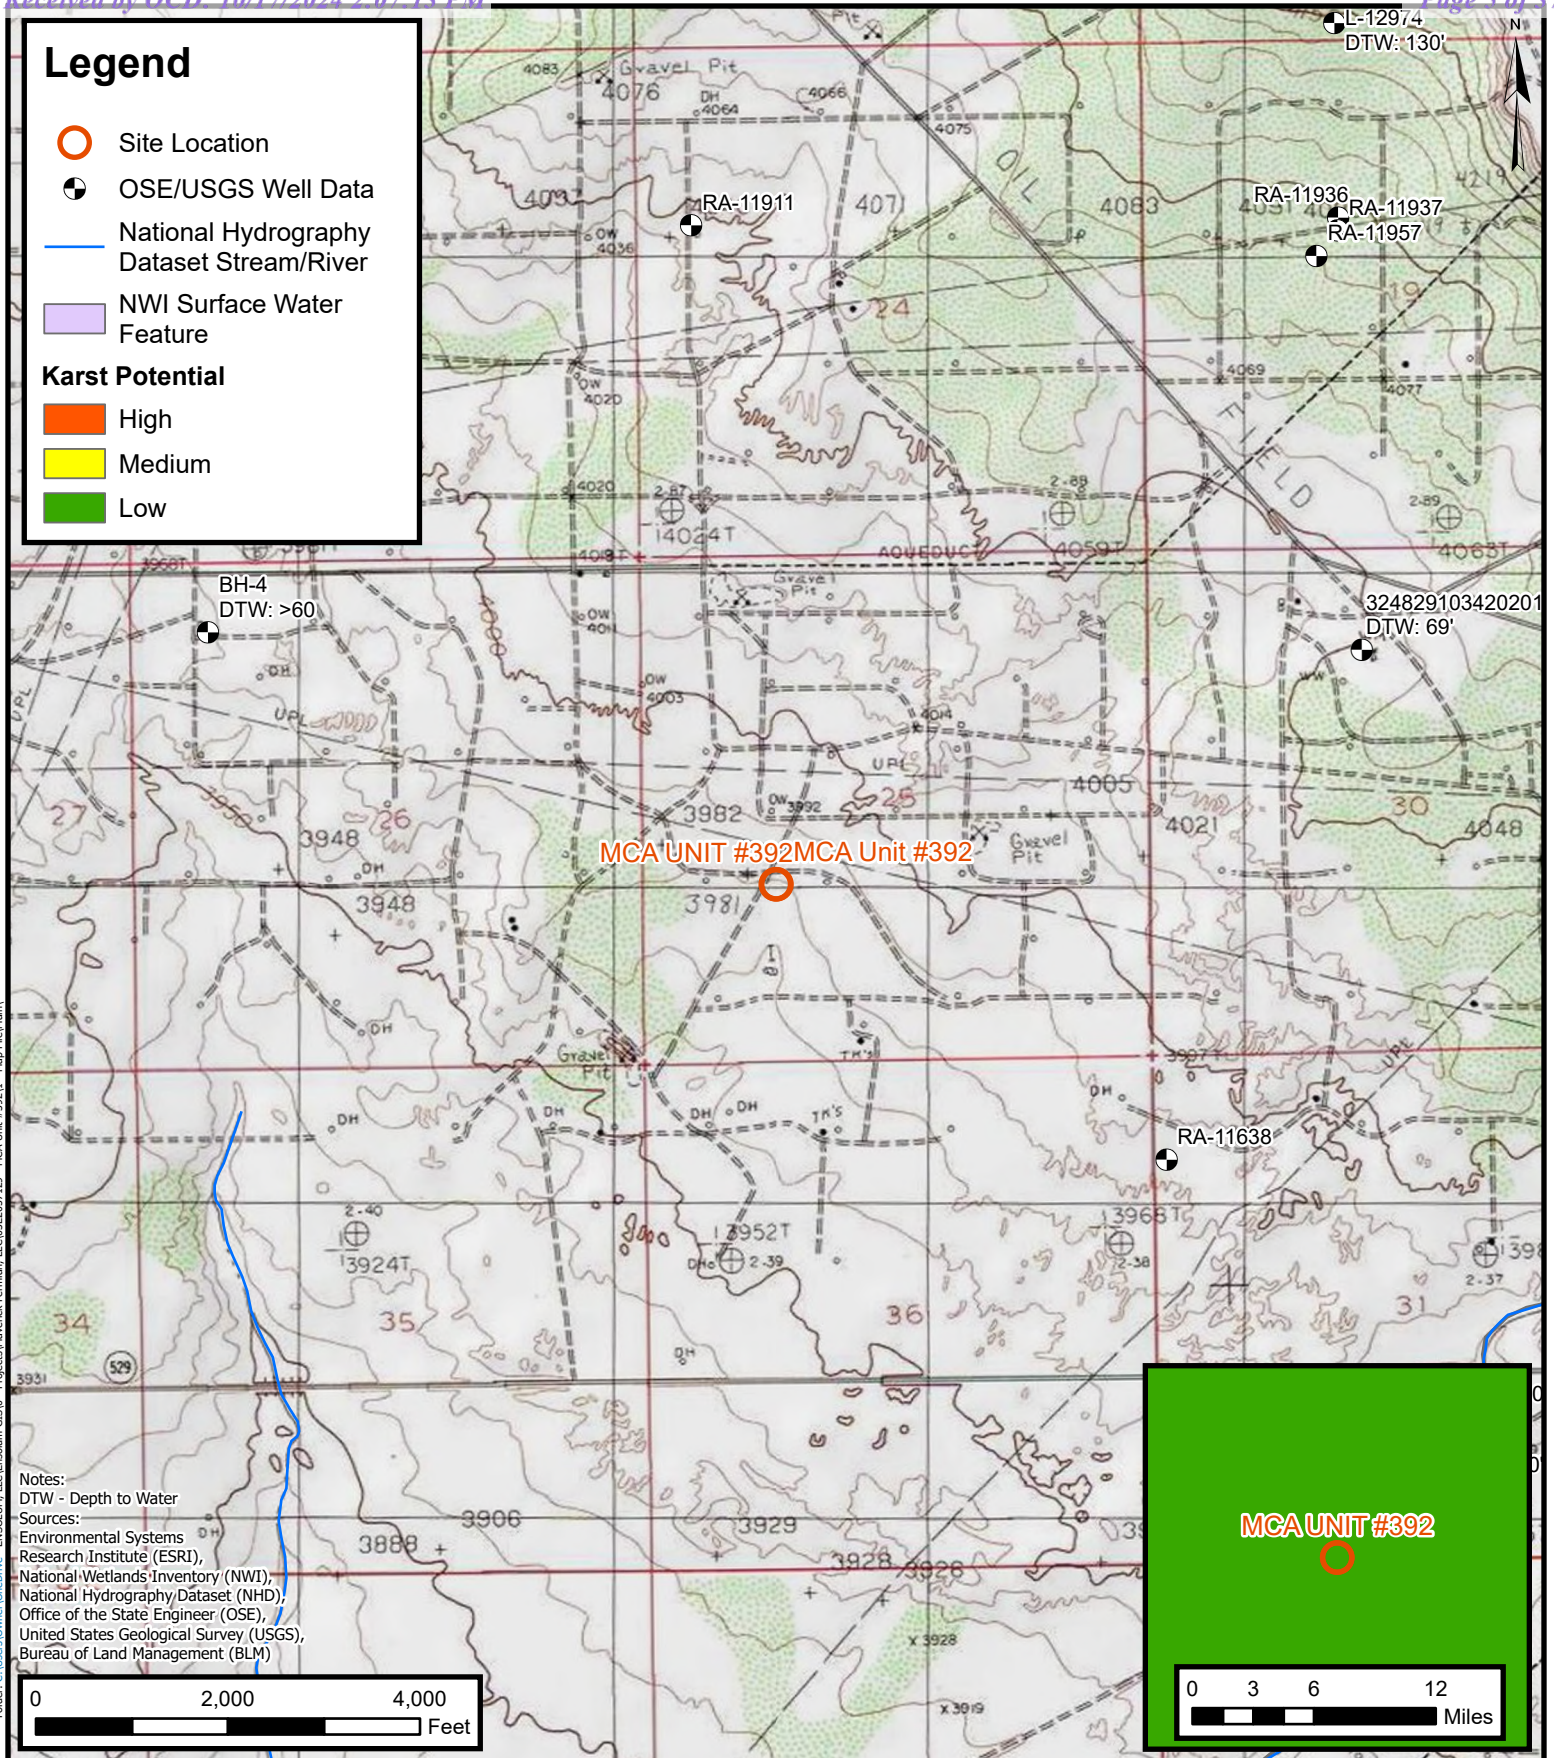
FIGURE

Depth to groundwater at the Site is estimated to be between 51 and 100 feet below ground surface (bgs) based on the nearest groundwater well data. The closest permitted groundwater well with depth to groundwater data is United States Geological Survey (USGS) well 324829103420201. The well has a reported depth to groundwater of 69 feet bgs. All wells used for depth to groundwater determination are presented on Figure 1.

The closest continuously flowing or significant watercourse is greater than 300 feet from the Site. The Site is greater than 200 feet from a lakebed, sinkhole, or playa lake and greater than 300 feet from an occupied residence, school, hospital, institution, church, or wetland. The Site is greater than 1,000 feet to a freshwater well or spring and is not within a 100-year floodplain or overlying a subsurface mine. The Site is not underlain by unstable geology (low potential karst designation area). Site receptors are identified on Figure 1.

Soil Sample Location Map

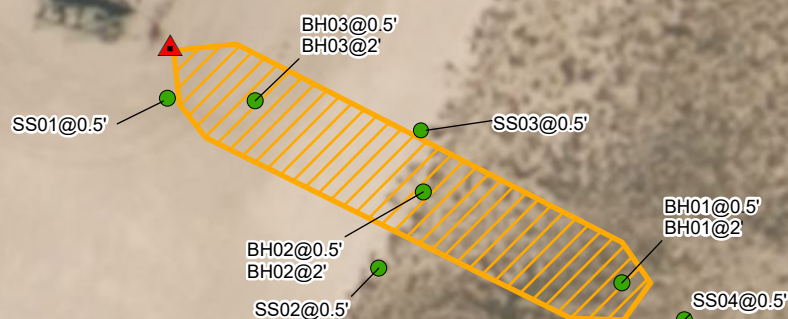
FIGURE
2

Laboratory analytical results for assessment soil samples SS01 through SS04, collected around the investigation area, and assessment samples from boreholes BH01 through BH03, collected within the investigation area, indicated that all COC concentrations were compliant with the most stringent Table I Closure Criteria. Laboratory analytical results are summarized on the attached Table 1 and the complete laboratory analytical reports are included in Appendix C.

Assessment Soil Sample Locations

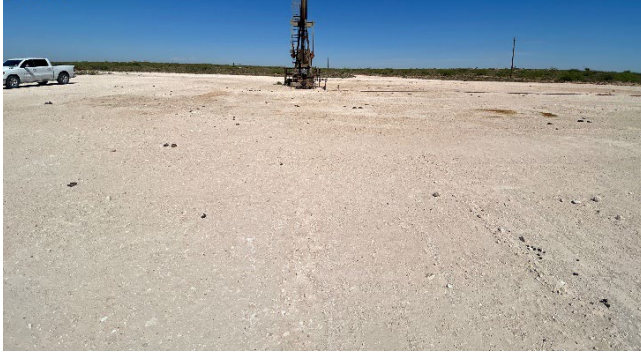
Photograph 1

Description: Historical release area

View: Northwest

Remediation and reclamation activities were completed historically by the previous operator. No information was available regarding backfill activities or seeding; however, the release area matches the surrounding topography and vegetation cover and composition in the pasture area appear consistent with the surrounding undisturbed land.

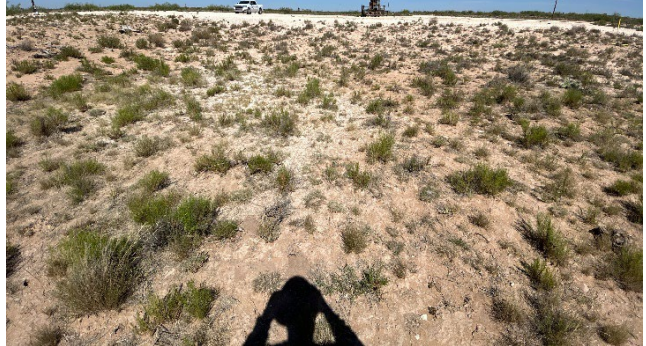
Photograph 2

Description: Historical release area

View: Northwest

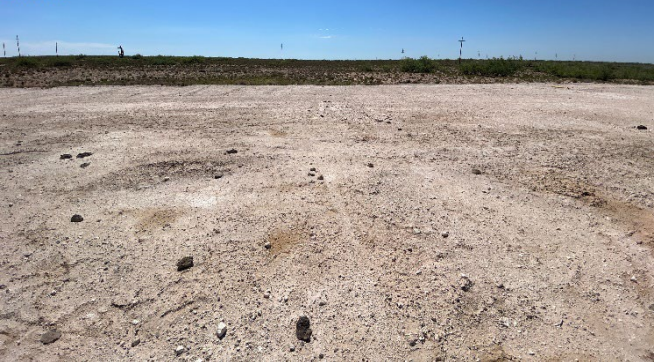
Photograph 3

Description: Historical release area

View: Southeast

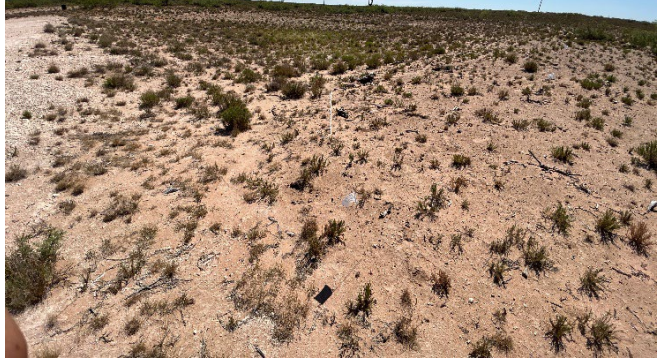
Photograph 4

Description: Historical release area

View: Northeast
