**Re: Liner Inspection and Closure Request
BTA Oil Producers, LLC
Ogden 29-32 Fed Com #5 South Release
Unit E, Section 32, Township 23 South, Range 28 East
Eddy County, New Mexico
Incident ID# NAPP2428855971**

Liner Inspection and Closure Request
October 31, 2024

**OGDEN 29-32 FED COM #5 SOUTH
OVERVIEW MAP**

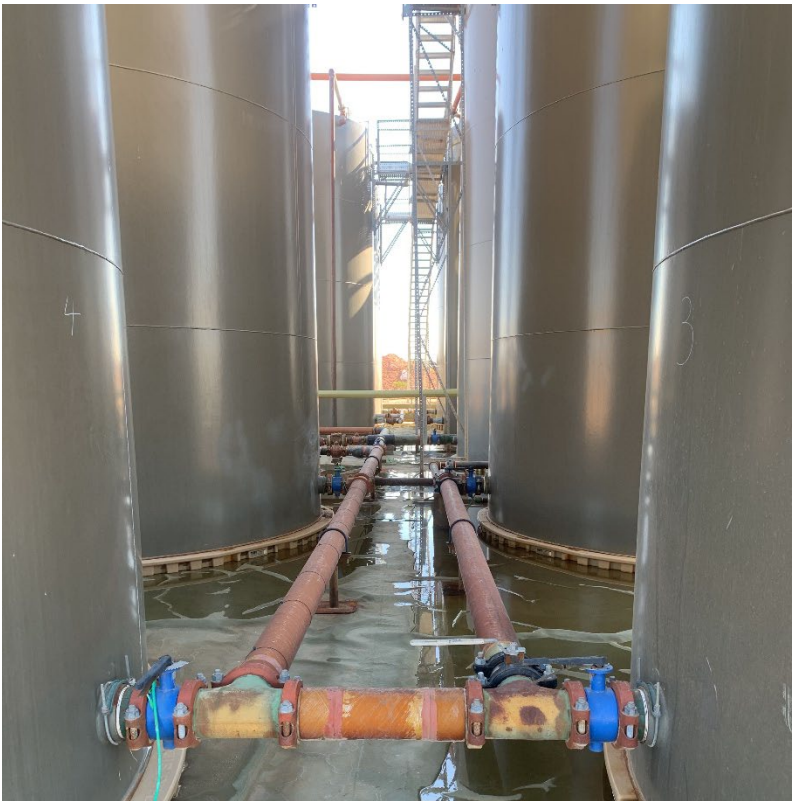
TETRA TECH, INC. PROJECT NO. 212C-MD-03669	DESCRIPTION	View of approximate release extent in secondary containment berm.	1
	SITE NAME	Ogden 29-32 Fed Com #5 South Release	N/A

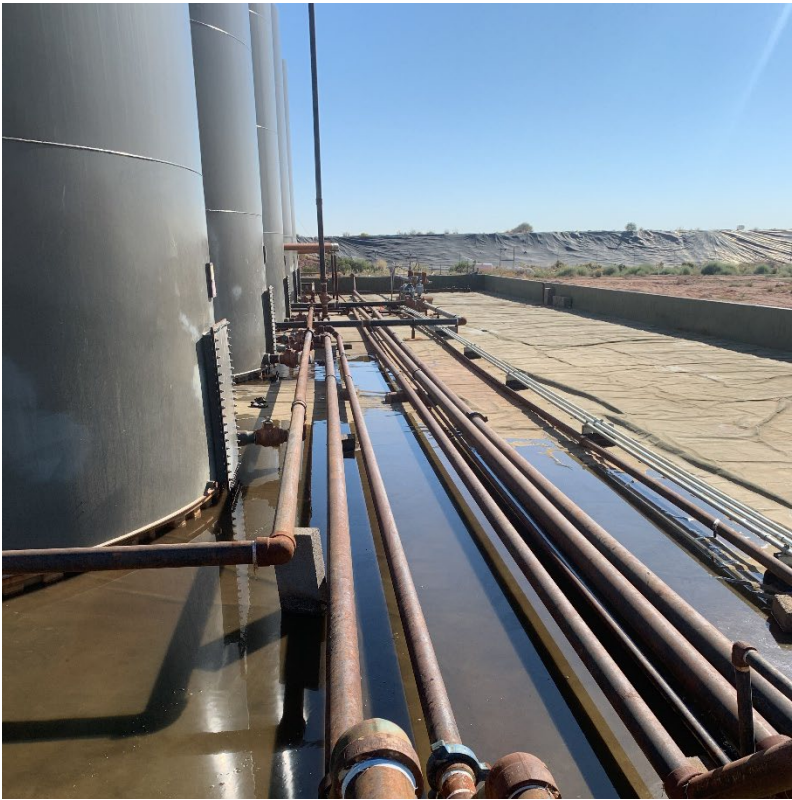
TETRA TECH, INC. PROJECT NO. 212C-MD-03669	DESCRIPTION	View of approximate release extent in secondary containment berm.	1
	SITE NAME	Ogden 29-32 Fed Com #5 South Release	N/A

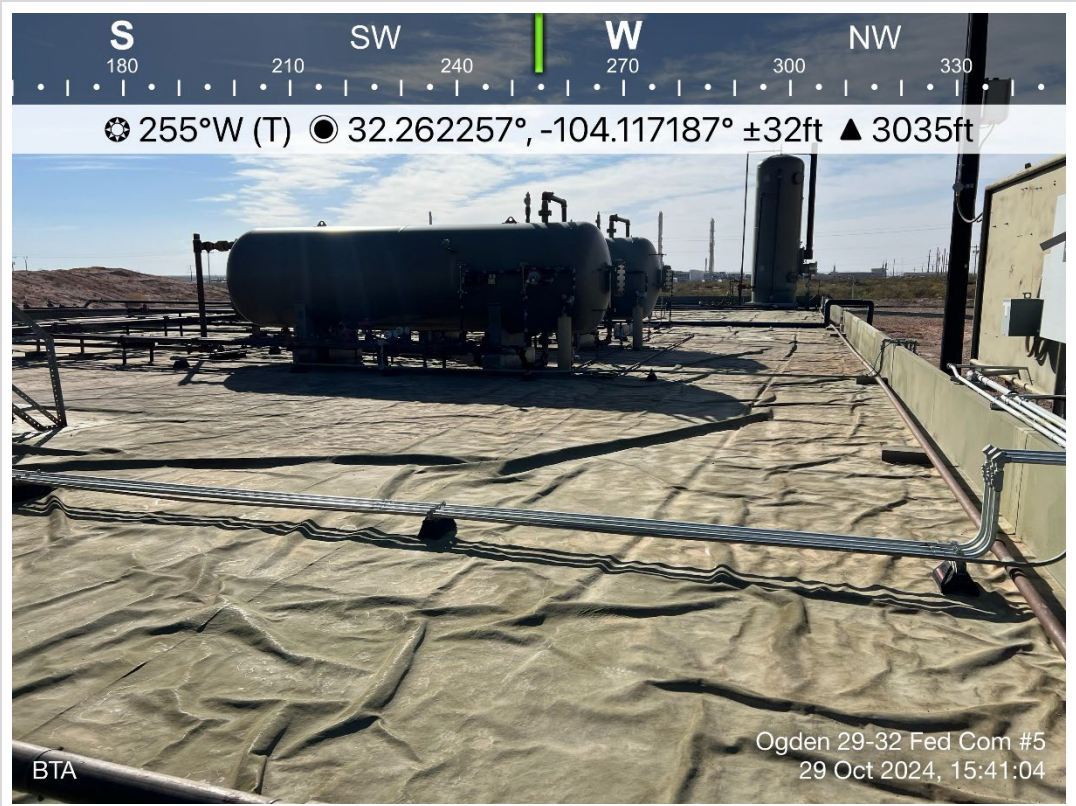
On October 29, 2024, Tetra Tech personnel performed an inspection of the liner within the containment area of the Ogden 29-32 Fed Com #5 South Battery. This work was completed to verify the integrity of the liner. The liner was observed to underlie the entirety of the tank battery containment area. The liner was intact with no visible rips or tears and encompassed by an approximately 2-foot-tall muscle wall. The liner

was anchored on the interior. At the time of the inspection, the liner was intact and had the ability to contain the documented release. Photographic documentation of the liner inspection is included in Appendix D.

TETRA TECH, INC. PROJECT NO. 212C-MD-03669	DESCRIPTION	View west-southwest. Current lined containment area conditions: no rips, holes, or tears observed.	1
	SITE NAME	Ogden 29-32 Fed Com #5 South Release	10/29/2024

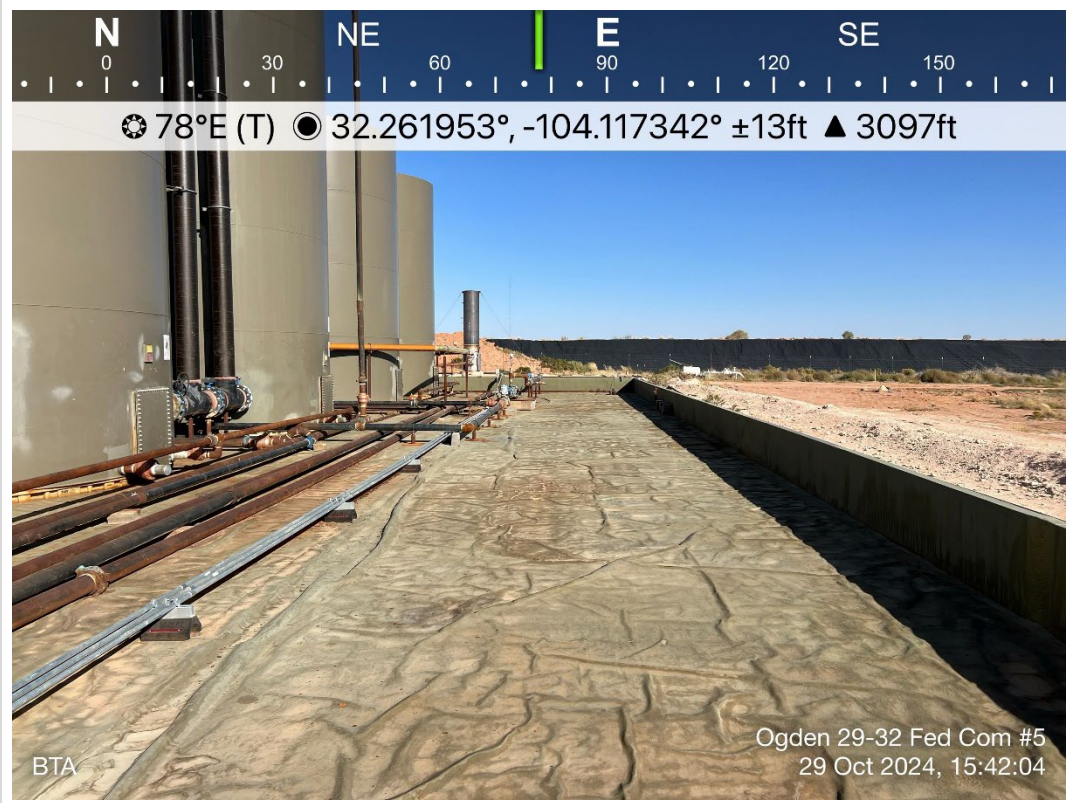
TETRA TECH, INC. PROJECT NO. 212C-MD-03669	DESCRIPTION	View east. Current lined containment area conditions: no rips, holes, or tears observed.	1
	SITE NAME	Ogden 29-32 Fed Com #5 South Release	10/29/2024

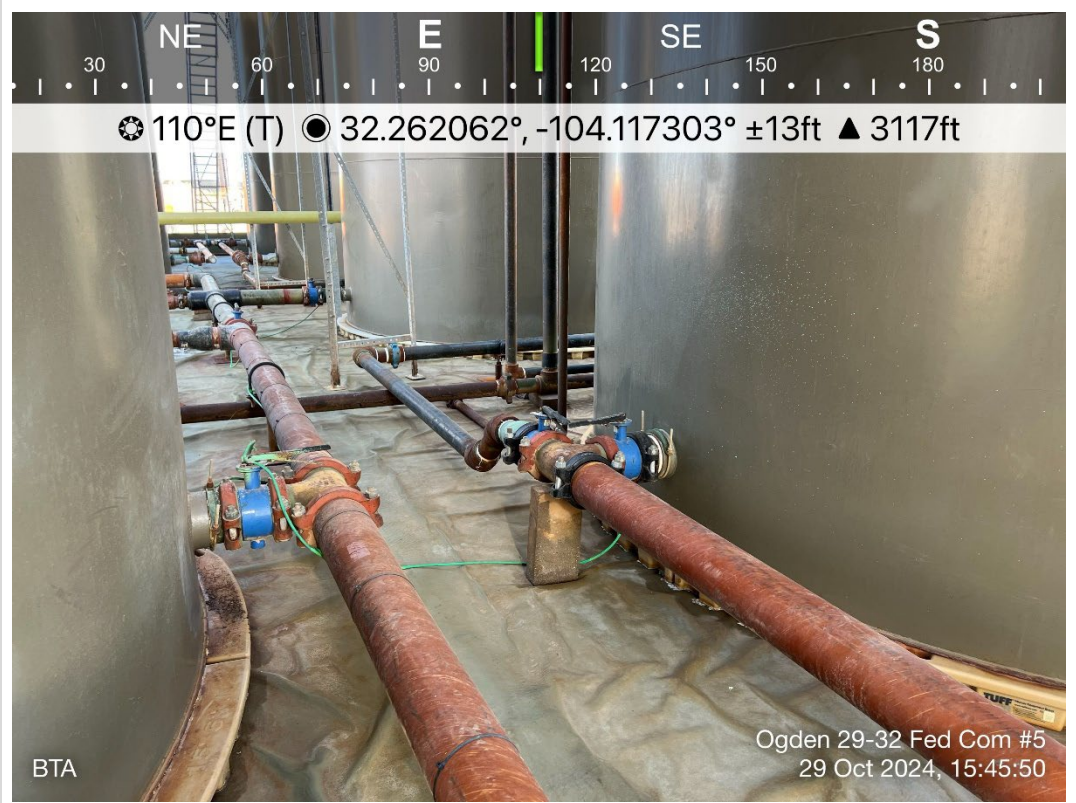
TETRA TECH, INC. PROJECT NO. 212C-MD-03669	DESCRIPTION	View east-southeast. Current lined containment area conditions: no rips, holes, or tears observed.	1
	SITE NAME	Ogden 29-32 Fed Com #5 South Release	10/29/2024

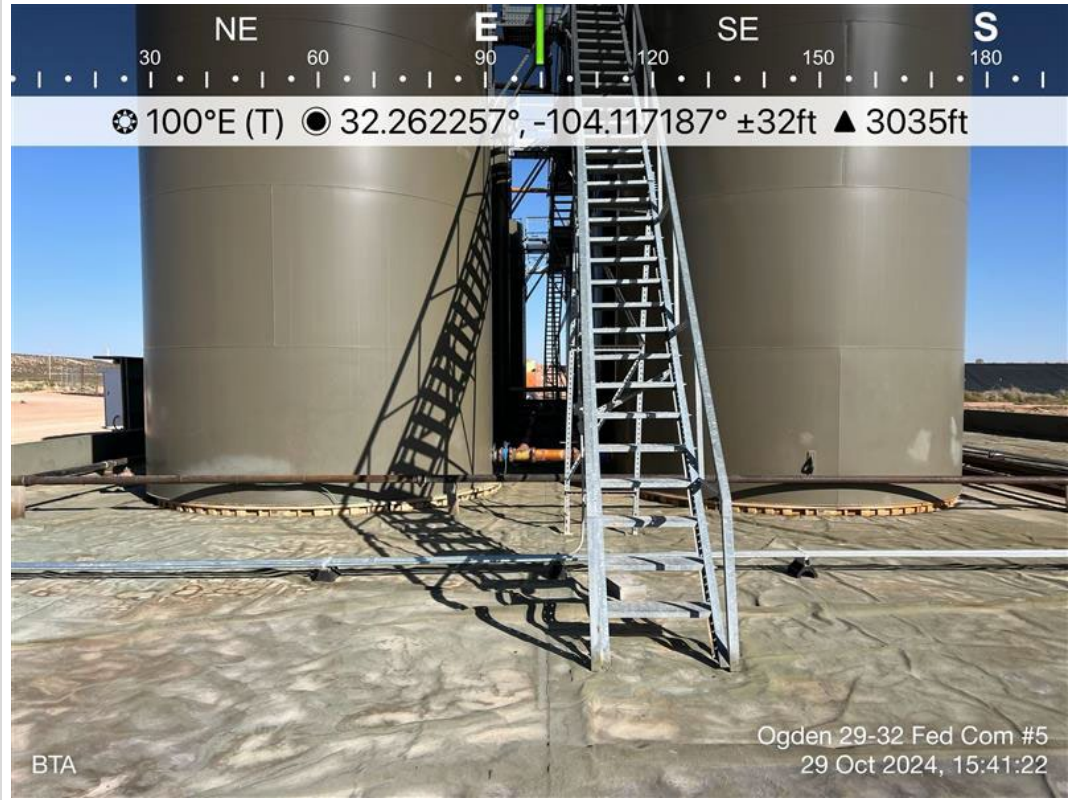
TETRA TECH, INC. PROJECT NO. 212C-MD-03669	DESCRIPTION	View east. Current lined containment area conditions: no rips, holes, or tears observed.	1
	SITE NAME	Ogden 29-32 Fed Com #5 South Release	10/29/2024
