Re: NMOCD #nAPP2425544956  
Rojo Toro #1 Purge Event  
32.21368, -103.44406  
U/L N, Section 14, Township 24 South, Range 34 East

### **Section 1: Event Details**

NMOCD Incident ID #nAPP2425544956 pertains to a residue gas purge event that occurred post processing and prior to custody transfer on January 7, 2024. There were no liquids released during the residue purge event. Please see the photos attached as Appendix C, showing no staining below the release point. This event was originally reported on a C-129 form on January 22, 2024 and assigned incident ID nAPP2400851399. Upon further review and per NMOCD direction, nAPP2400851399 did not meet the requirements of Part 27 or Part 28 NMAC, therefore the C-129 was cancelled using a C-129C form and an Initial C-141 submitted being assigned incident ID #nAPP2425544956. Reasoning for the venting event is summarized below.

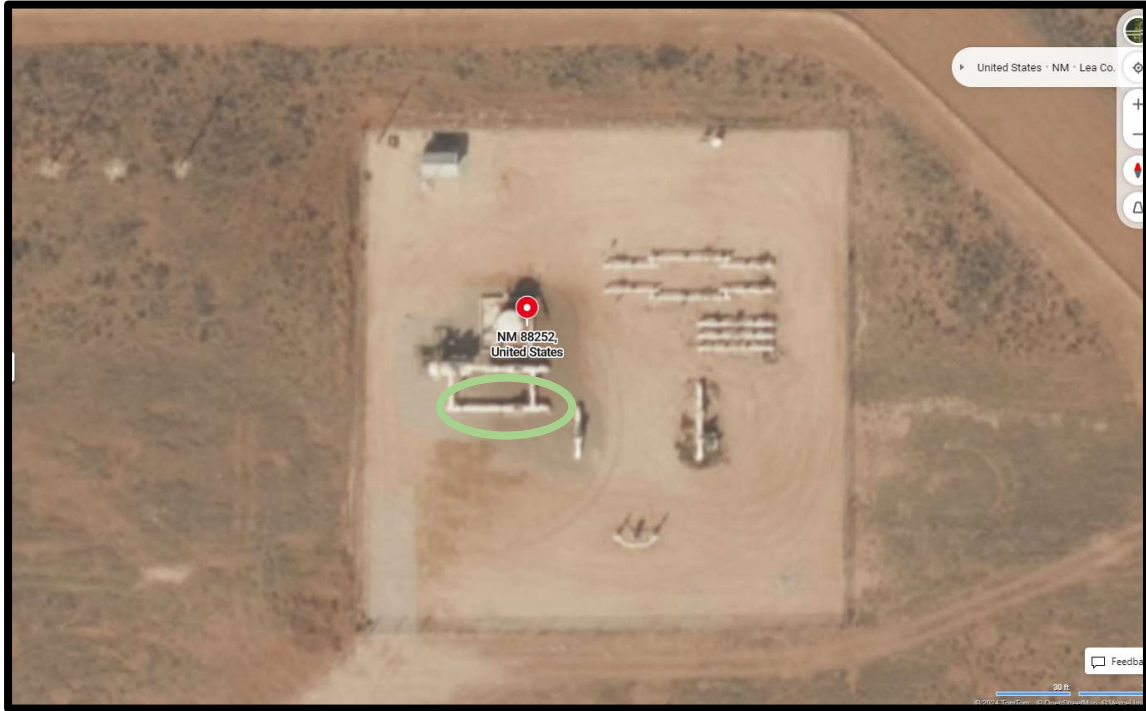
**Figure 9**

Gas was vented to atmosphere to purge the pipeline of off-spec residue gas. It was necessary to purge the line to bring the residue gas line back within specification. Third party gas producers delivered off spec gas to the inlet of the processing facilities which resulted in off spec gas in the residue line. Gas was vented until the pipeline was purged. Once the residue gas was back within spec, the emission event ended. Please see Figure 9 illustrating the purge point.

**Green Circle Indicates Purge Point at Rojo Toro Facility**
