December 18, 2024

Re: NMOCD #nAPP2425553101  
Rojo Toro #8 Purge Event  
32.21368, -103.44406  
U/L N, Section 14, Township 24 South, Range 34 East

### **Section 1: Event Details**

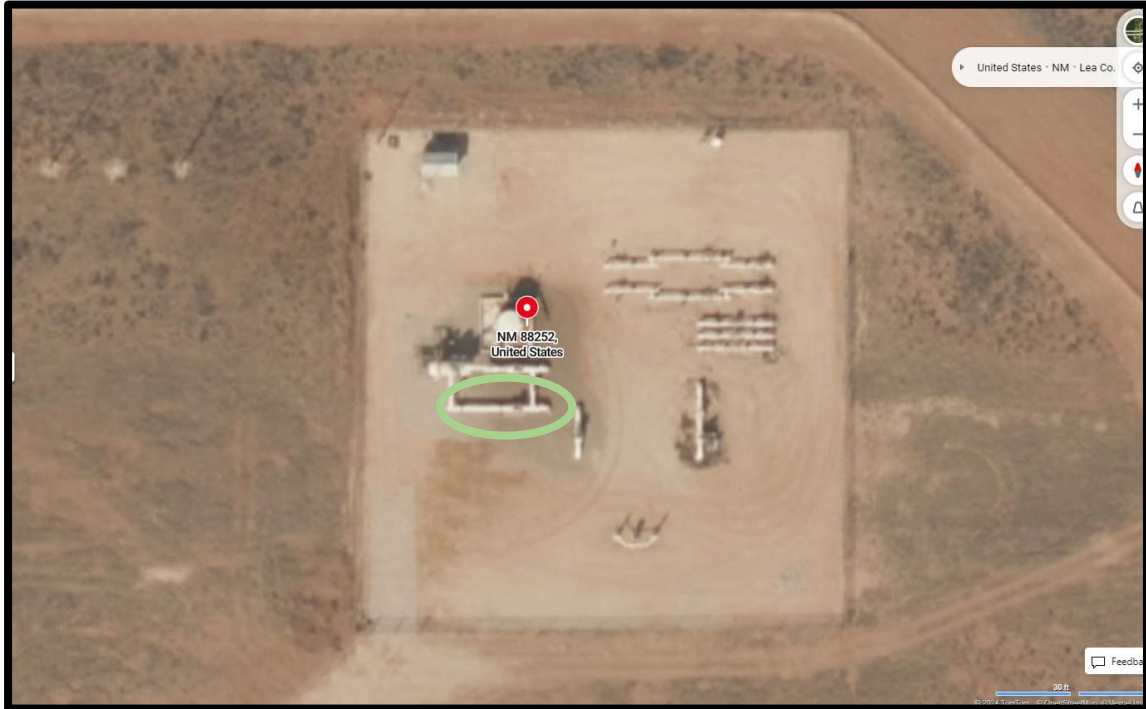
**Figure 9**

Gas was vented to atmosphere to purge the pipeline of off-spec residue gas. It was necessary to purge the line to bring the residue gas line back within specification. Third party gas producers delivered off spec gas to the inlet of the processing facilities which resulted in off spec gas in the residue line. Gas was vented until the pipeline was purged. Once the residue gas was back within spec, the emission event ended. Please see Figure 9 illustrating the purge point.

**Green Circle Indicates Purge Point at Rojo Toro Facility**

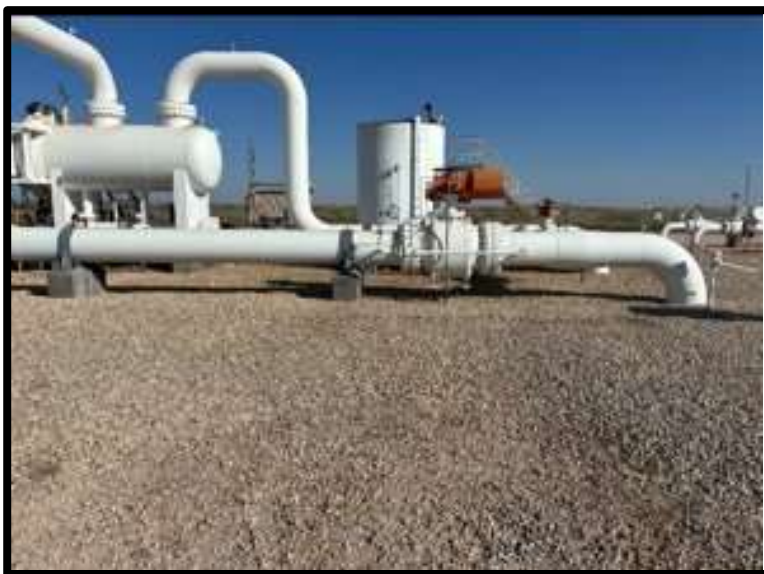
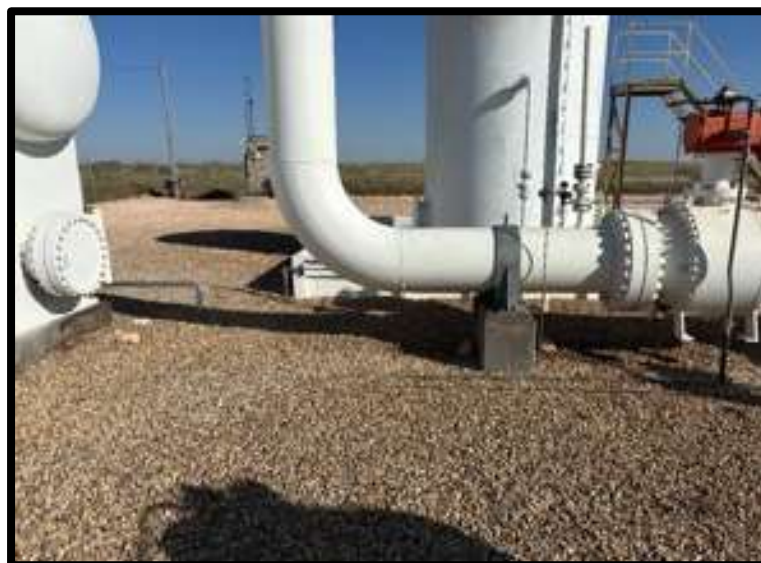
This was an above ground residue gas only purge to atmosphere event due to off-spec gas being sent from producers. The purge event did not release any liquids to the ground, photographs are shown in Appendix C illustrating no staining to soil. Per NMOCD direction on September 6, 2024, Targa is respectfully requesting a variance to NMAC Part 29 sampling requirements due to the absence of liquids released.

**Photo of Purge Point facing North**
