Release Assessment and Closure Request

Scripps Water Transfer Pipeline

Silverback Operating II, LLC.

Vertex Resource Services Inc.

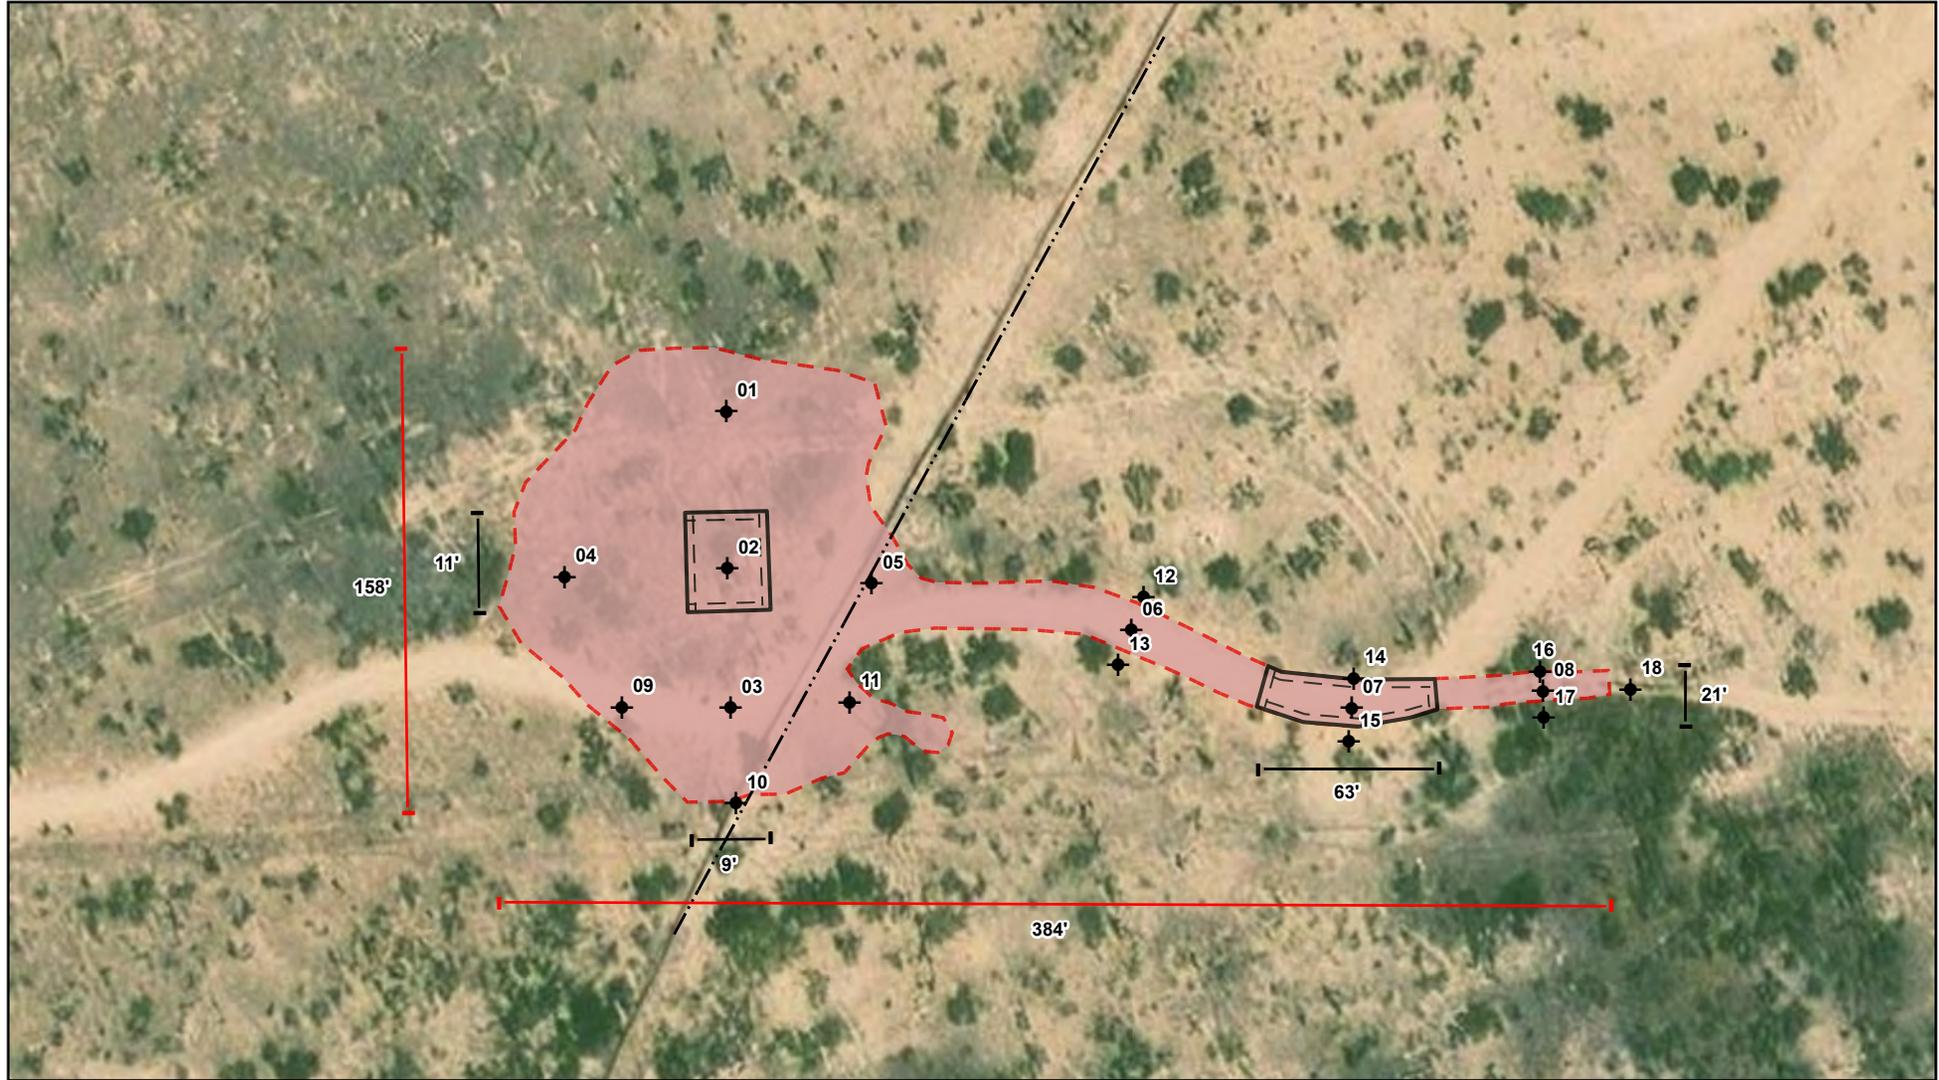
- Borehole (Prefixed by "BH24-")
- Release Area/Initial Scrape (~20,671 sq. ft. | 1,046 ft)
- Proposed Excavation East 0.5ft bgs (~918 sq. ft.)
- Pipeline (Underground)
- Proposed Excavation West 0.5ft bgs (~998 sq.ft.)

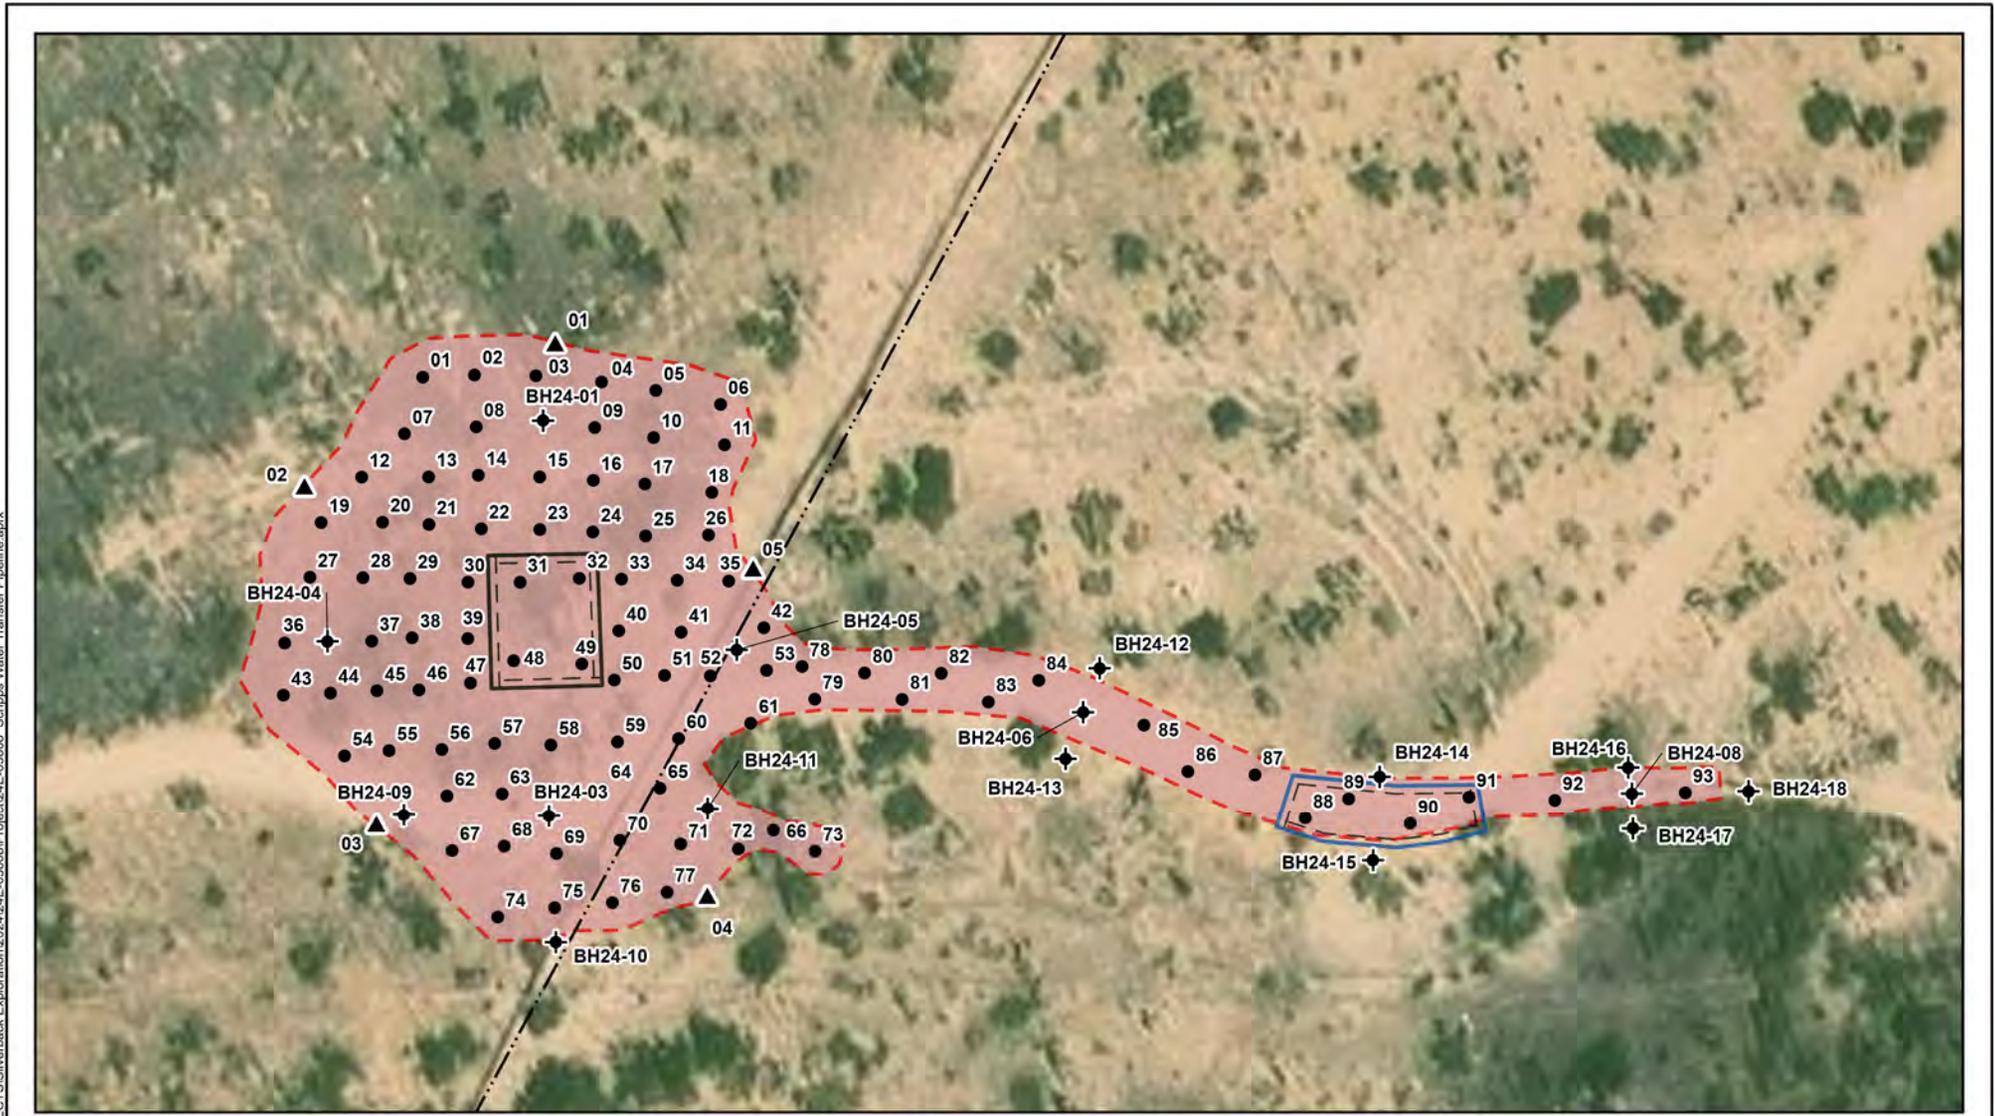
- Base Sample (Prefixed by "BS24-")
- ◆ Borehole
- ▲ Wall Sample (Prefixed by "WS24-")
- - - Pipeline (Underground)
- ▭ Excavation to 1' bgs (~806 sq.ft. | 131 ft.)
- ▭ Excavation to 1' bgs (~999 sq.ft. | 127 ft.)
- ▭ Release Area/ Scraped Area to 0.5' bgs (~20,672 sq.ft. | 1,046 ft.)

Vertex recommends no additional remedial actions at the site. Laboratory analyses of confirmation samples collected at the site show final confirmatory values below NMOCD closure criteria for areas where depth to groundwater is less than 50 feet, as presented in Table 2. There are no anticipated risks to human, ecological, or hydrological receptors at this site. The excavation will be backfilled with non-waste-containing, uncontaminated, earthen material, sourced locally, and placed to meet the site's existing grade to prevent water ponding and erosion. The reclamation requirements of 19.15.29.13 NMAC will be completed following backfilling activities. The DFR and site photographs prior to backfill procedures are included in Appendix C.

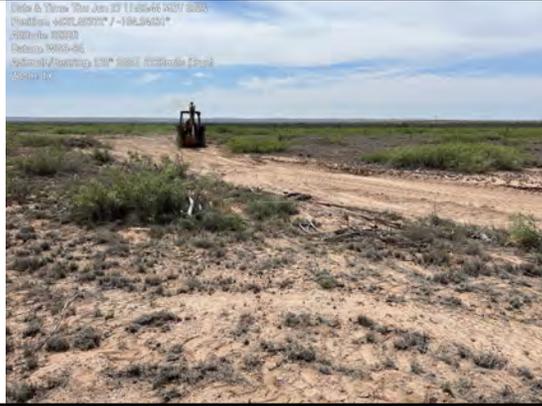
Viewing Direction: Northeast

Eastern extent of the release/scraped areas

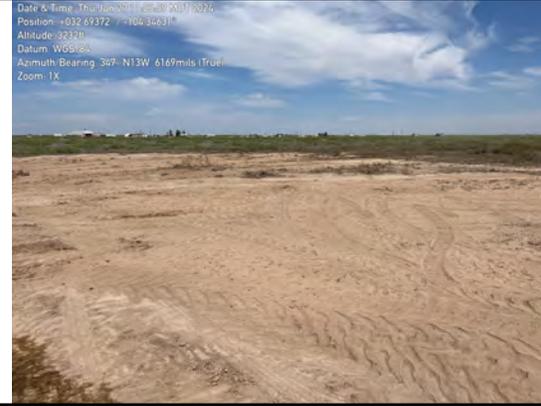
Viewing Direction: Northwest

Western extent of the release/scraped areas

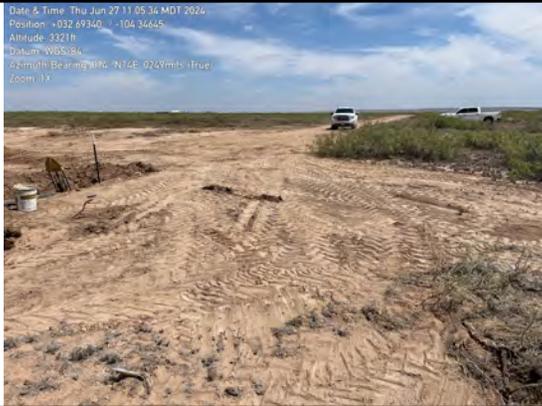
Viewing Direction: Southwest

Southern portions of the release/scraped areas

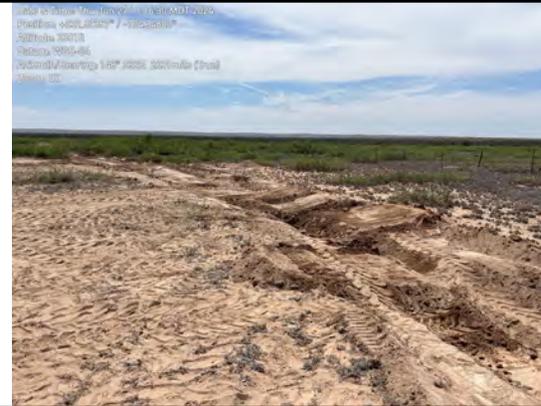
Viewing Direction: Southeast

Eastern extent of the release/scraped areas

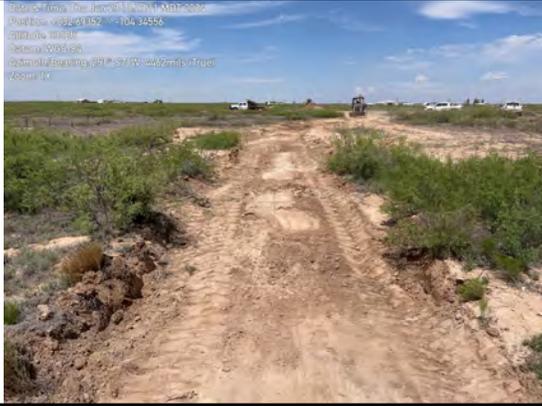
Viewing Direction: East

Eastern extent of the release/scraped areas

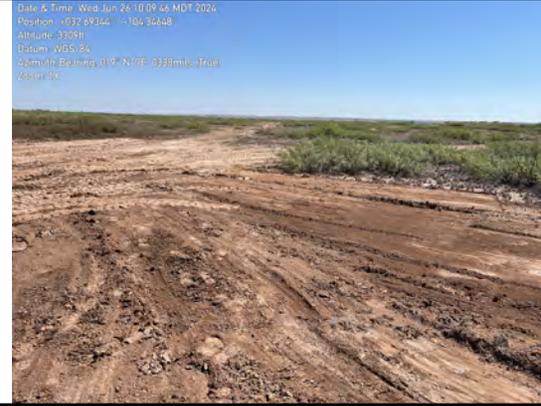
Viewing Direction: North

Western extent of the release/scraped areas

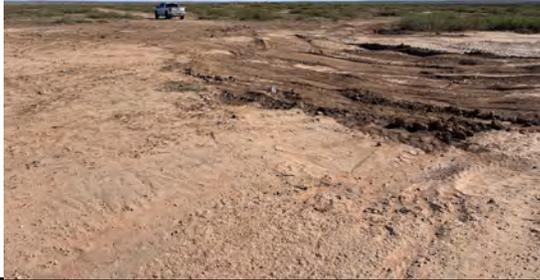
Viewing Direction: South

Overview of west excavation

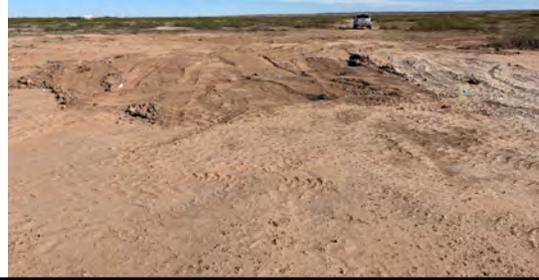
Viewing Direction: Northwest

Overview of west excavation

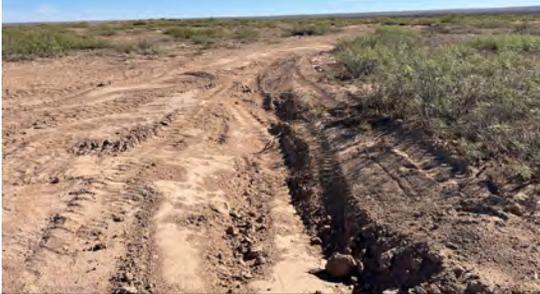
Viewing Direction: Northeast

Overview of west excavation

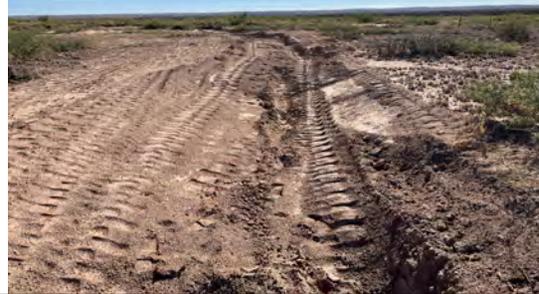
Viewing Direction: Southeast

Overview of west excavation

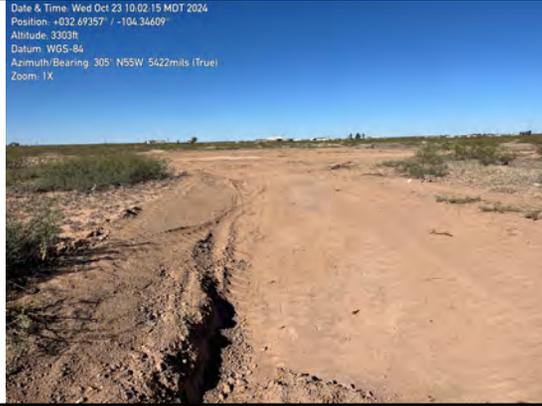
Viewing Direction: West

Western extent of the release/scraped areas

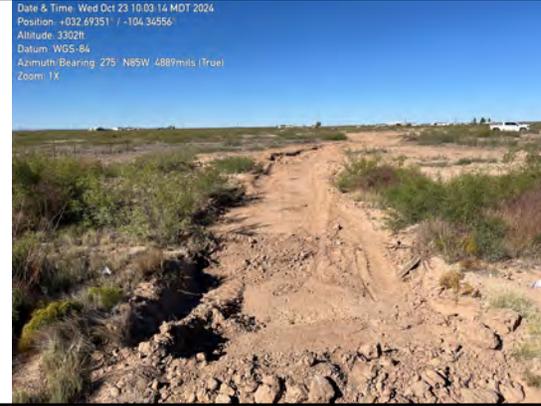
Viewing Direction: Southwest

Western extent of the release/scraped areas

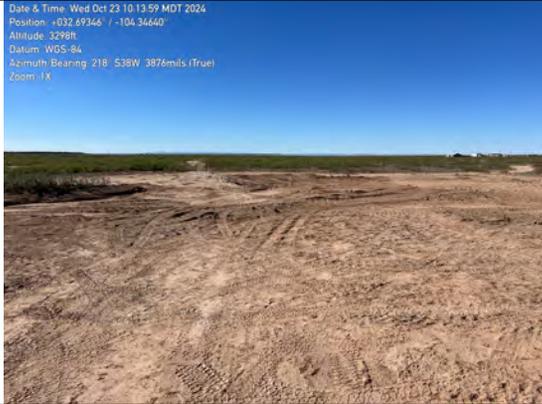
Viewing Direction: West

Eastern portions of the release/scraped areas

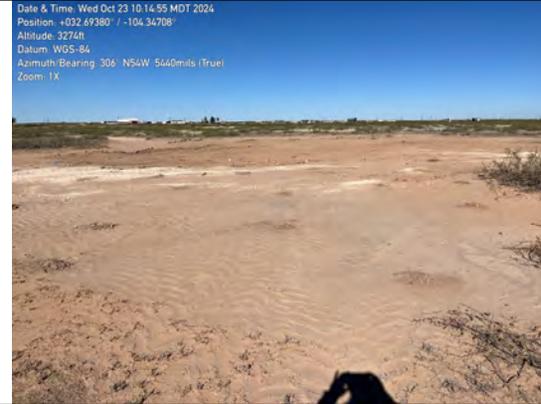
Viewing Direction: North

Western extent of the release/scraped areas

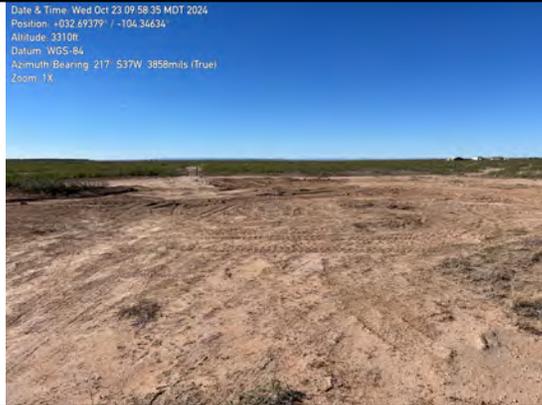
Viewing Direction: East

Overview of east excavation

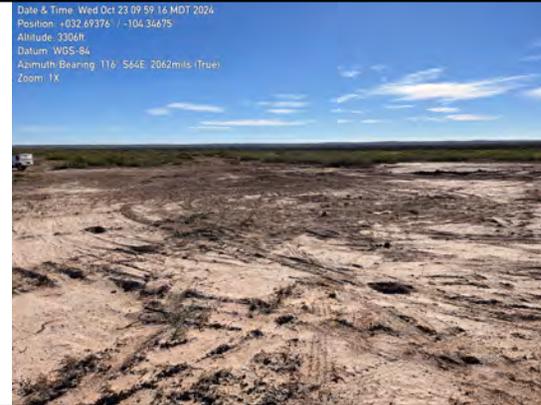
Viewing Direction: West

Overview of east excavation
