Closure Report

INCIDENT ID#: nRM2018235623, nRM2023461379

Site Name:	CEDAR CANYON 16-1
Company:	Oxy USA, Inc.
Legal Description:	U/L D, Section 16, T24S, R29E
County:	Eddy County, NM
GPS Coordinates:	N 32.223316 ,W-103.995515

Date of Release:	6/10/2020,7/14/2020
Type of Release:	CRUDE OIL ,PRODUCED WATER
Source of Release:	GASKET FAILURE, 1/2" NPPL ON WATER TRANSFER PUMP
Volume of Release:	7 BBLs,1BBLs / 7 BBS
Volume Recovered:	0 BBLs, 0BBLs /0BBLs

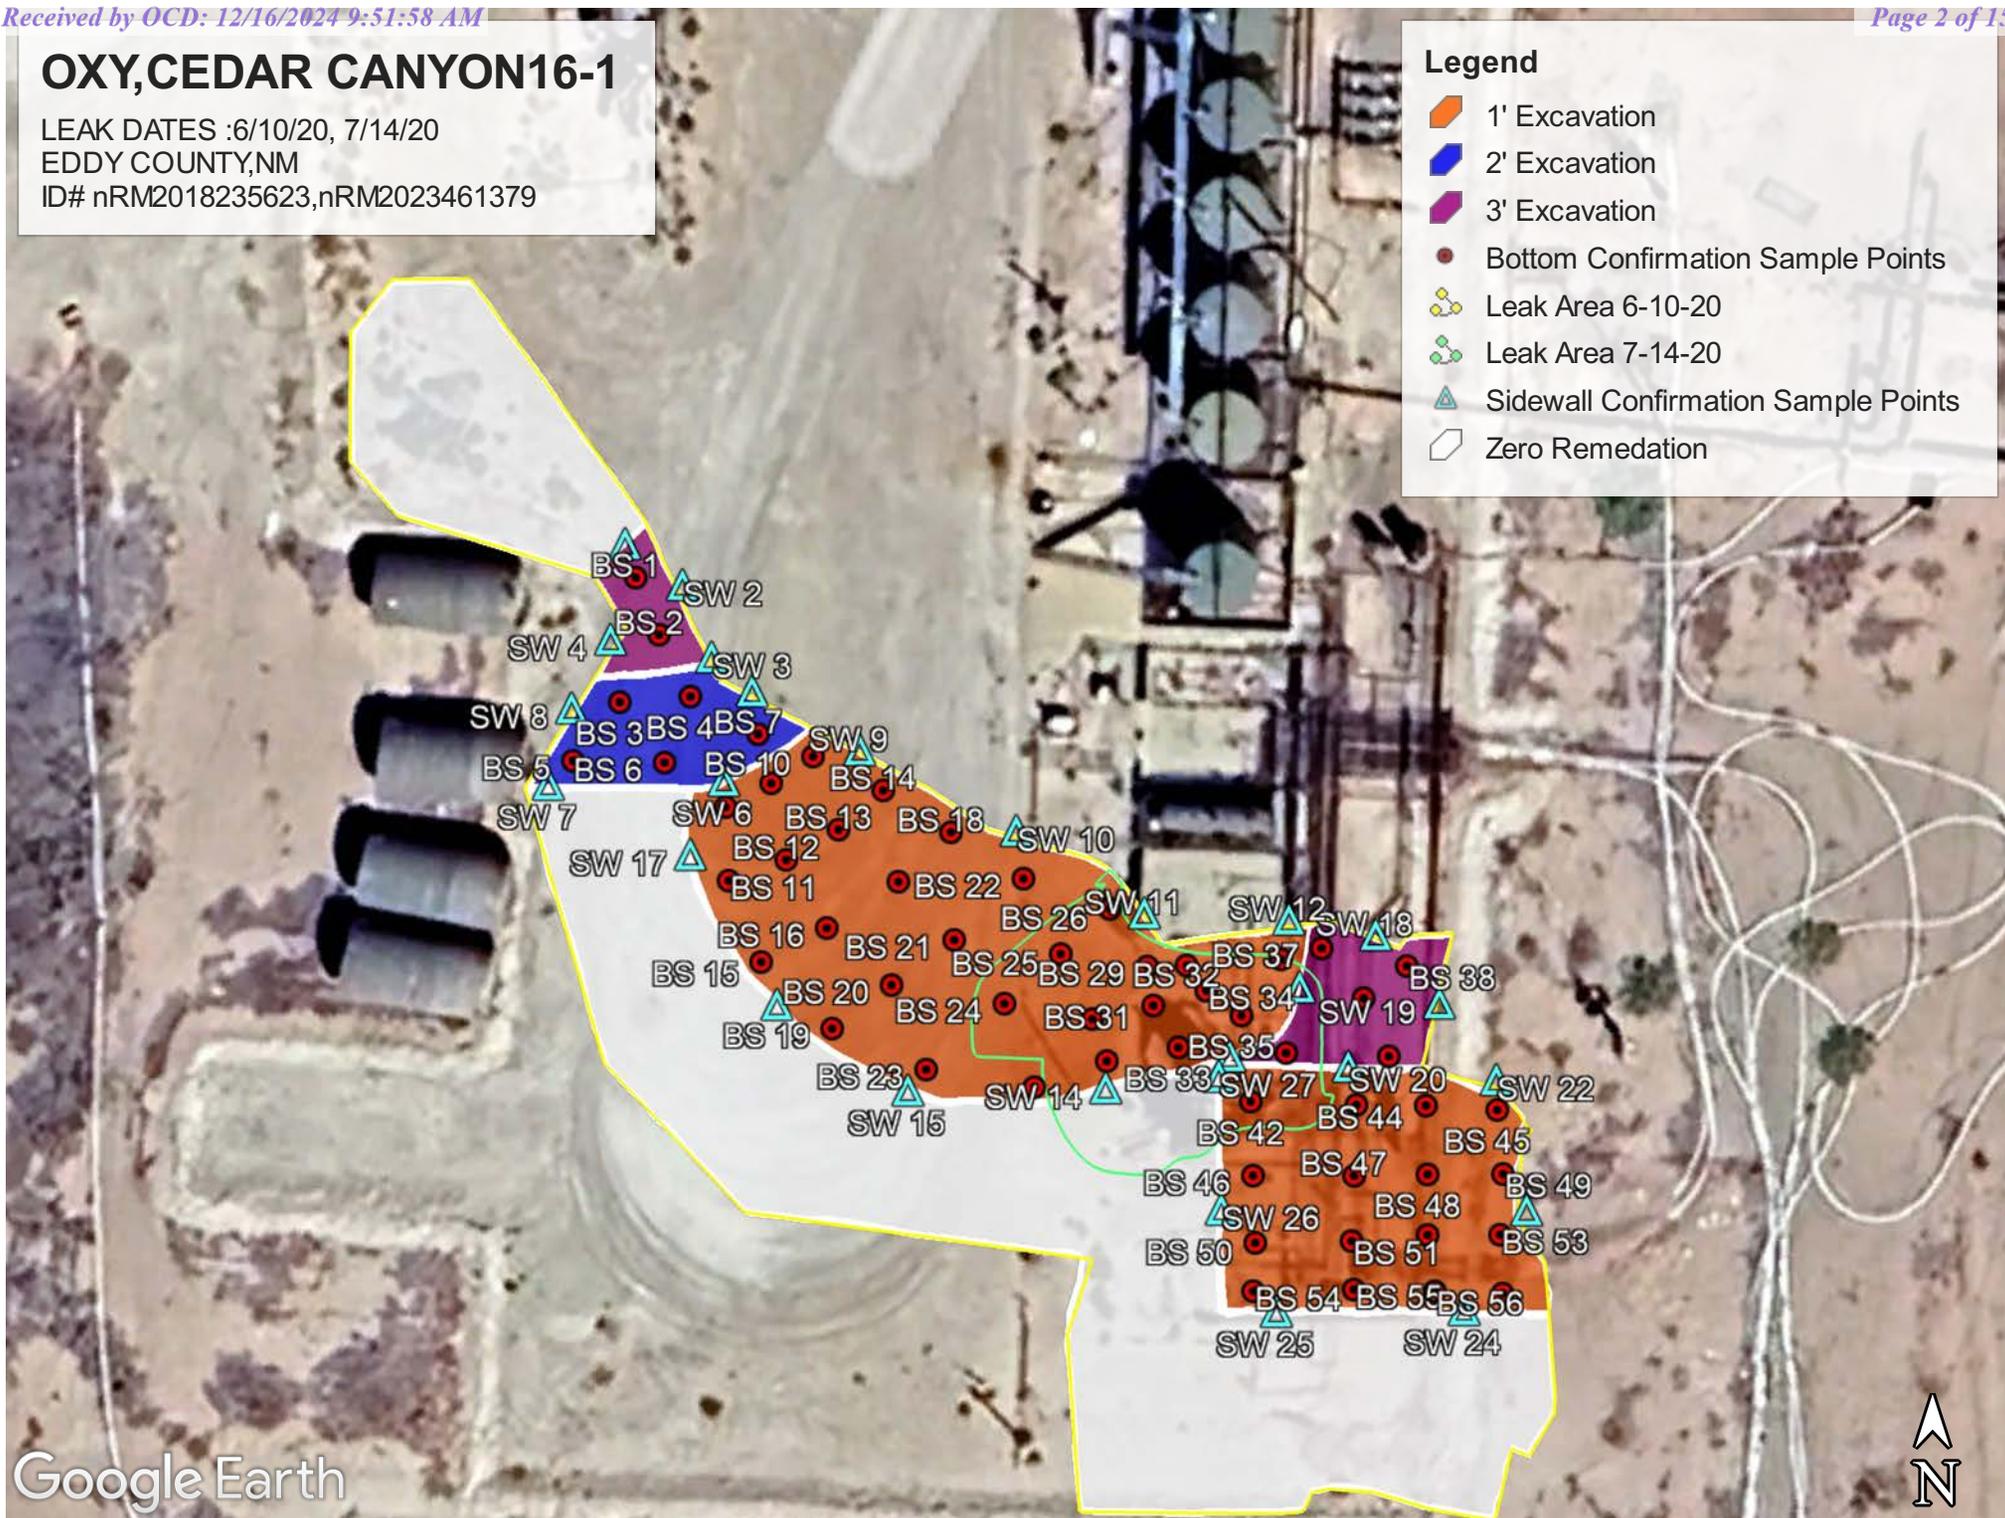
OXY,CEDAR CANYON16-1

Remediation Parameters:	OXY excavatd the spill area as depicted on the following site diagram. The leak area near SP1 - SP3, SP10, SP13, and SP16 (orange shade on diagram) was excavated to a depth of 1 foot. The leak area near SP4 (dark blue shade on diagram) was excavated to a depth of 2 feet. The leak area near SP8 and SP17 (purple shade on diagram) was excavated to a depth of 3 feet. The leak area near SP5 – SP7, SP9, SP11, SP12, SP14, and SP15 (white shade on diagram) require zero remediation. OXY collected sidewall and confirmation samples every 400 square feet.
Remediation Activities:	8/29/24-10/9/24
