Re: NMOCD #nAPP2434444859
Coriander Compressor Station
32.364297, -103.634594
U/L E, Section 25, Township 22 South, Range 32 East

Section 1: Event Details

NMOCD Incident #nAPP2434444859 pertains to an incipient fire that occurred at Targa's Coriander Compressor Station. A second party contractor was visually inspecting equipment and noticed oil running down the side of unit 2519. The cause contributing to this event was a malfunction of the valve gasket cover. The valve malfunction caused oil to run down the side of the unit acting as a fuel source. There was no gas released to atmosphere and no liquids released to surface.

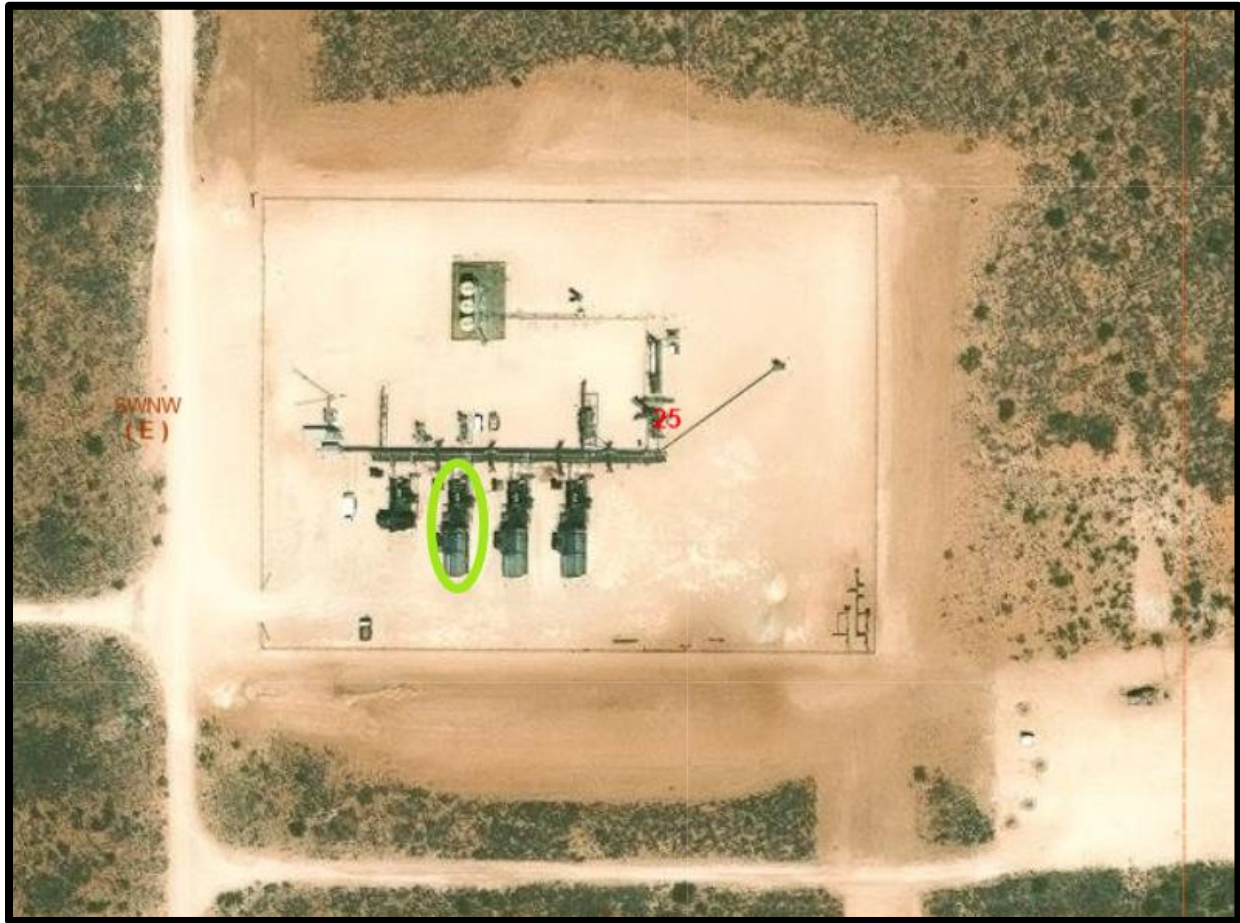
Figure 7

Green Circle Indicates Referenced Targa Compression Unit

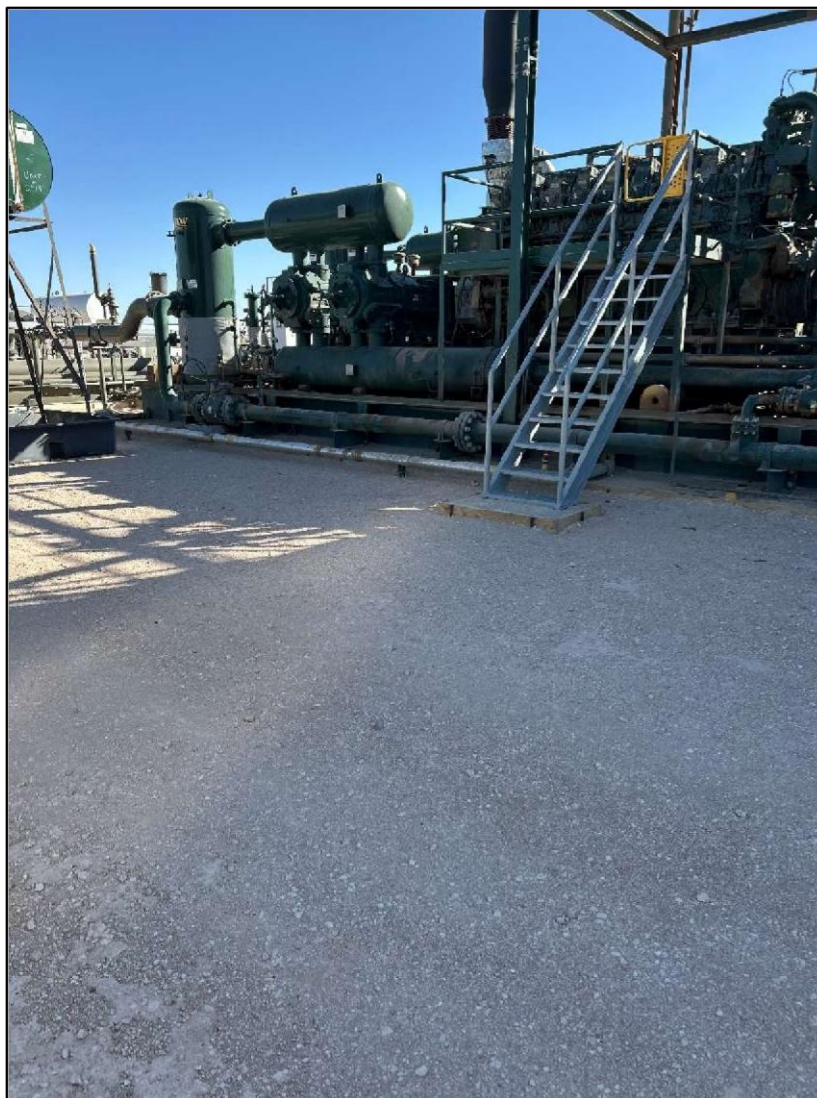
Photo of compression unit 2519 facing north.

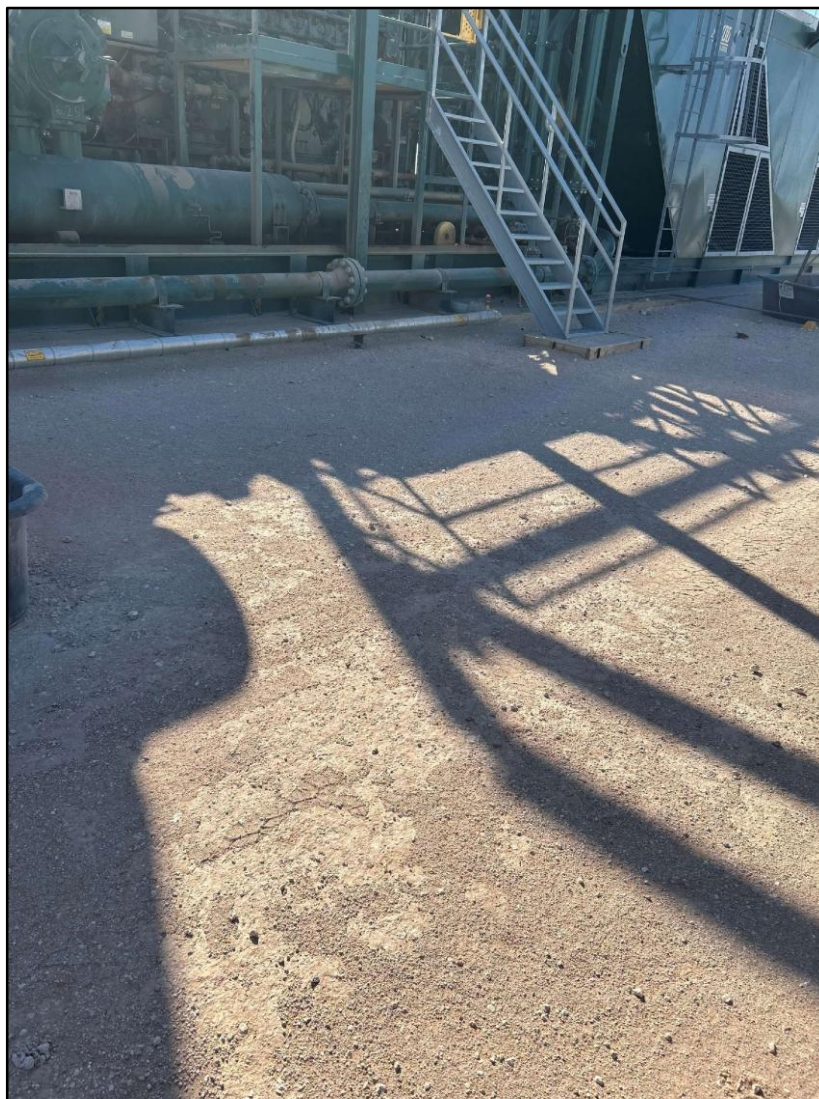
Photo indicating no soil was impacted during this fire event.

This was an above ground fire event with no gas released to atmosphere and no liquids released to surface, photographs are shown in Appendix C illustrating no staining to soil. This event was an incipient fire and extinguished utilizing a fire extinguisher. Targa is respectfully requesting a variance to NMAC Part 29 sampling requirements due to the absence of liquids released. Photographs indicating no soil impact are shown in Appendix C.

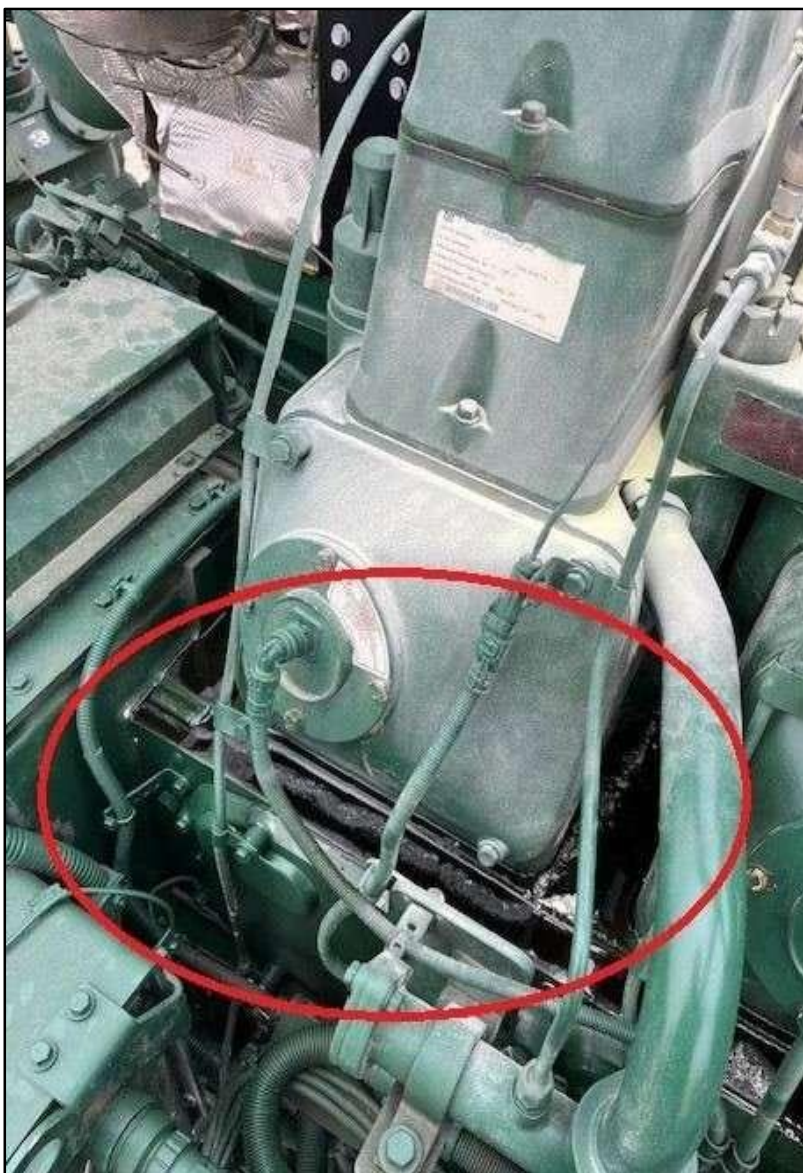
Photo of unit 2519 with the burnt oil stain that was cleaned following the fire event.
