RE: 2024 Annual Groundwater Report

Rice Operating Company – BD SWD System

BD H-35 Emergency Overflow Pit (AP-71): UL/H, Section 35, T22S, R37E

NMOCD Incident ID: nAPP2109553878

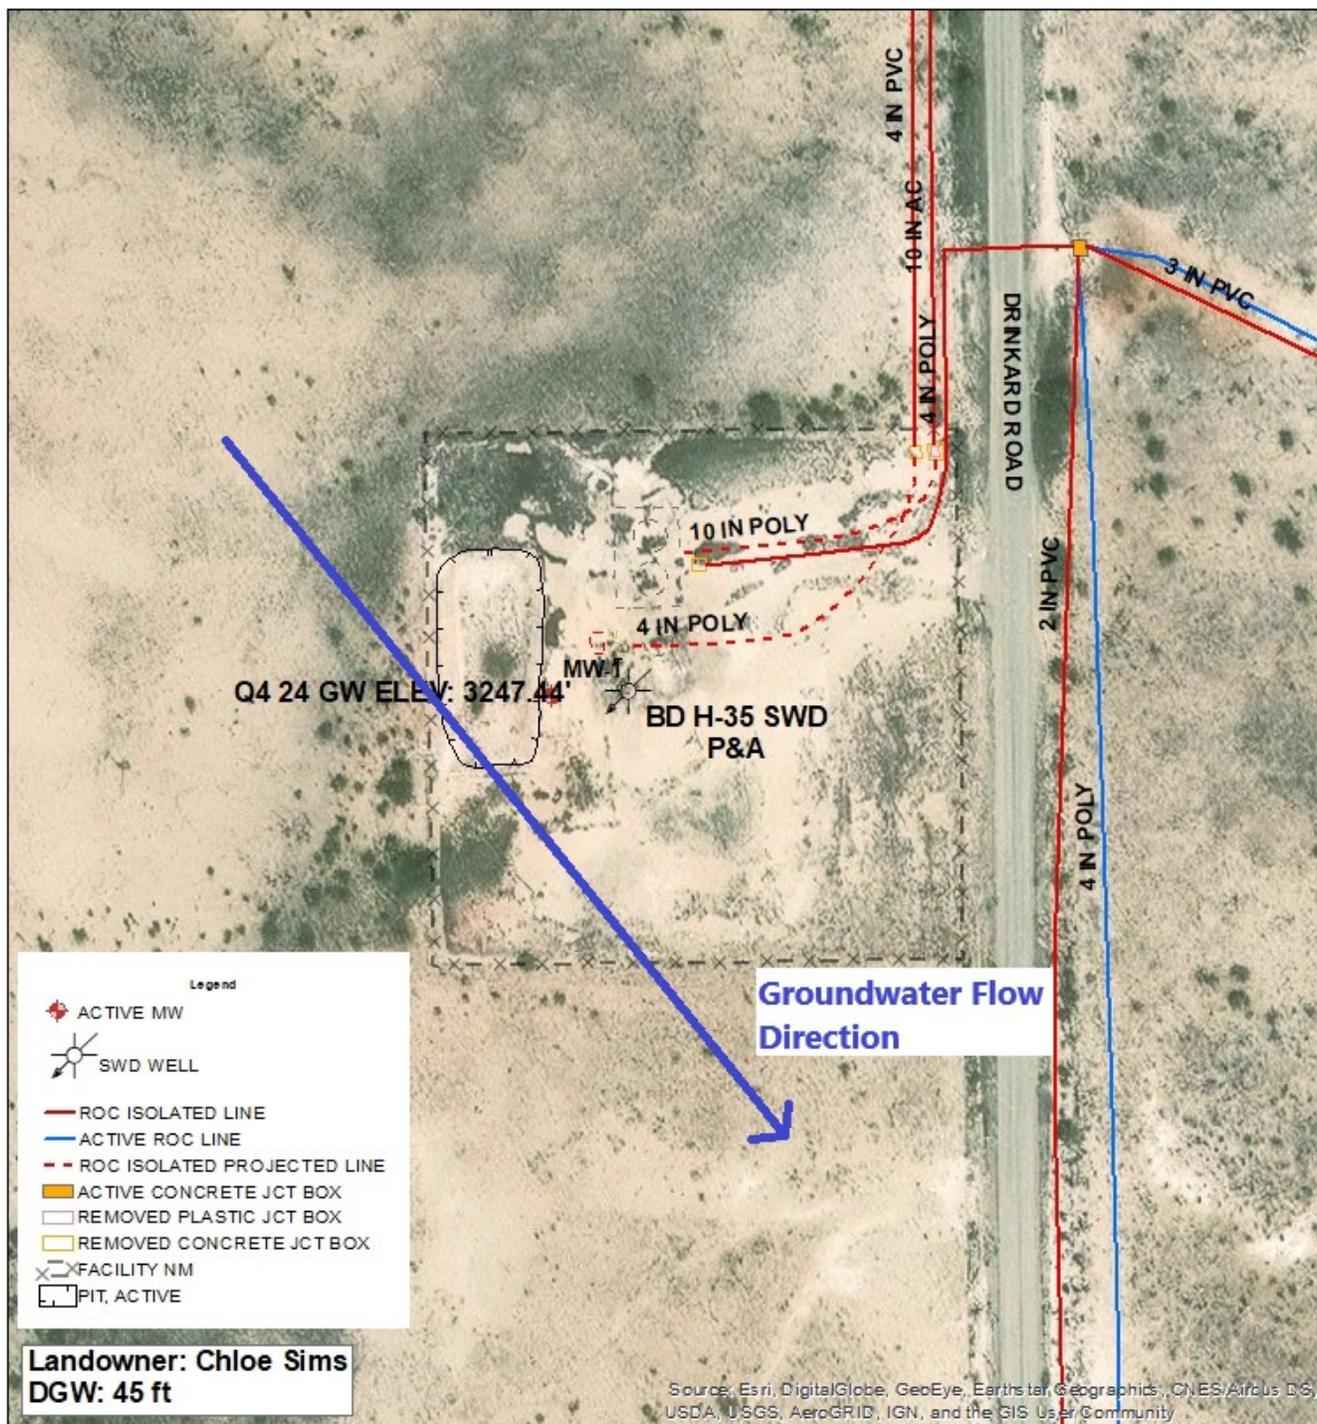
Groundwater Flow Direction

1. NMOCD response to the 2023 Annual Report.
2. A Geographic Location Map.
3. An Area Map.
4. A map showing the monitoring well location and estimated groundwater gradient (generated by Peter Galusky of Terrae LLC).
5. A graph showing laboratory results, and a table presenting all laboratory results and depth to groundwater for the well at the site.
6. The laboratory analytical results for 2024.

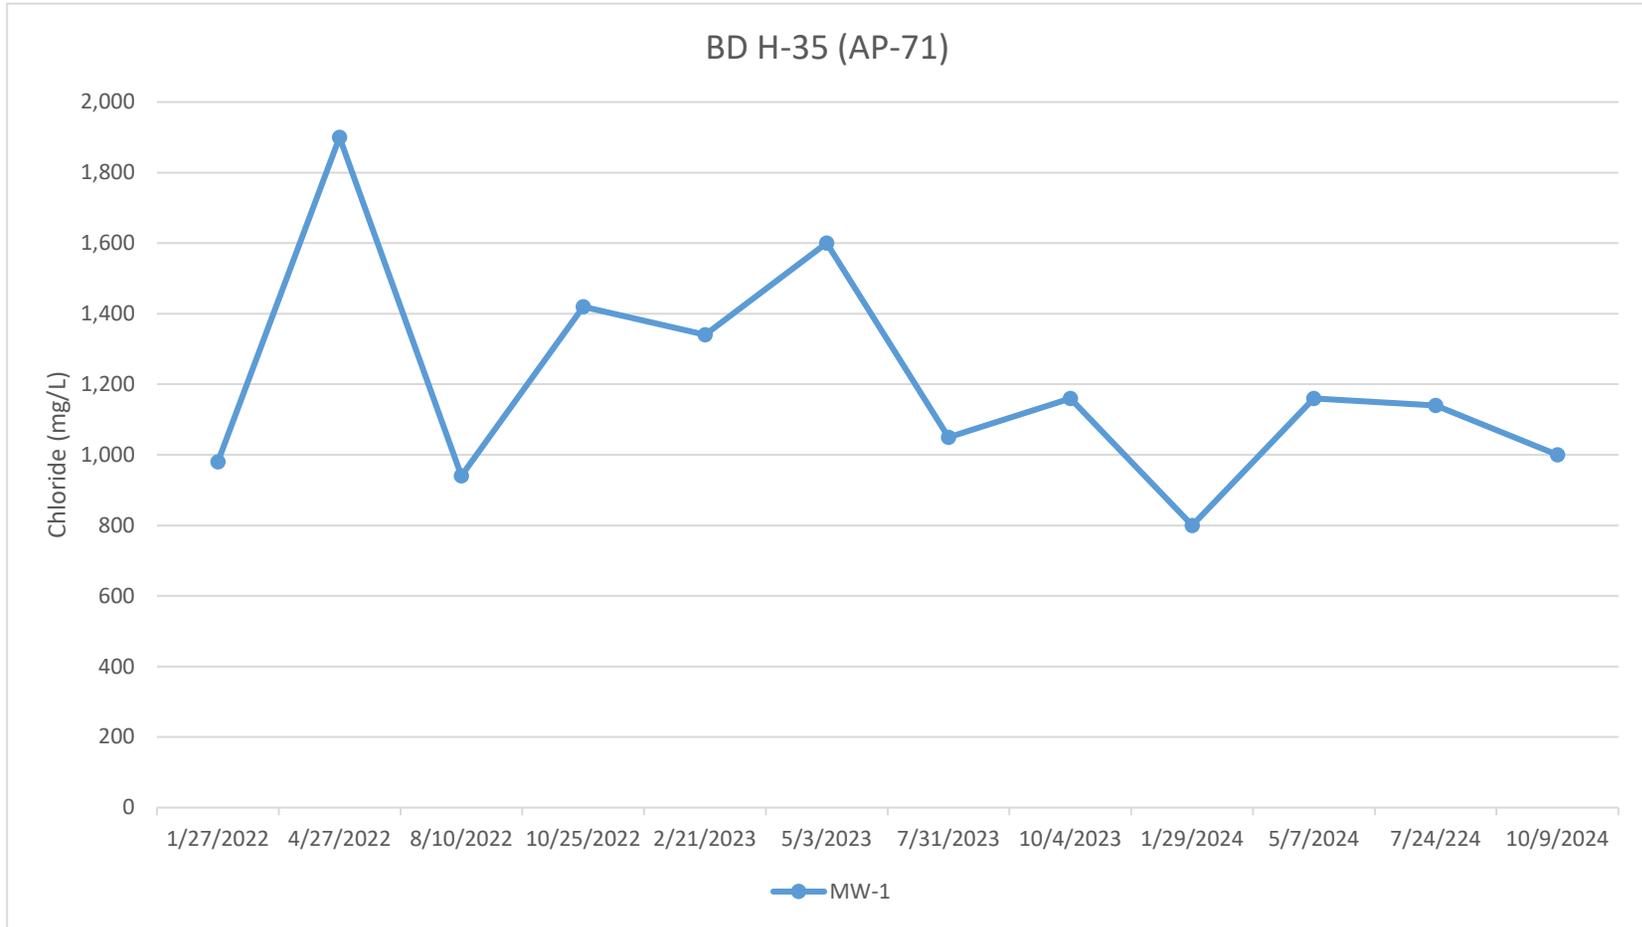
ROC - BD H-35 (AP-71)
Unit Letter H, Section 35, T22S, R37E

One monitoring well was installed on December 21st, 2005, following the approval of the Investigation and Characterization Work Plan on November 9th, 2004. The well has been sampled regularly since installation. The most recent sampling event resulted in a chloride concentration of 1,000 mg/L in MW-1. On February 4th, 2022, NMOCD granted approval to cease sulfate analysis from MW-1. ROC will continue quarterly sampling in 2025.
