**Deferral Report**  
**Yukon Gold 31 19 Federal Com #212H**  
**Incident ID: NAPP2427461130**  
**Unit H Sec 31 T23S R30E**  
**Eddy County, New Mexico**  
**32.262943°, -103.916068°**

**Produced Water Release**  
**Point of Release: Pinhole Leak on 3-Phase Water Leg**  
**Release Date: 09.30.2024**  
**Volume Released: 7.6 Barrels of Produced Water**  
**Volume Recovered: 5 Barrels of Produced Water**

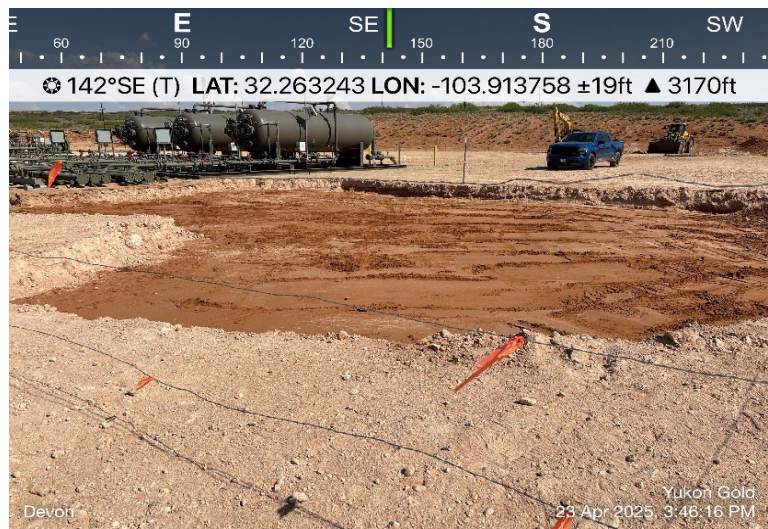
### Photograph No. 3

View Southeast, area of CS-1 through CS-12.

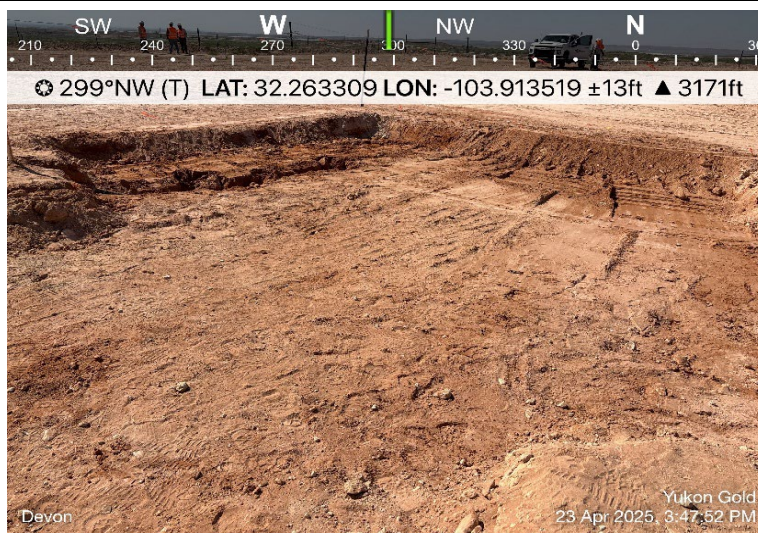
View Northwest, area of CS-13.

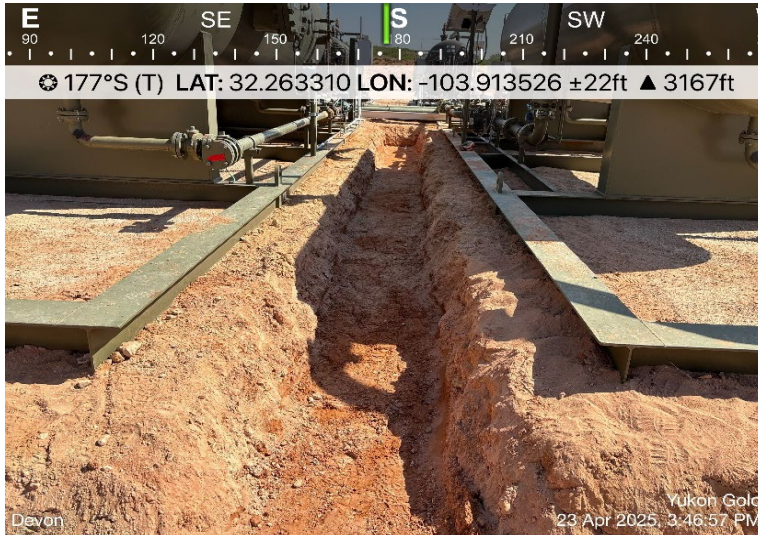
## Photograph No. 6

View South, area of CS-14.

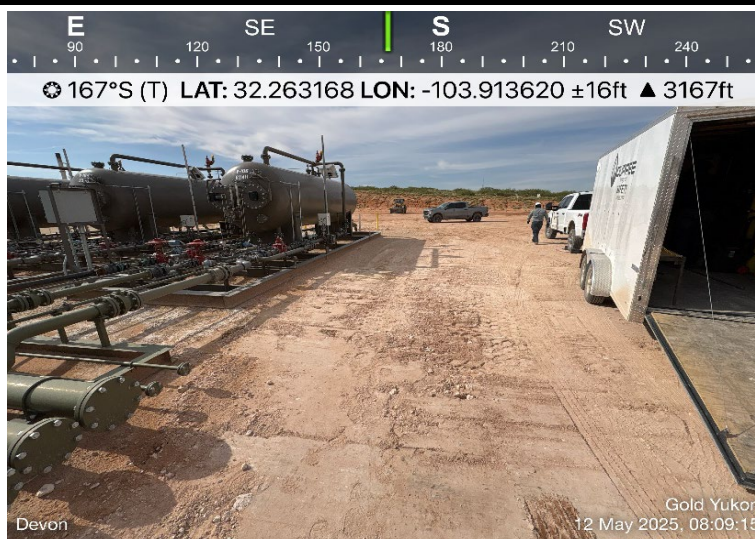
View South of backfilled areas of CS-1 through CS-12

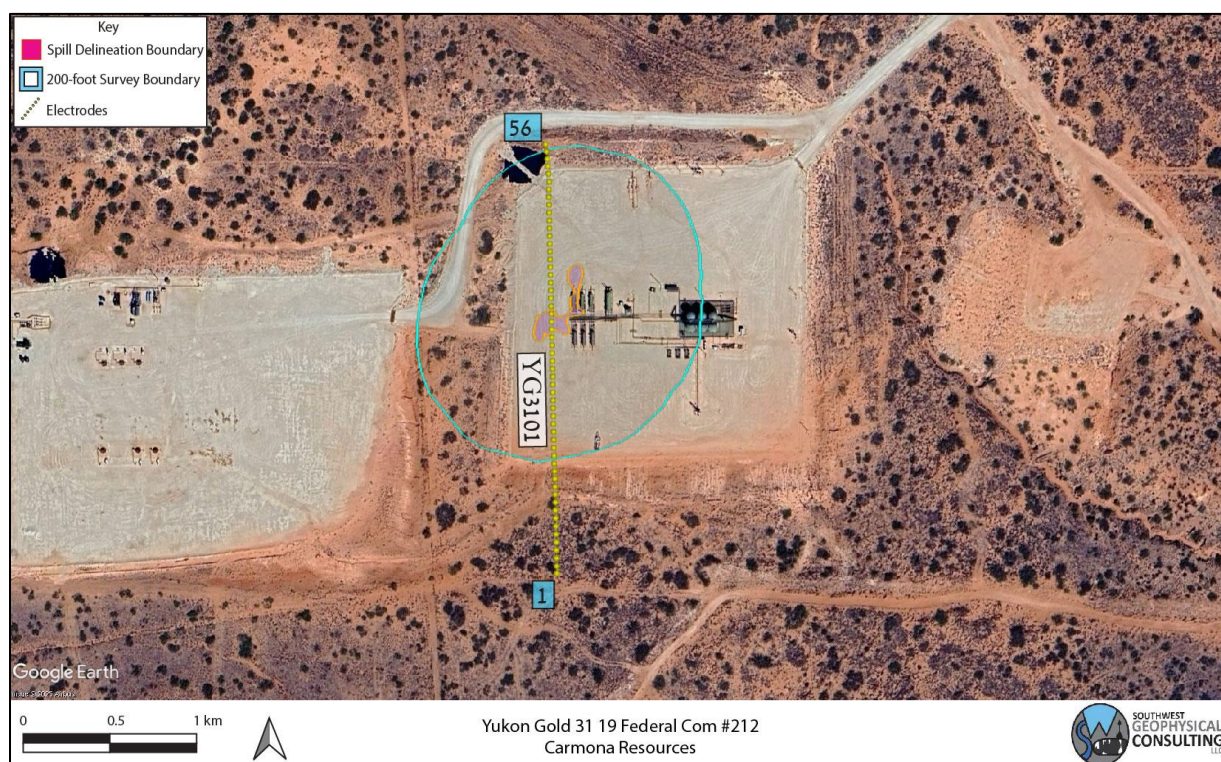
For this survey, an Advanced Geosciences Inc. (AGI) SuperSting™ Wifi R8 with a multi-electrode switchbox, a 56-electrode array of 40-centimeter-long electrodes, and a tablet controller were used to image the subsurface. This survey consisted of one resistivity line in a dipole-dipole strong-gradient configuration laid out south to north. The single line consisted of 56 electrodes at 4-meter spacing, resulting in a 220-meter-long array (**Figure 5, Table 1**). A preconfigured command file was used to run the data collection (DDSG56). This electrode configuration provided a depth of investigation of 44 meters (144 feet) and a resolution of 2.0 to 2.5 meters (6.6 to 8.2 feet) within the first 5 to 8 meters (16 to 26 feet) from the surface. A Leica GS18 GPS was used to record electrode locations and elevations.

**Figure 5: Geophysical survey overview.** One survey line was conducted with 56 electrodes each at 4-meter spacing (yellow dots denoted with blue numbers). Background image credit: Google Earth. Image date: August 21, 2024. Image datum: WGS-84.
