**C-141 - CO2 GAS RELEASE ONLY (No Liquids)**  
**EVENT SUMMARY, VARIANCE REQUEST & CLOSURE REQUEST REPORT**

| <b>Facility ID:</b> | fJXK1520829861 | <b>Incident #:</b> | nAPP2512233630 |
| <b>Facility Name:</b> | South Hobbs CTB | <b>Flare Date:</b> | 04/19/2025 |

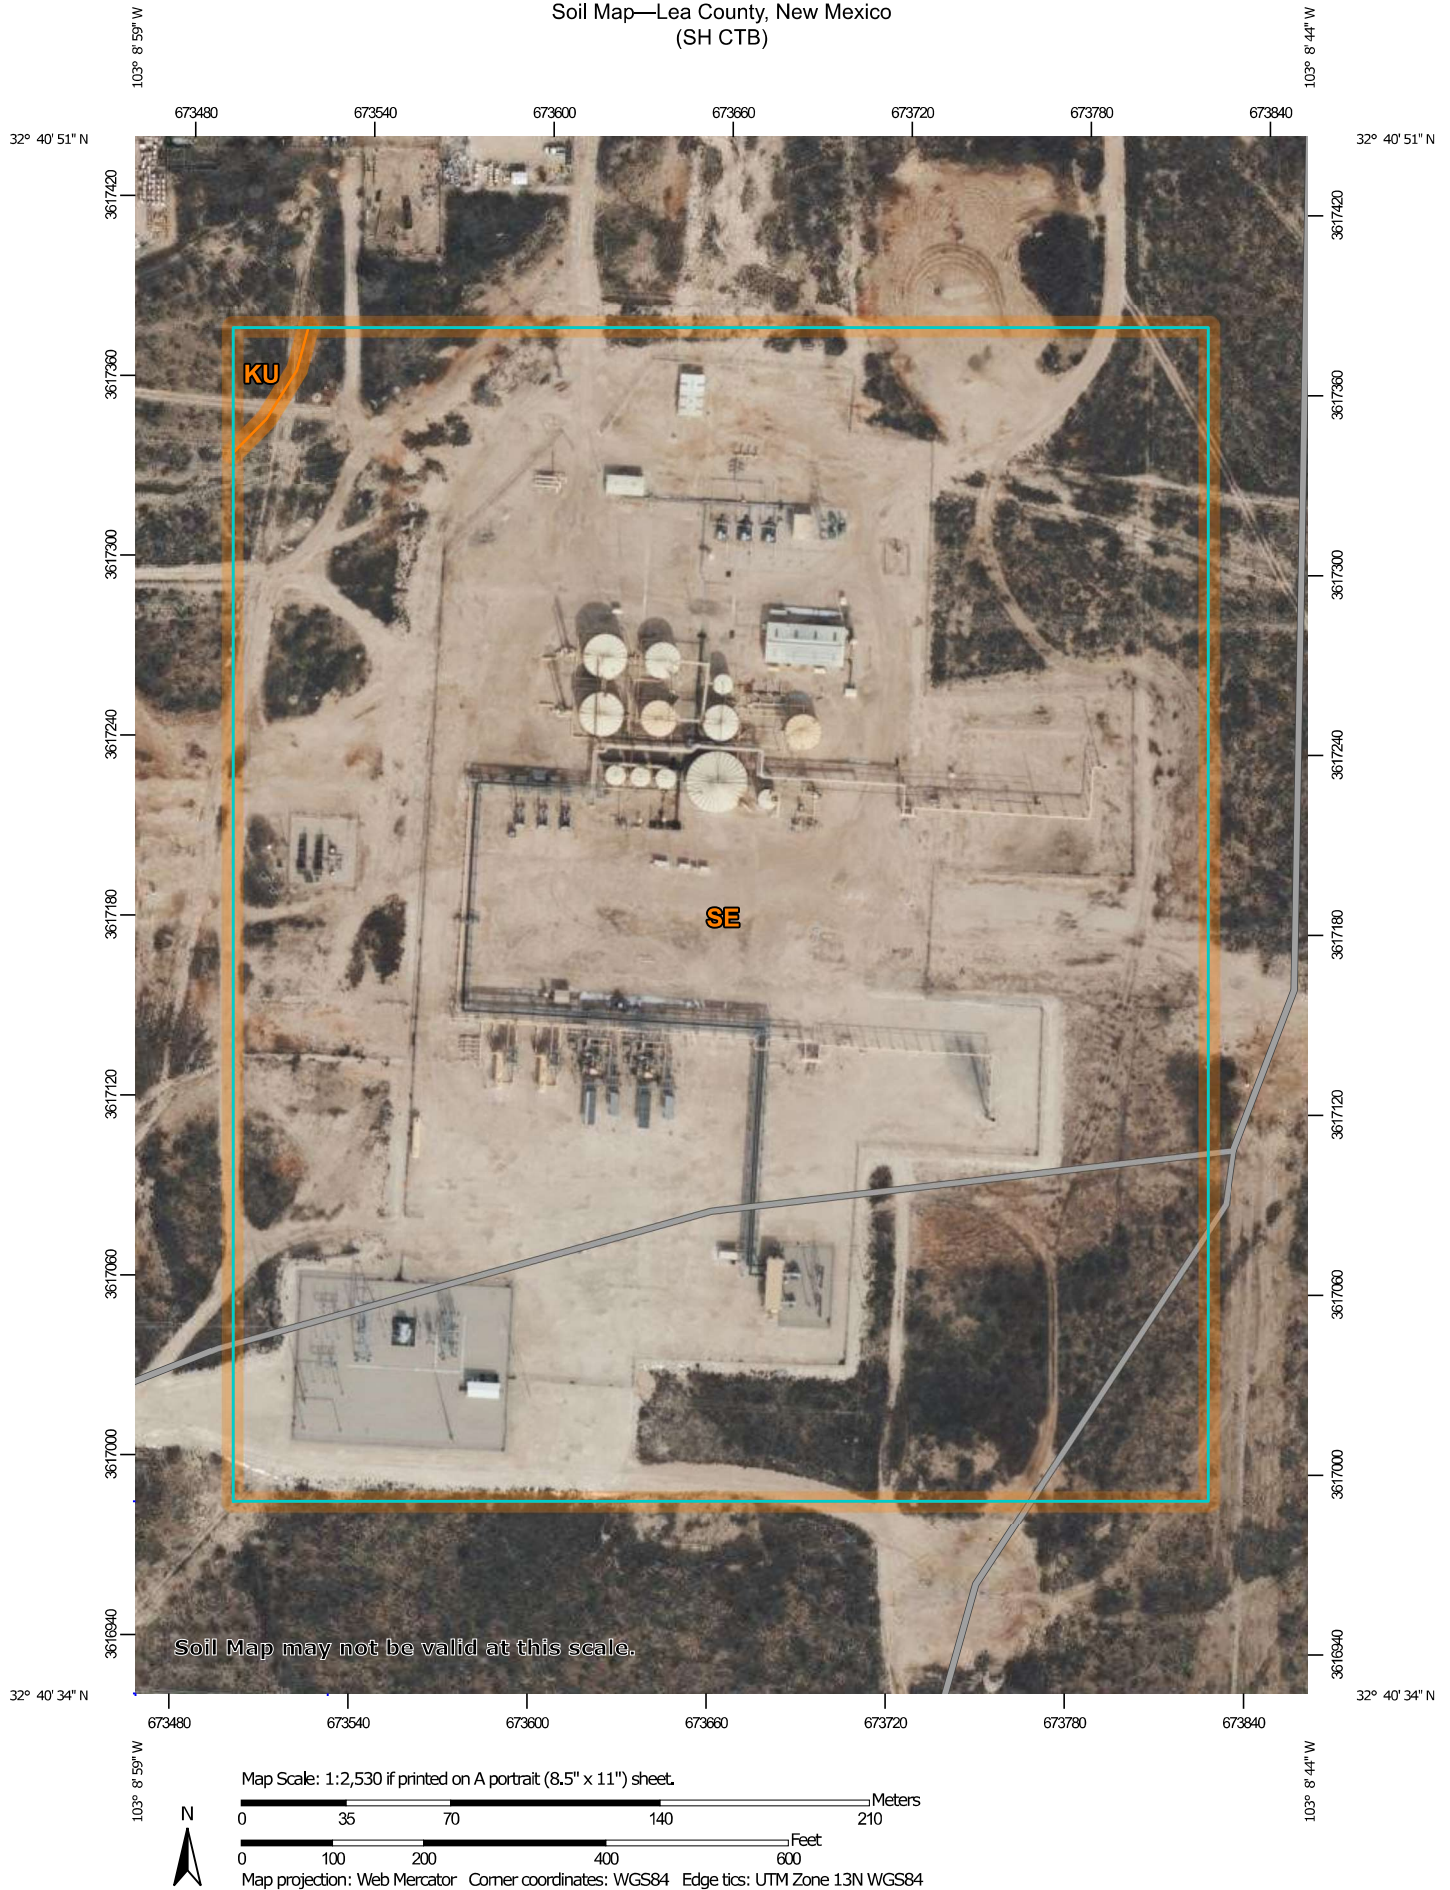
Soil Map—Lea County, New Mexico  
(SH CTB)

| Map Unit Symbol | Map Unit Name | Acres in AOI | Percent of AOI |
|---|---|---|---|
| SE | Simona fine sandy loam, 0 to 3 percent slopes | 31.6 | 99.5% |
