## Remediation Summary & Soil Closure Request

**XTO Energy, Inc.**

**PLU 26 Brushy Draw CVB**

**NMOCD Reference No. nAPP2406161820**

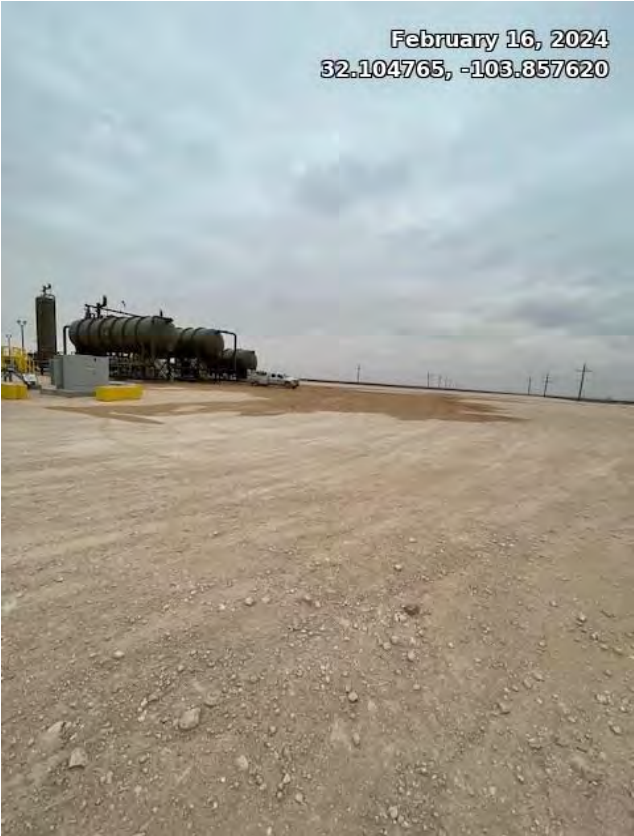
| 1 | |

| View of the affected area. | |

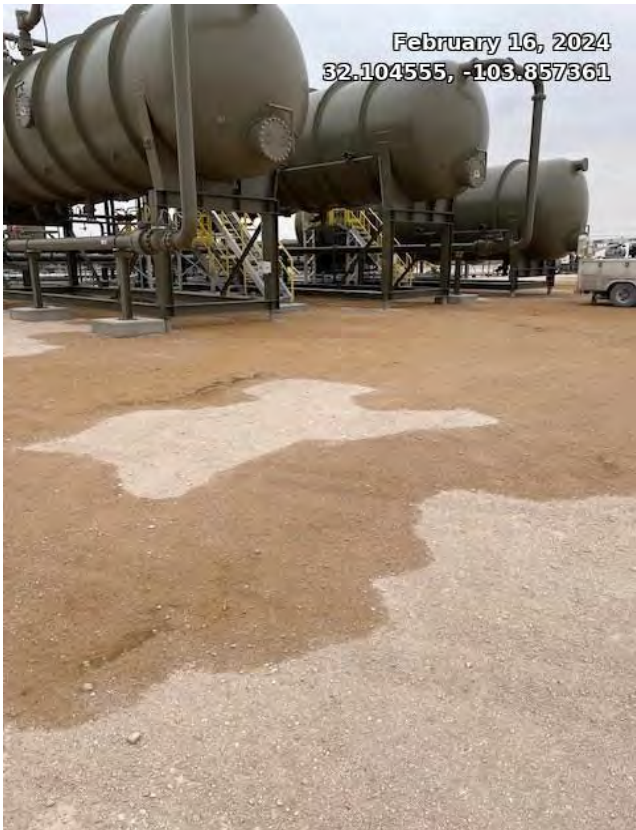
| <b>Photo Number:</b><br>2 | |

| <b>Photo Description:</b><br><br>View of the affected area. | |

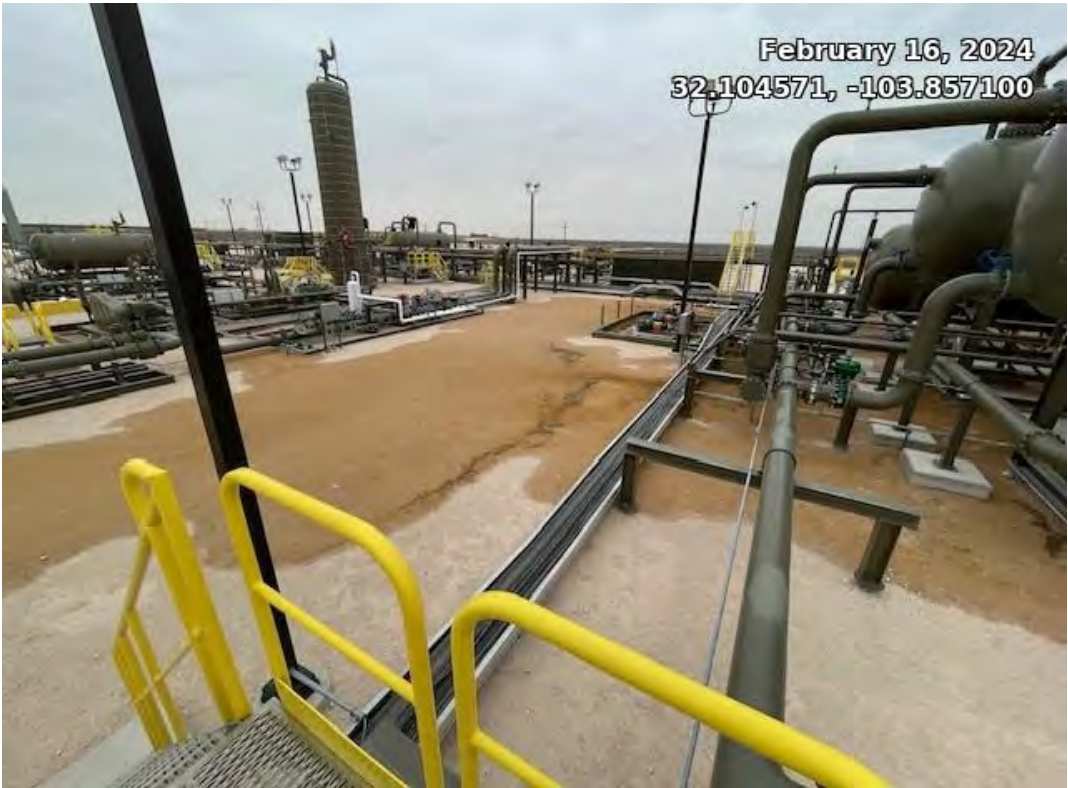
| <b>Photo Number:</b><br>3 | |

| <b>Photo Description:</b><br><br>View of the affected area. | |

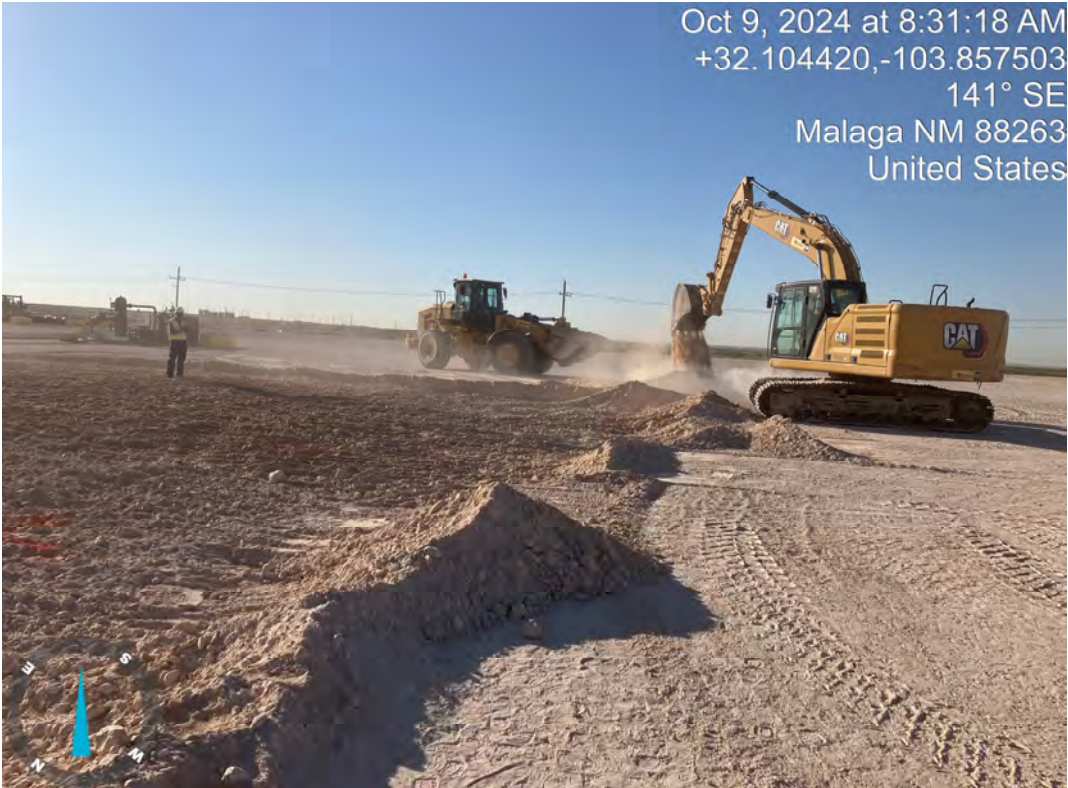
| <b>Photo Number:</b><br>4 | |

| <b>Photo Description:</b><br><br>View of the excavated area. | |

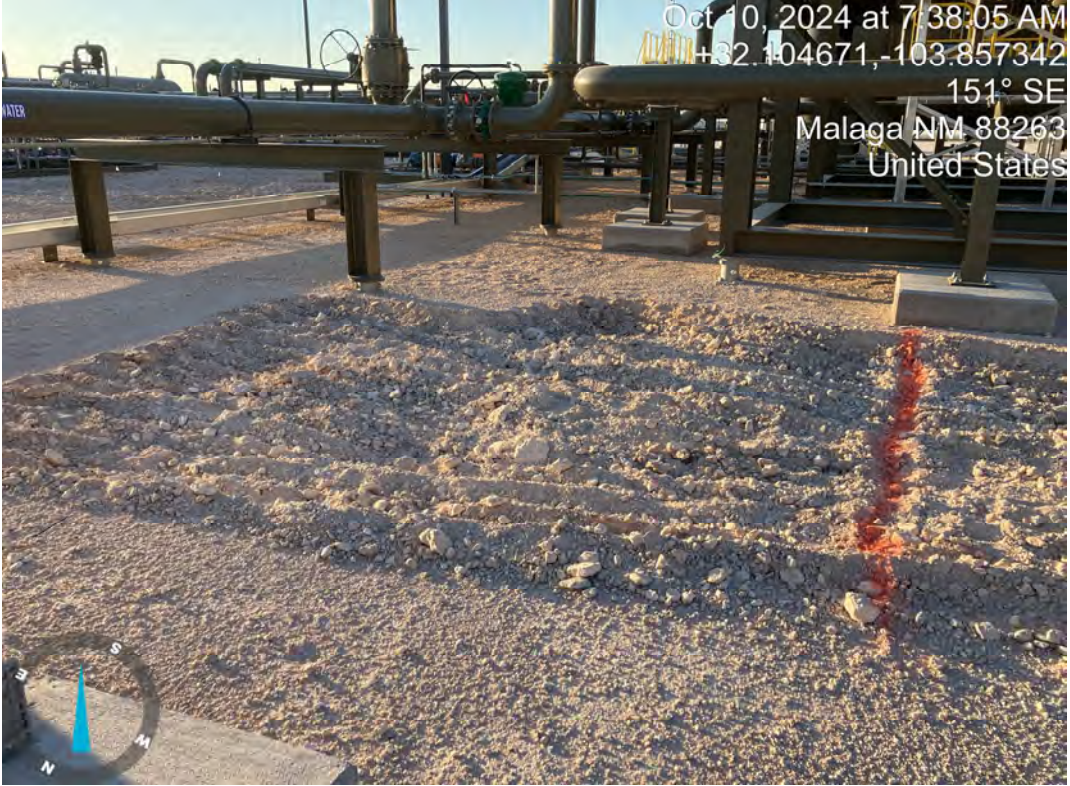
| <b>Photo Number:</b><br>5 | |

| <b>Photo Description:</b><br><br>View of the excavated area. | |

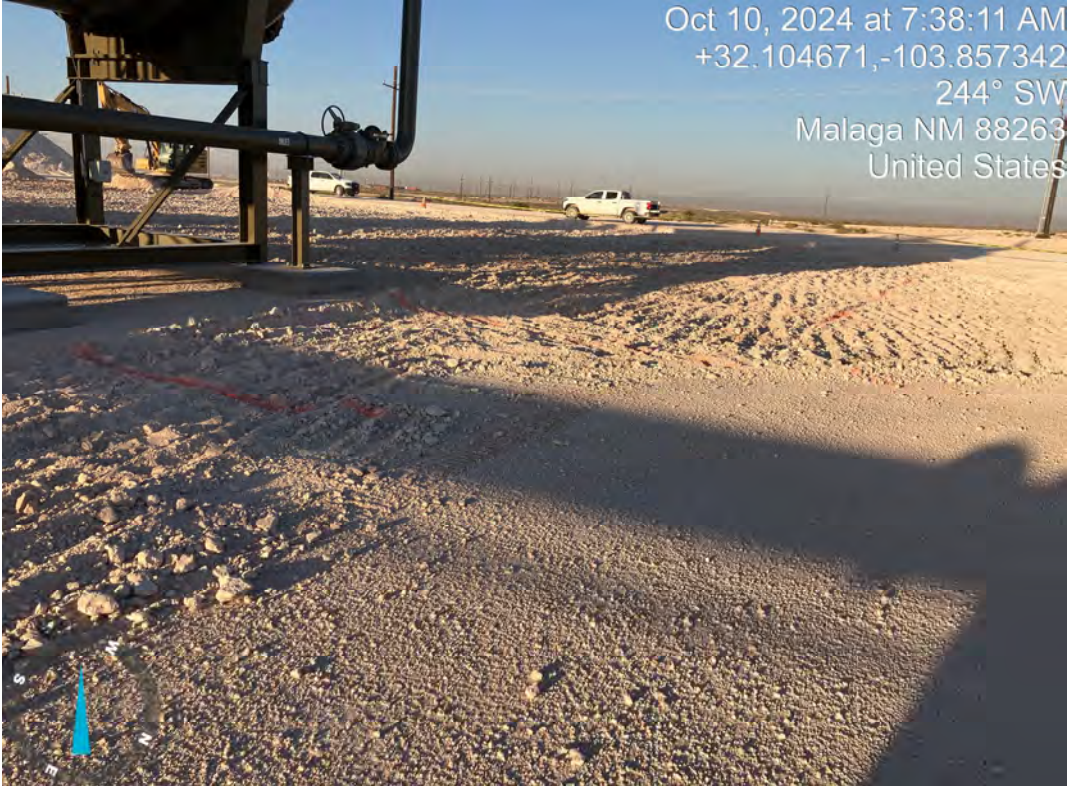
| <b>Photo Number:</b><br>6 | |

| <b>Photo Description:</b><br><br>View of the excavated area. | |
