**C-141 - CO2 GAS RELEASE ONLY (No Liquids)**  
**EVENT SUMMARY, VARIANCE REQUEST & CLOSURE REQUEST REPORT**

**Facility ID:**fJXK1521644806

**Facility Name:** North Hobbs CTB**Flare Date:** 1/2/2026**Duration of Event:** 34minutes**MCF Flared:**71 MCF**Start Time:** 2:46 PM**End Time:**3:20 PM**Cause:** controlled release of gas only, no liquids involved - combusted in a flare to reduce emissions;

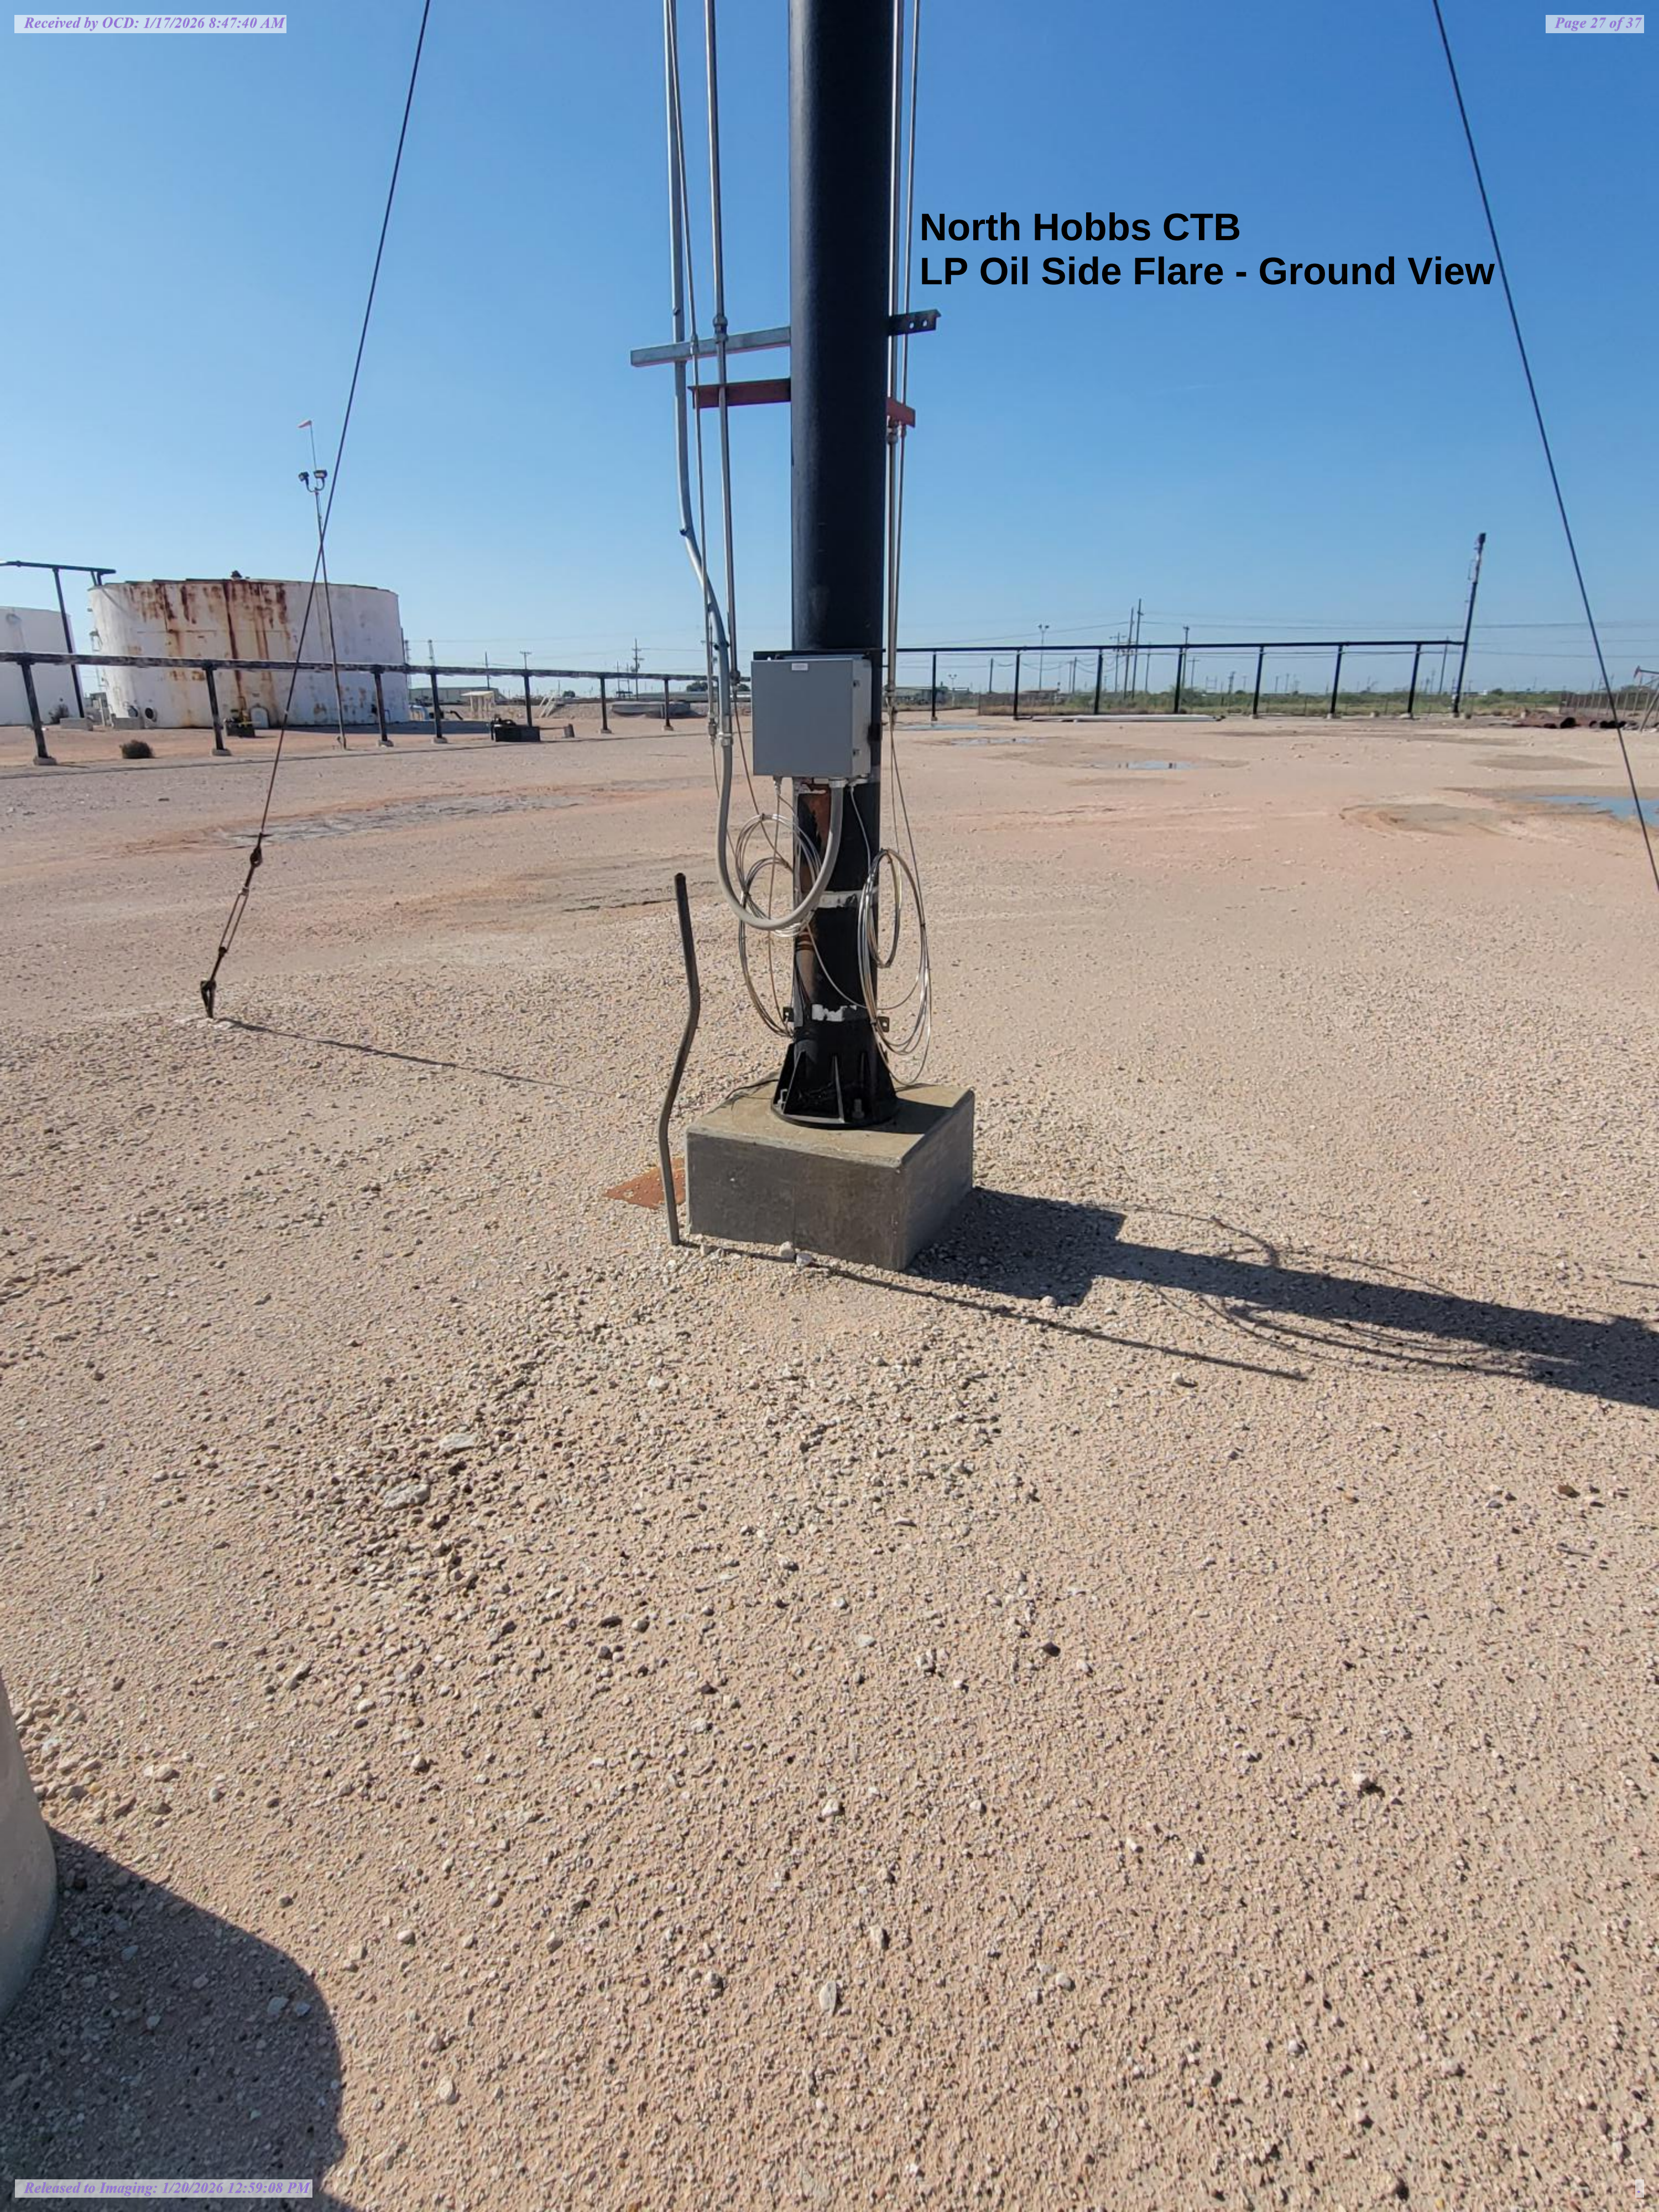
**North Hobbs CTB  
LP Oil Side Flare - Ground View**

- I. This flaring event was a controlled release of gas only, no liquids involved - combusted in a flare to reduce emissions; due to an unavoidable process upset at the facility involving CO2 gas.

- III. The flaring event has ceased.
- IV. This flare event consists primarily of CO2 gas and includes a small number of hydrocarbons. This flaring event did not result in a fire or result of a fire and no injuries were sustained or reported.
