## 2025 Q3/Q4 Semi-Annual – Remediation System Operation and Monitoring Report

**Florance Gas Com J No. 16A  
Harvest Four Corners, LLC  
San Juan County, New Mexico**

**API # 30-045-21790  
Incident # NCS1629854256  
Remediation Permit Number 3RP-364**

January 14, 2026  
Ensolum Project No. 07B2002007

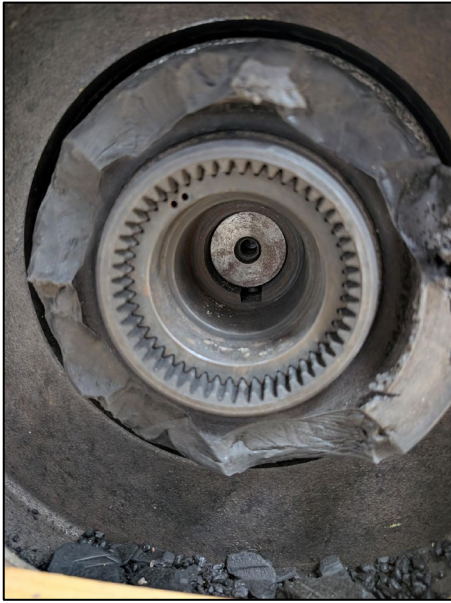
During the evening of November 3, 2025, telemetry indicated a significant drop in operational amperage for the blower motor accompanied by a significant vacuum drop to near zero inches of mercury (inHg). On November 5, 2025, Ensolum personnel visited the Site to assess the issue. Inspection of the blower and associated motor indicated that there had been a coupling failure between the electric motor shaft and the blower. A replacement coupling was ordered, and on December 12, 2025, an attempt was made to install the coupling. Due to the weight of the motor and difficult access, this original repair attempt was unsuccessful. On January 7, 2026, Ensolum personnel returned to the Site to attempt to replace the coupling. Following removal of the broken coupling, it was determined that a rubber bushing was also deteriorated and in need of replacement. The replacement bushing has been requested and will be installed upon receipt. Photographs of the failed coupling and bushing are provided in Appendix A.

Photograph: 1  
Description: Failed coupling, blower side  
View: NA

The DPE remediation system will continue operating with the goal of optimizing vapor and liquid recovery using one blower. The failed parts detailed in Section 3.0 will be replaced as soon as practical once the replacement part has been received. If replacement of these parts does not resolve the issue, the electric motor and blower will be shipped to the manufacturer for repairs.

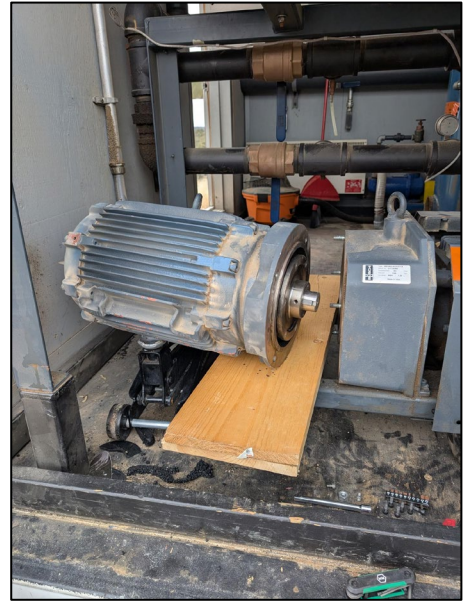
Photograph: 2  
Description: Electric motor – removed from blower  
View: West

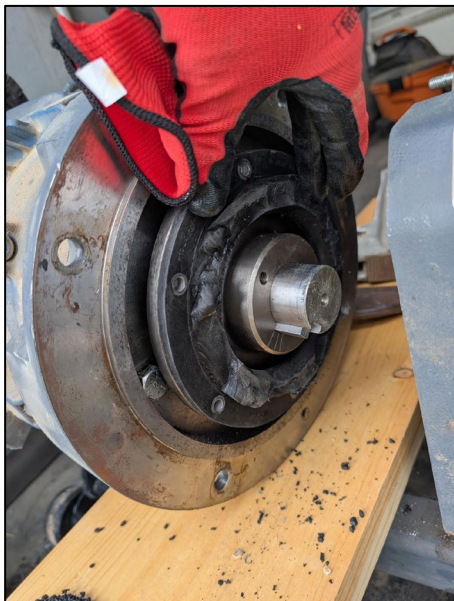
Photograph: 3  
Description: Failed coupling, motor side  
View: NA

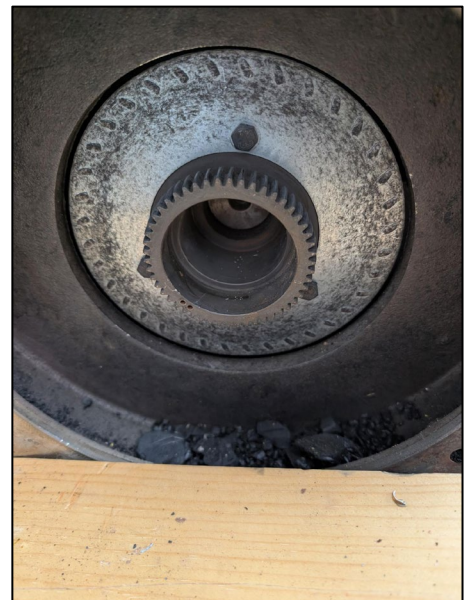
Photograph: 4  
Description: Coupling removed – Blower side  
View: NA
