## Site Characterization and Remediation Closure Report

CDU 150H PW

nAPP2530845674

B-34-24S-31E

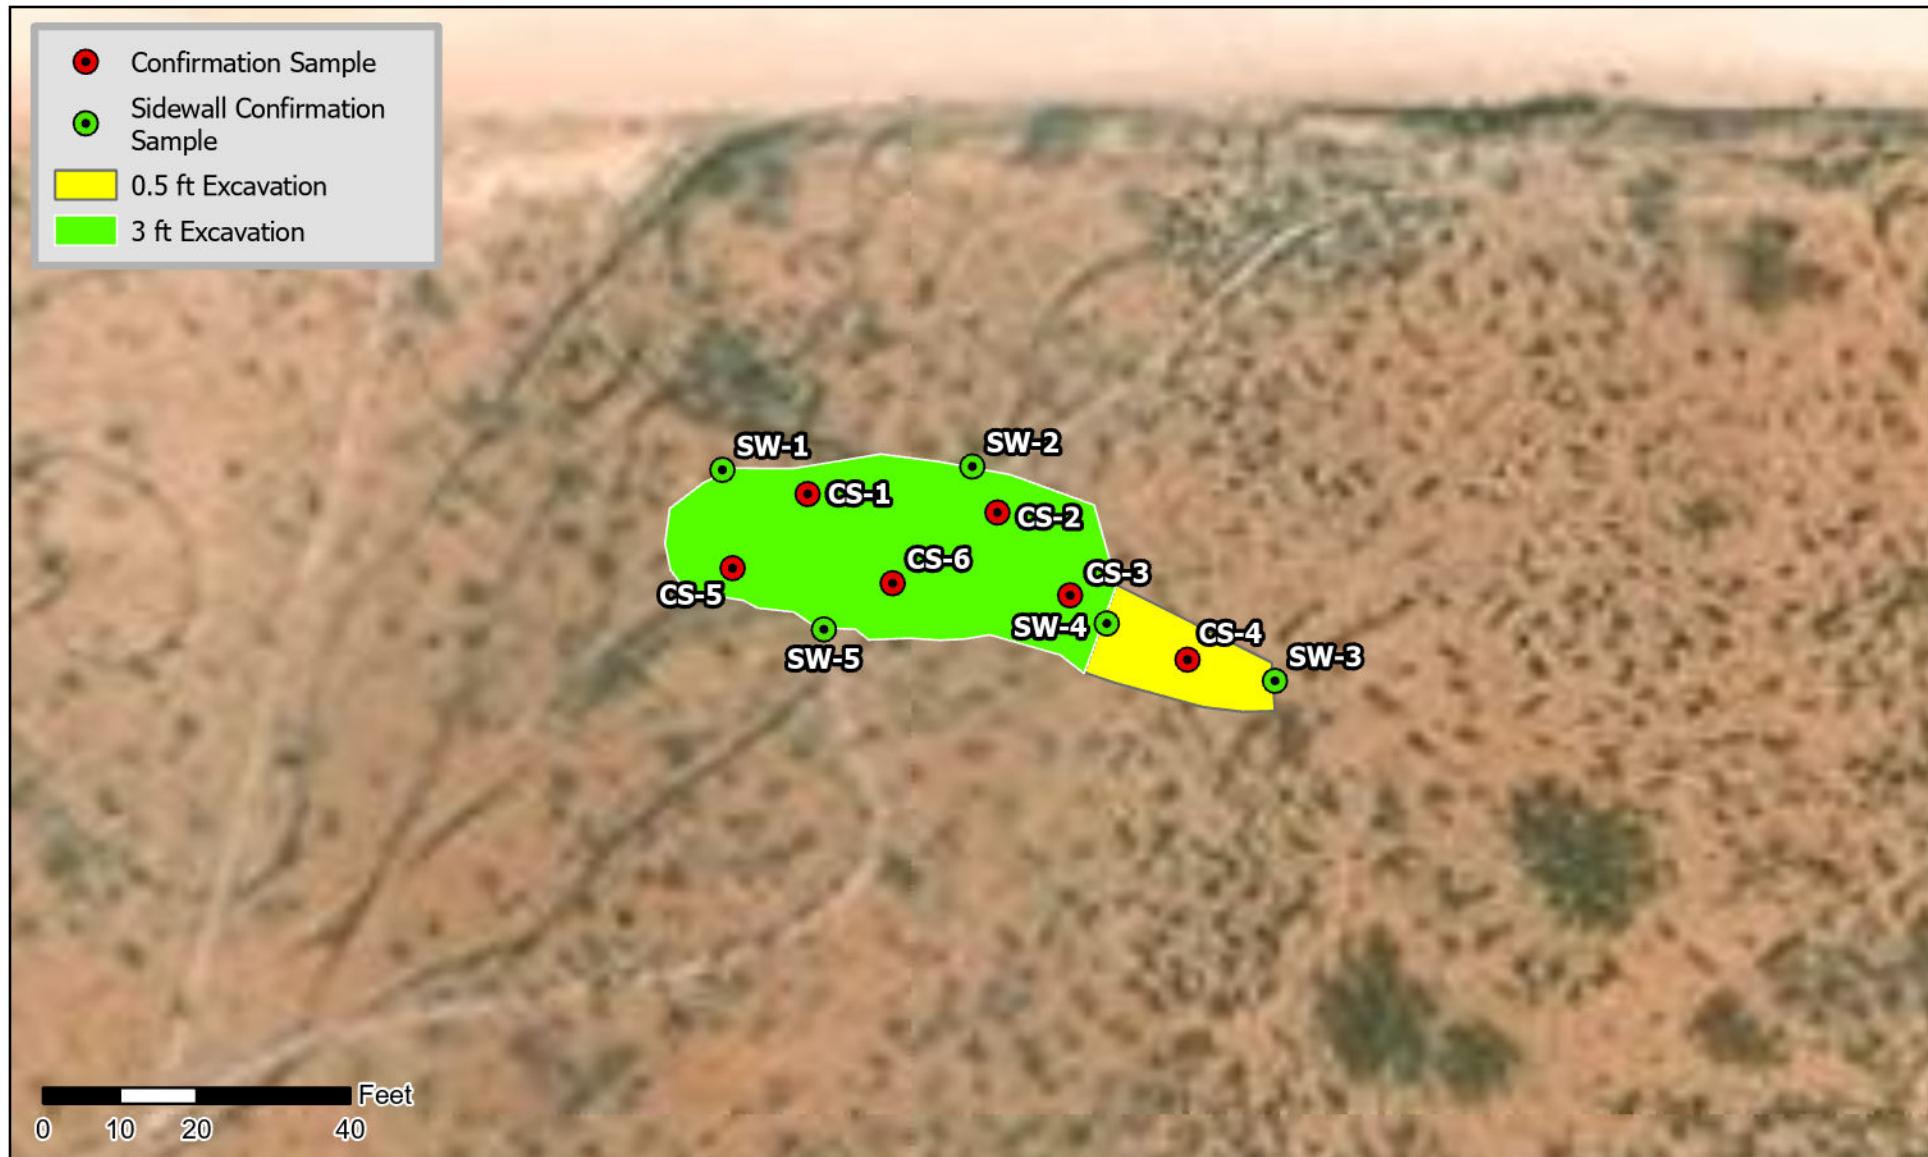
Figure 3. Confirmation Sampling Map  
Eddy County, New Mexico

On December 9<sup>th</sup>, 2025, Standard was onsite to perform a confirmation sampling event where six (6) base samples (CS-1 to CS-6) and five (5) sidewall samples (SW-1 to SW-5) were collected. Soil samples were jarred in lab provided containers, placed on ice then transported under proper chain-of-custody to Eurofins in Carlsbad, New Mexico, for the analysis of BTEX, TPH, and chloride. Analytical results indicated that all samples were below closure criteria for the Site. Soil samples were collected as a five-point composite and represented an area no greater than 200 square feet. There was an estimated one hundred and forty (140) cubic yards of impacted material that was excavated and transported off to the closest approved disposal facility.

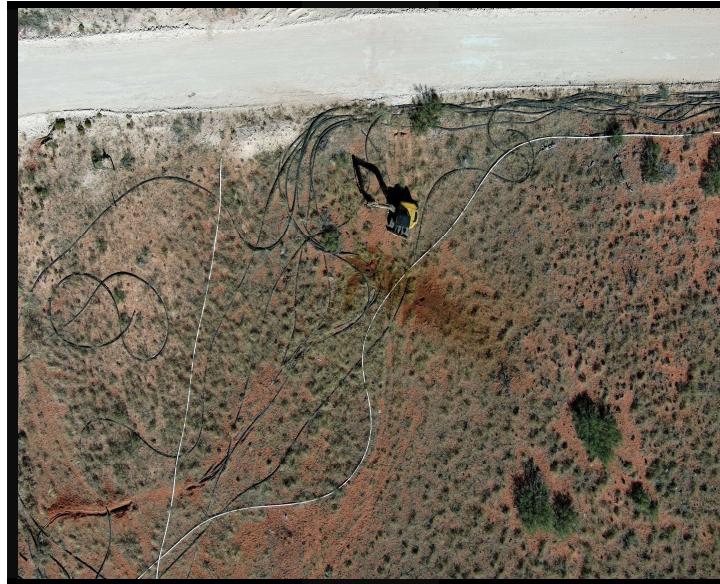
Drone Photo of Area of Concern

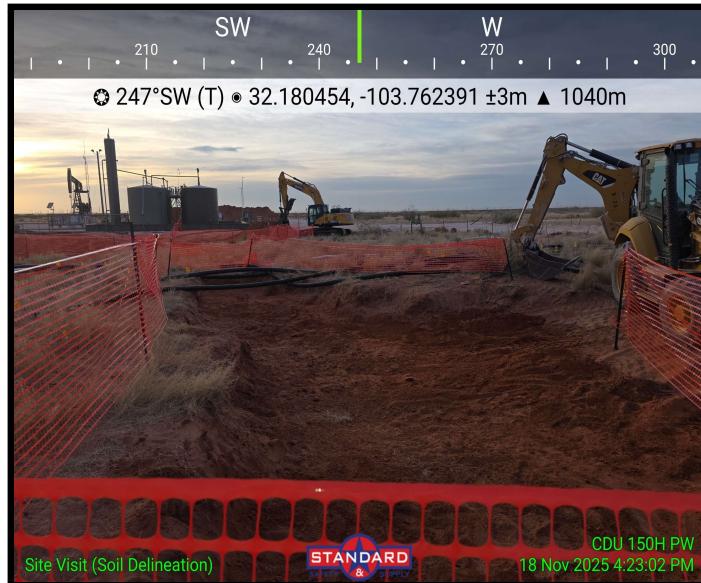
View of Open Excavation

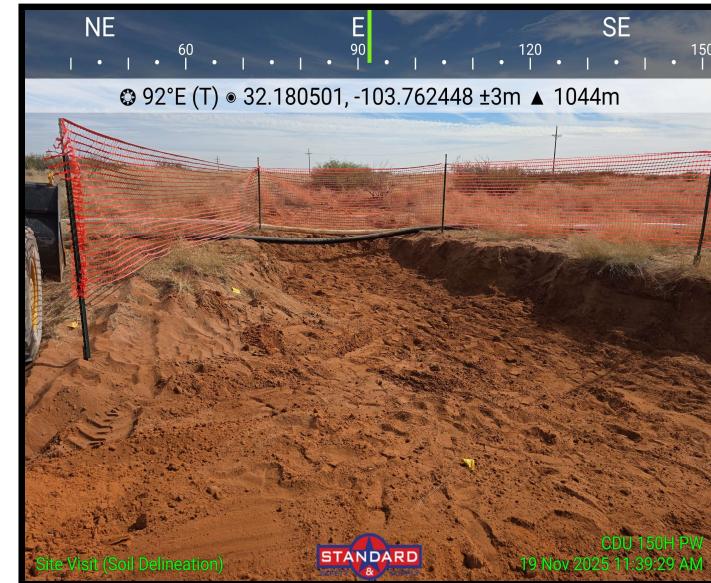
View of Open Excavation

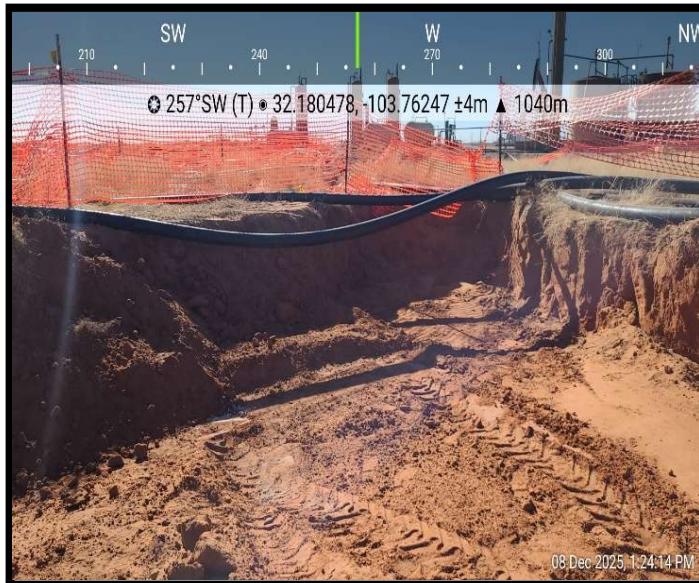
View of Open Excavation

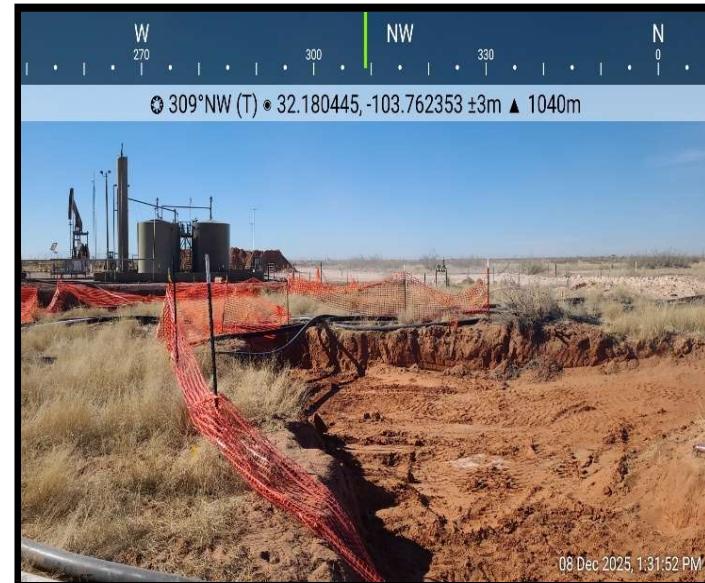
View of Open Excavation
