C-141 - CO2 GAS RELEASE ONLY (No LIQUIDS)
EVENT SUMMARY, VARIANCE REQUEST & CLOSURE REQUEST REPORT

Facility Name: South Hobbs RCF

Flare Date: 1/18/2026

Cause: controlled release of gas only, no liquids involved - combusted in a flare to reduce emissions;

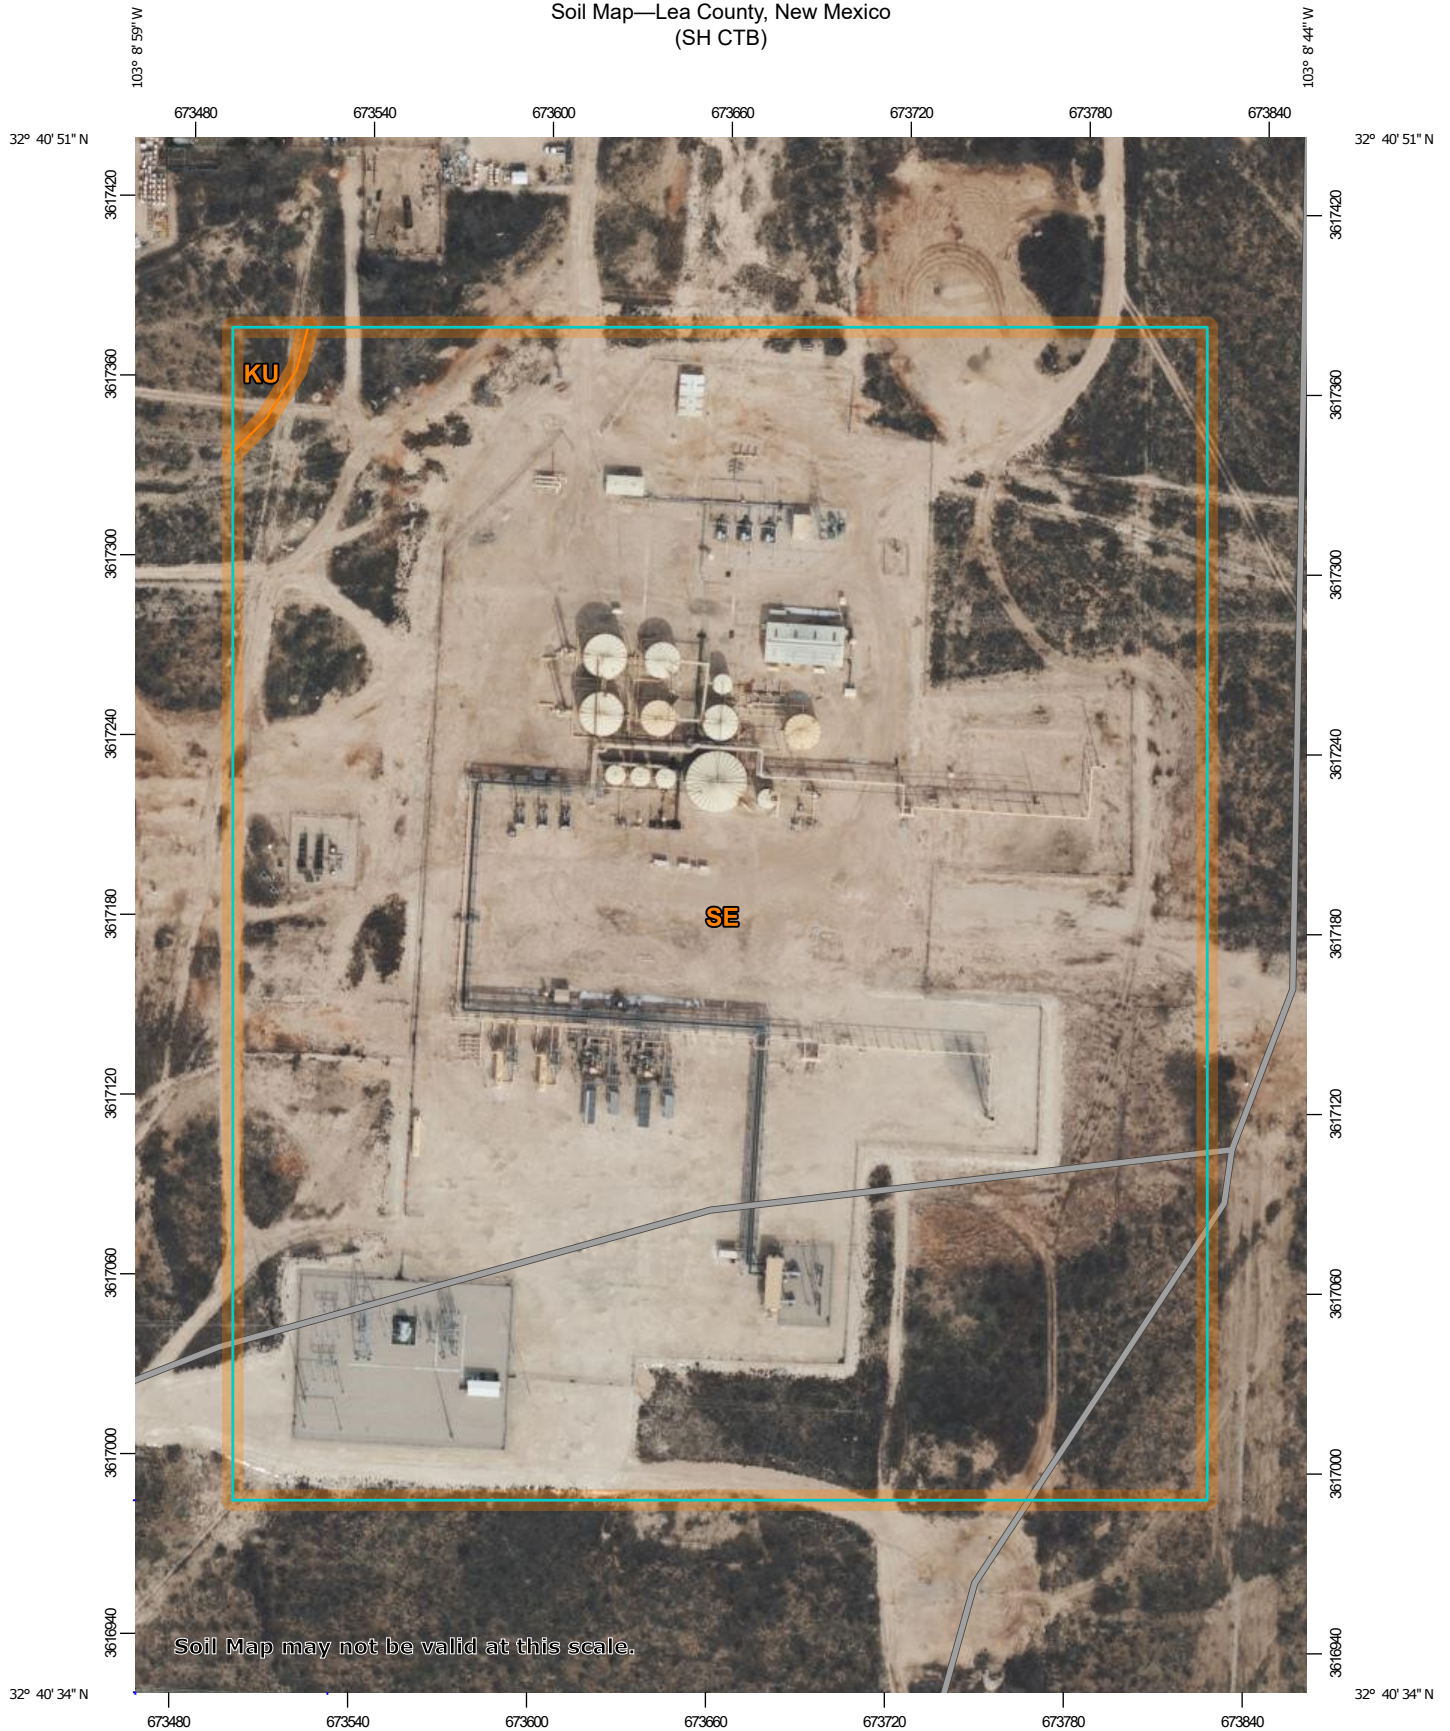
Soil Map—Lea County, New Mexico
(SH CTB)

Map Unit Symbol	Map Unit Name	Acres in AOI	Percent of AOI
KU	Kimbrough-Lea complex, dry, 0 to 3 percent slopes	0.2	0.5%
SE	Simona fine sandy loam, 0 to 3 percent slopes	31.6	99.5%
Totals for Area of Interest		31.7	100.0%
