SOFTSHELL 22 FEDERAL #001H

Incident ID nRM2010649724

Reclamation Closure Report

Re: Reclamation Closure Report
Softshell 22 Federal #001H
API No. 30-015-39727
GPS: Latitude 32.1222076 Longitude -103.7627106
ULSTR – B – 22 – 25S – 31E 0 FNL 0 FEL Eddy County, NM
NMOCD Incident ID nRM2010649724

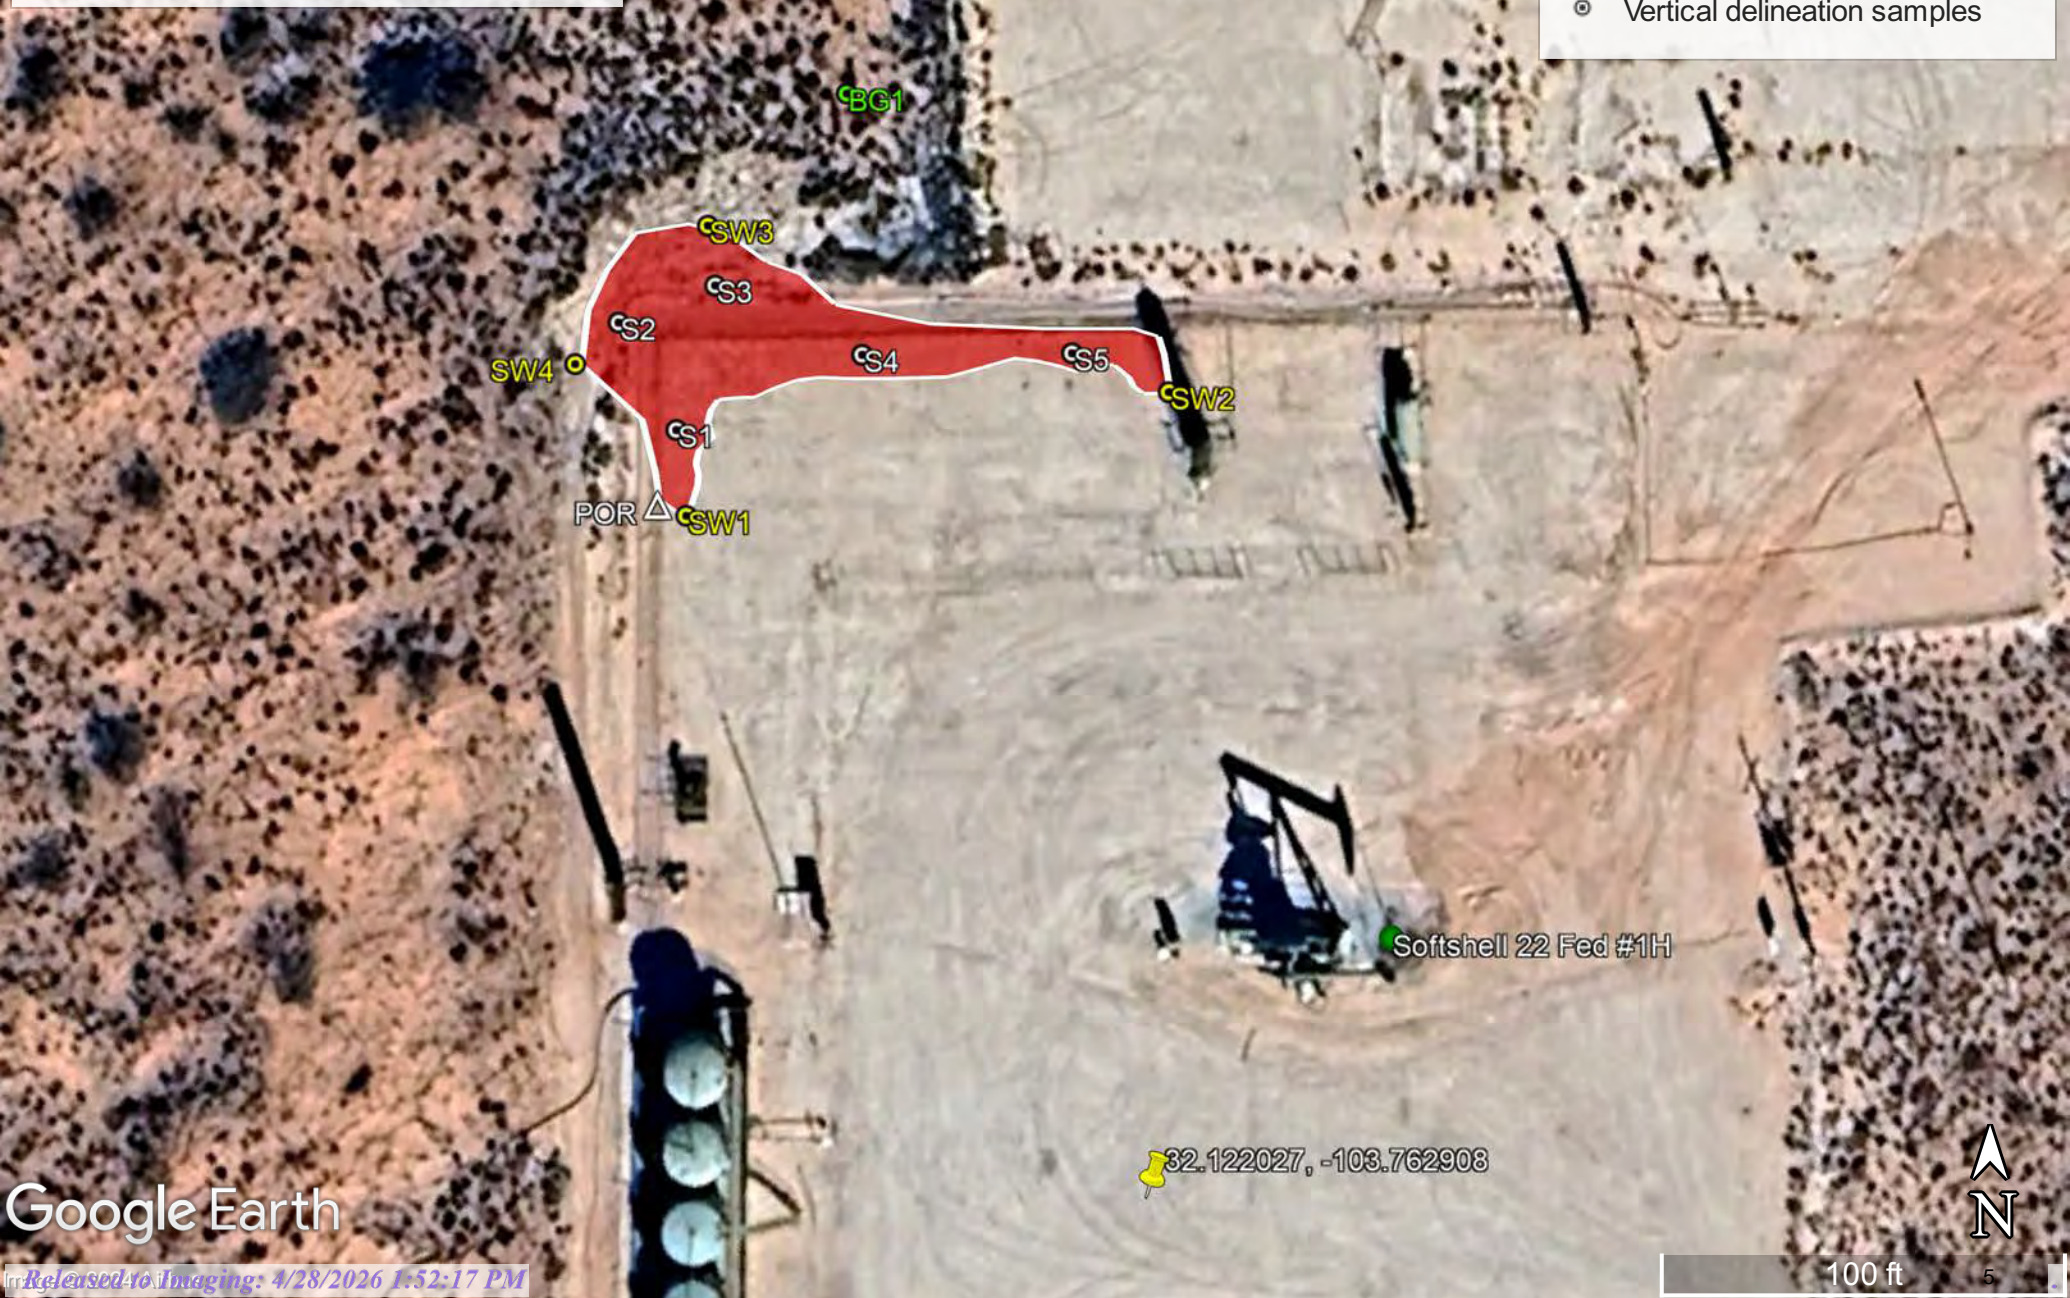
Devon Energy
API #30-015-39727
Eddy County, NM
nAPP2010649724
Site Map

On June 29, 2023, Pima mobilized personnel to the site to collect soil samples from the spill area to delineate the release. Twenty-five samples were collected from 10 different sample points. Twenty samples were collected for the purpose of vertical delineation from 5 different sample points within the release area. These discreet samples were collected from depths of 1', 2', 3', and 4' bgs. Four composite samples were collected from the edges of the release area for the purpose of horizontal delineation. These composite samples consisted of samples from 1', 2', 3', and 4' depths from each sample point. One sample was collected as a background sample from a depth of 1' bgs. The laboratory results of this sampling event can be found in the following data table. A Site Map can be found in Figure 4.

- Background sample
- Horizontal delineation samples
- △ POR
- Release area - 3,462 sqft
- Vertical delineation samples

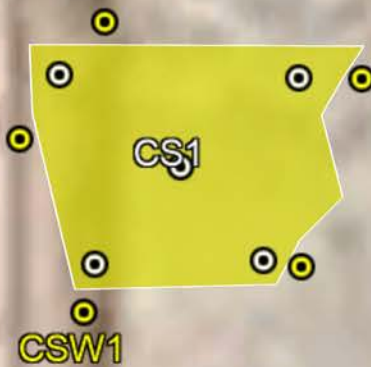
Devon Energy
API #30-015-39727
Eddy County, NM
nAPP2010649724
Confirmation Sample Map

confirmation sampling of this excavation, one base composite sample and one wall composite sample was collected from the excavated area. These samples represented no more than 200 square feet each from the base and walls of the excavation. All samples were immediately put on ice, jarred, and prepared for delivery to Envirotech Analytical Laboratory where they were tested for all constituents listed in Table 1 of 19.15.29.12 NMAC. The results of this confirmation sampling event can be found in the following data table. A corresponding Confirmation Sample Map can be found in Figure 5.

- Composite base sample
- Composite wall sample
- Excavated area - 200 sqft - 1.5' bgs

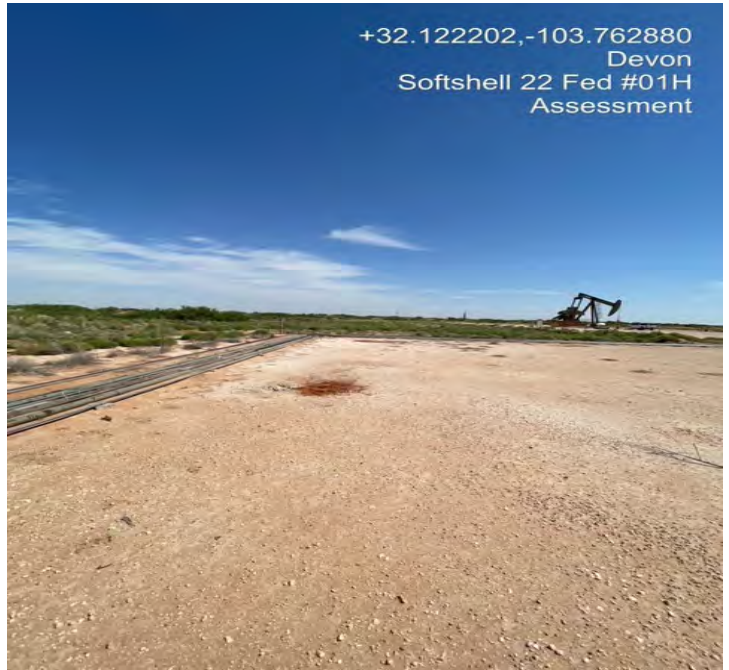
nRM2010649724: On April 3, 2020, a 2" check valve on water line developed a pin hole leak. Spill was not in containment and ran off pad. The released fluids were calculated to be approximately 89.37 barrels (bbls) of produced water. A vacuum truck was able to recover approximately 30 bbls of standing fluid.

Point of Release

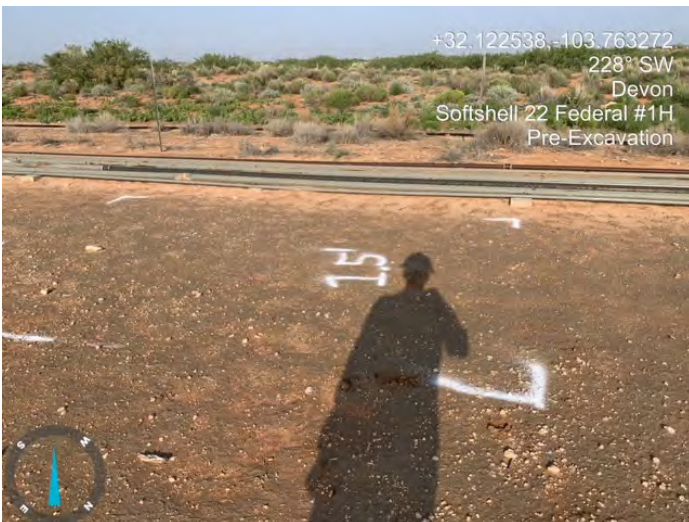
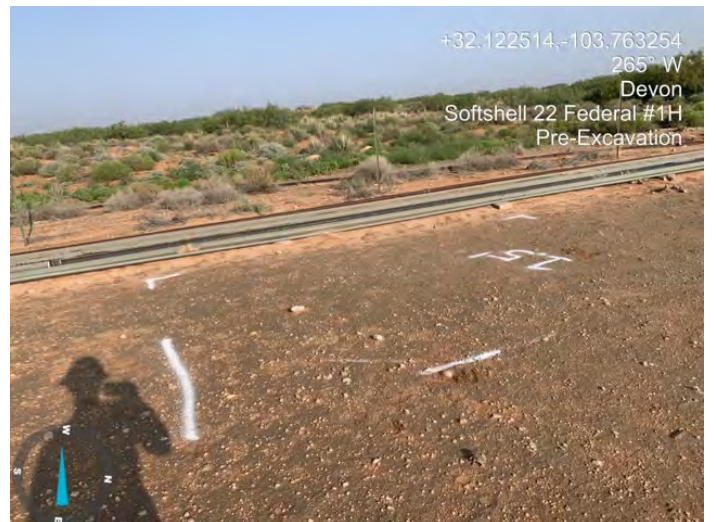
Flagging/Marking S1 area

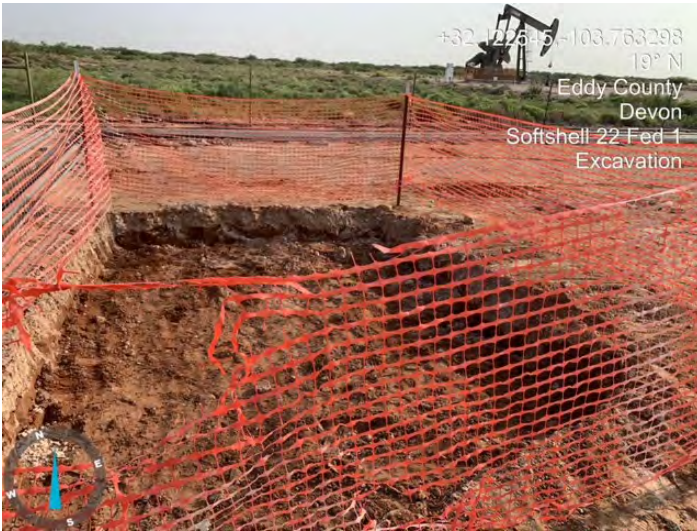
Excavation 1

On July 24, 2024, the Devon construction department and Pima Environmental Services mobilized personnel and equipment to the site to begin remediating the area surrounding sample point S-1. Approximately 11 cubic yards of contaminated soil were removed by mechanical and hand excavation means from an area measuring approximately 200 square foot and from an approximate depth of 1.5' bgs. After Devon submitted a 48-hour notification (OCD Online: Permitting – Application ID 366392) (Appendix C) for the

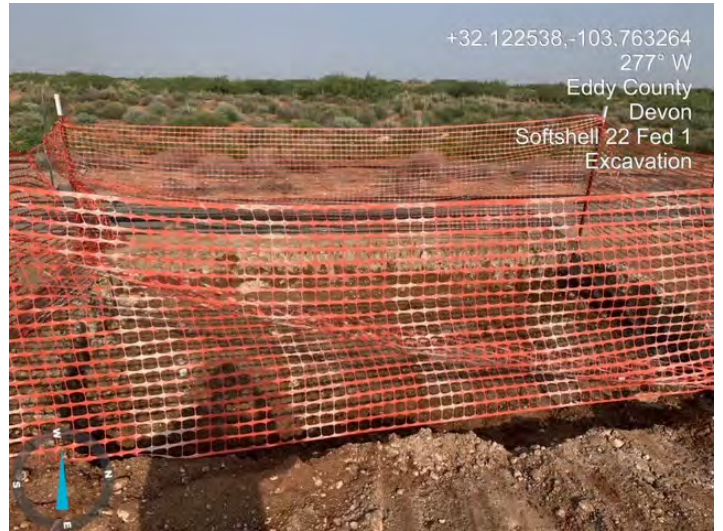
Excavation 2

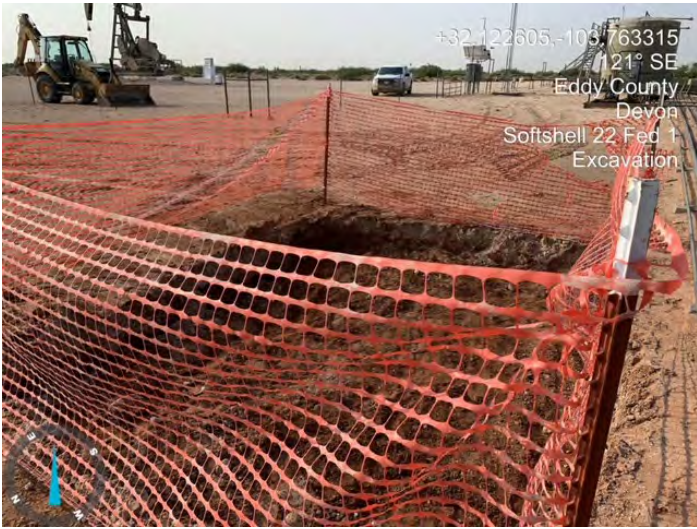
Excavation 3
