Pit, Closed-Loop System, Below-Grade Tank, or Proposed Alternative Method Permit or Closure Plan Application

BELOW-GRADE TANK CLOSURE PLAN

Florance R # 8B – Tank ID: A

API #: 3004531963

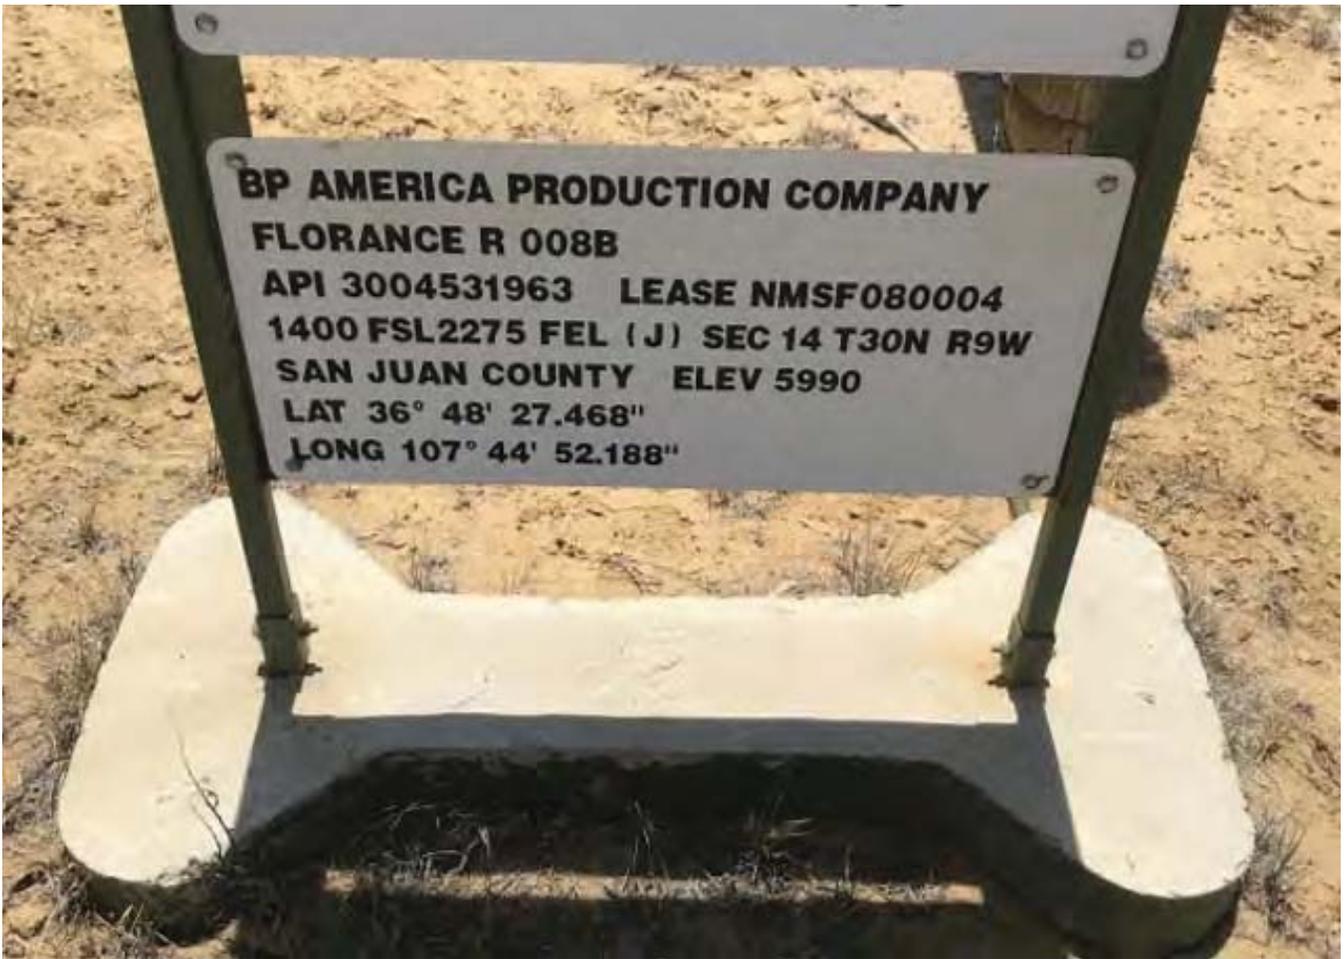
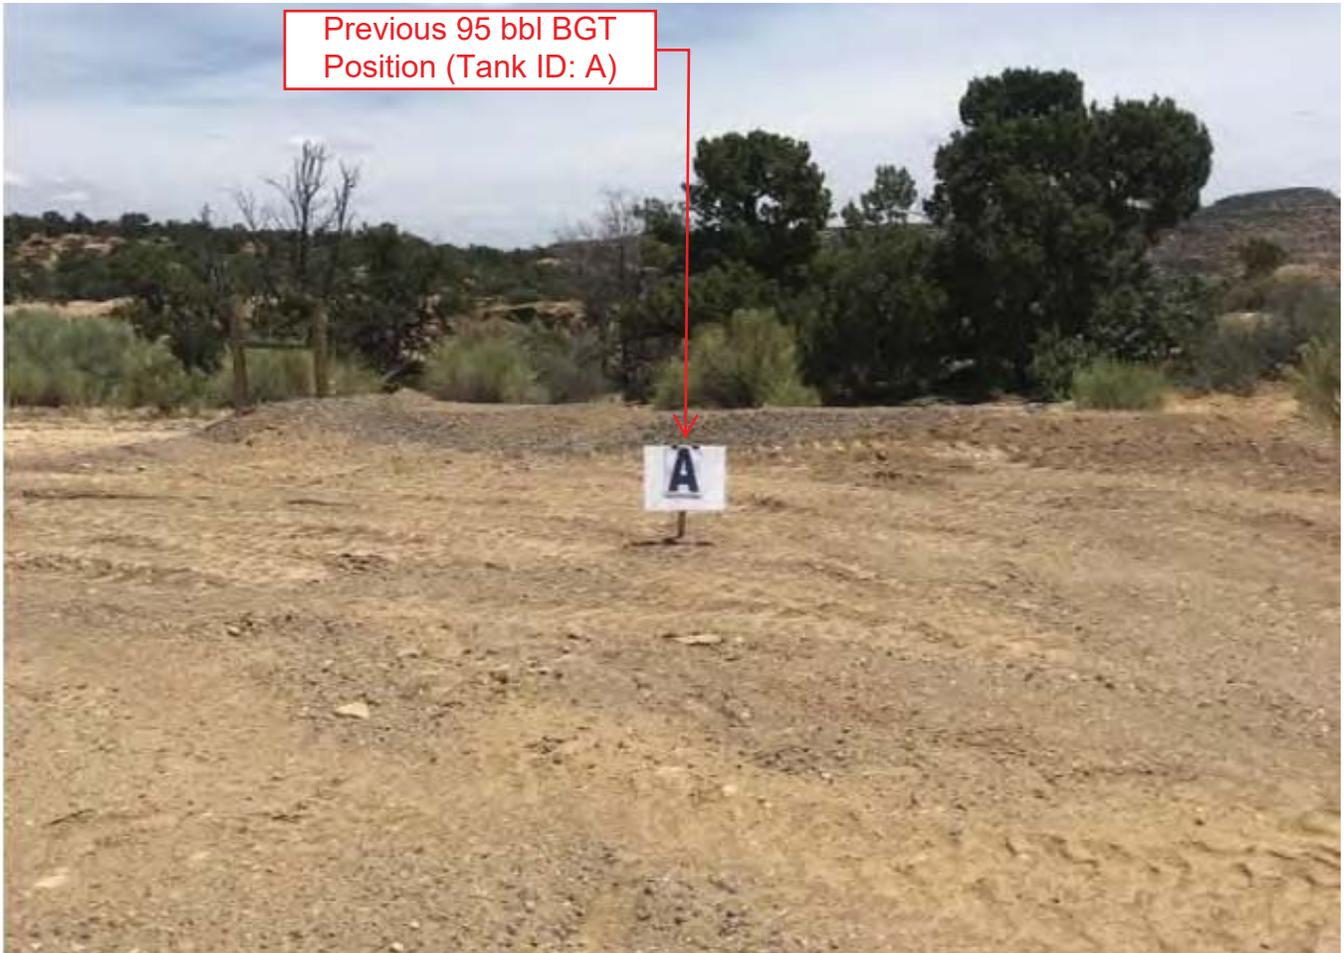
- e. site reclamation, photo documentation.**Closure report on C-144 form is included & contains a photo of the current reclamation requirements completed.**

Sampling results reveal no evidence of a release had occurred. BGT area has been backfilled with clean, earthen material after remedial activity has been completed.

BGT area has been backfilled with clean, earthen material. Reclamation will be completed within the allowable timeframe and will meet the specified requirements of 19.15.17.13 NMAC.
