BELOW-GRADE TANK CLOSURE PLAN

Roelofs B # 3 – Tank ID: B

API #: 3004508208

Unit Letter M, Section 15, T29N, R08W

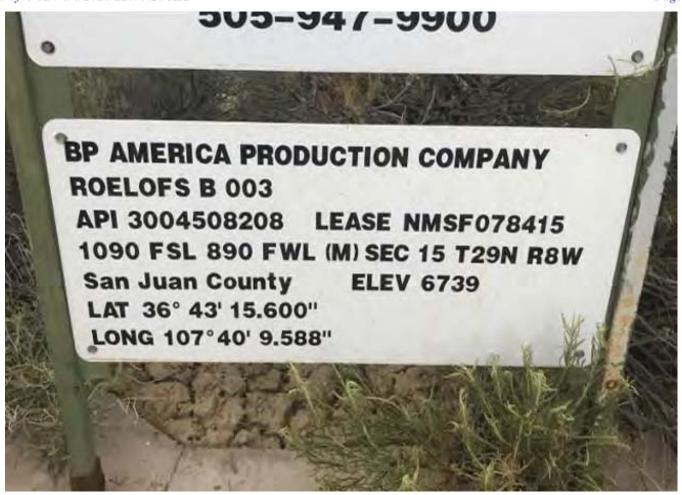
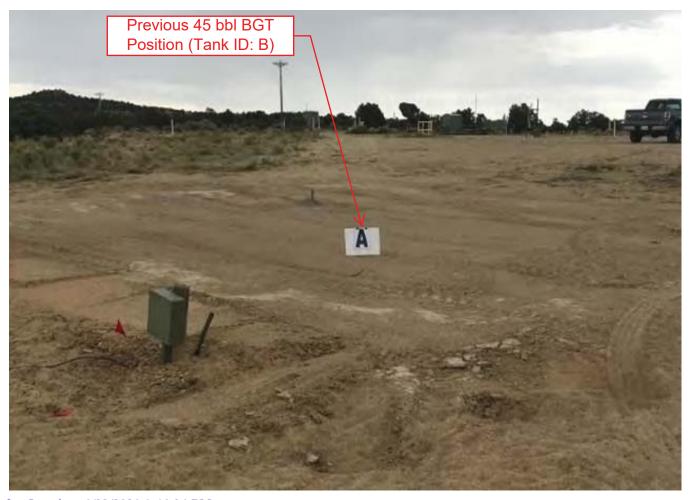
<u>Closure report on C-144 form is included & contains a photo of the current reclamation</u> requirements completed.

BGT area has been backfilled with clean, earthen material. Reclamation will be completed within the allowable timeframe and will meet the specified requirements of 19.15.17.13 NMAC.
