Pit, Closed-Loop System, Below-Grade Tank, or  
Proposed Alternative Method Permit or Closure Plan Application

BELOW-GRADE TANK CLOSURE PLAN

**GCU # 226E – Tank ID: A**

**API #: 3004524948**

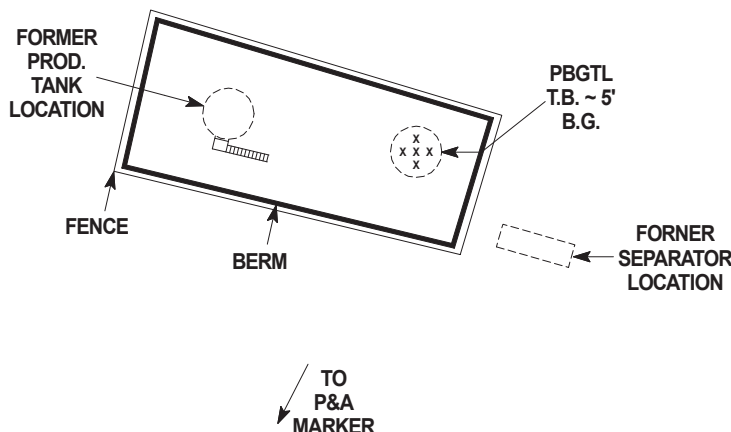
**NA**DEPTH TO GROUNDWATER: **<50'**NEAREST WATER SOURCE: **>1,000'**NEAREST SURFACE WATER: **<300'**NMOC D TPH CLOSURE STD: **100** ppm**SITE SKETCH**BGT Located: off ☒ on sitePLOT PLAN circle: **attached**

**N**OVM CALIB. READ. = **100.0** ppm RF=1.00OVM CALIB. GAS = **100** ppmTIME: **9:20** am/pm DATE: **08/17/20****MISCELL. NOTES**
