Pit, Below-Grade Tank, or  
Proposed Alternative Method Permit or Closure Plan Application

1.  
Operator: Hilcorp Energy Company OGRID #: 372171  
Address: 382 Road 3100 Aztec, NM 87410  
Facility or well name: Whitley 1  
API Number: 30-045-06531 OCD Permit Number: \_\_\_\_\_  
U/L or Qtr/Qtr E Section 17 Township 27N Range 09W County: San Juan  
Center of Proposed Design: Latitude 36.577845 Longitude -107.817361 NAD83  
Surface Owner: ☒ Federal ☐ State ☐ Private ☐ Tribal Trust or Indian Allotment

**Closure Report (required within 60 days of closure completion):** 19.15.17.13 NMAC

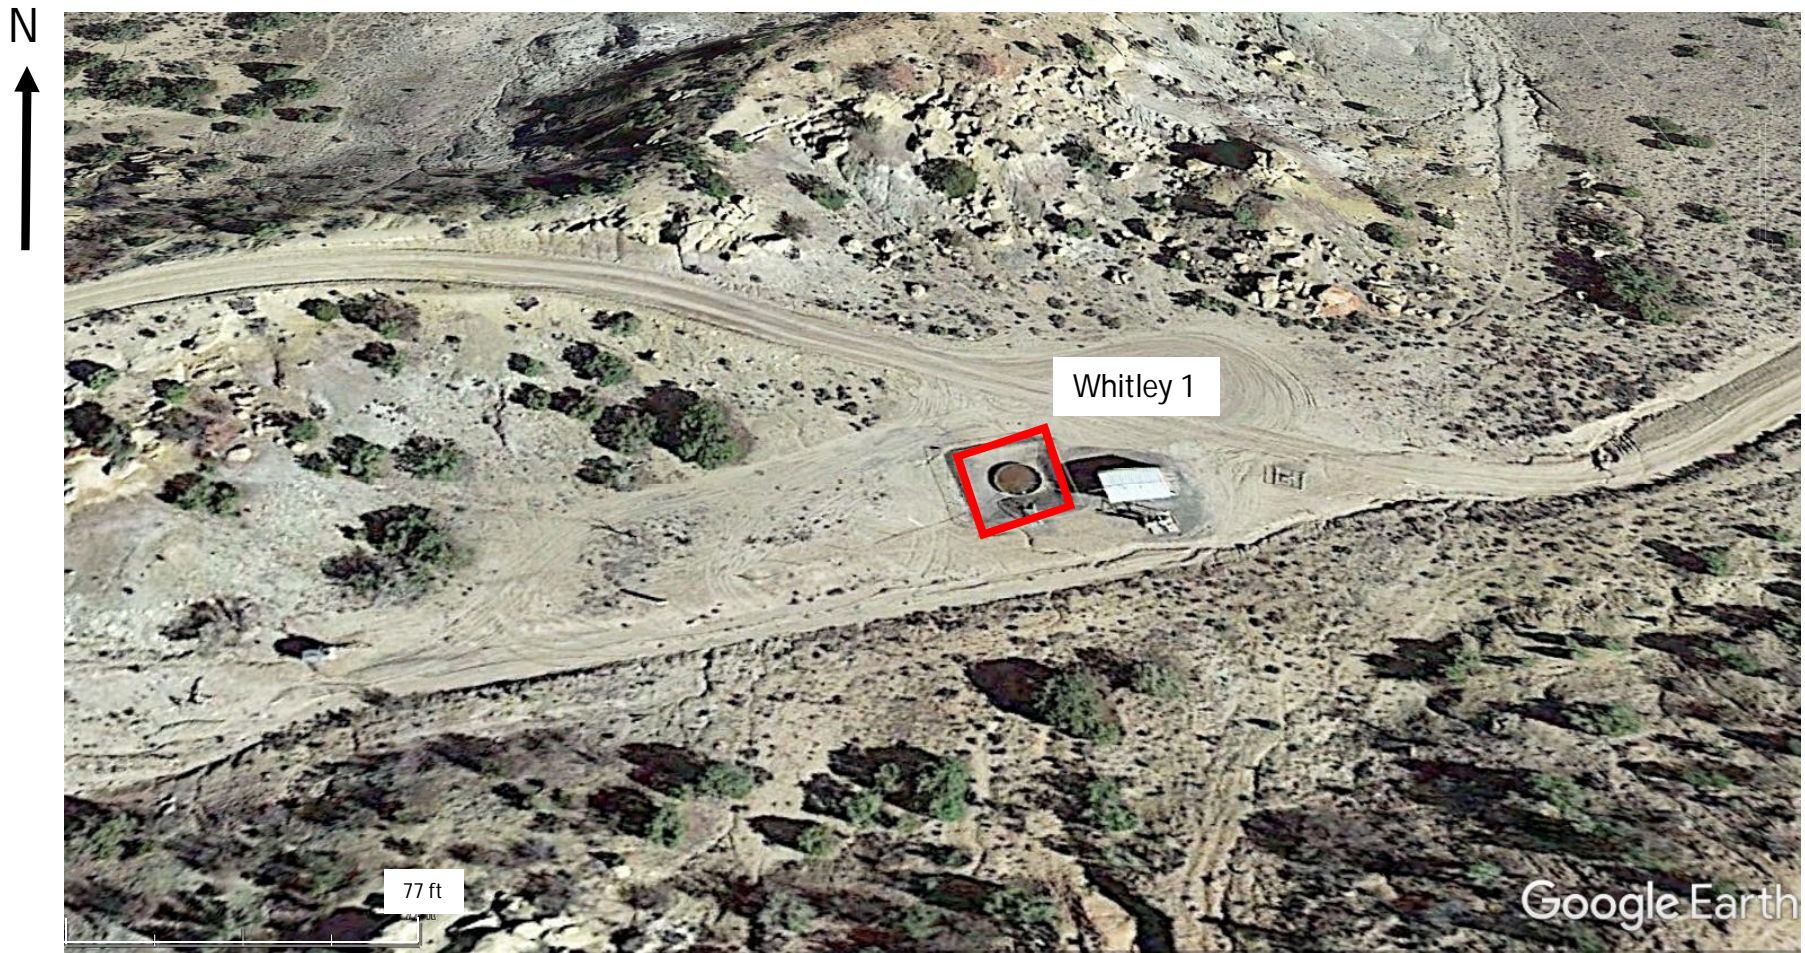
Release Area

On 6/22/2020 Hilcorp Energy removed a below grade tank (BGT) at the Whitley in accordance with NMAC 19.15.17.13 and the closure plan of the BGT permit for this facility. A five-point composite was taken and submitted to the laboratory for analysis.

Sample results yielded Total Petroleum Hydrocarbon (TPH) level higher than the level included in the closure plan of the BGT permit. The site was then ranked in accordance with NMAC 19.15.29.12 falling in the > 100ft closure criteria for impacted soil. The sample taken on 6/22/2020 is in compliance with clean up action levels and no further action is required.

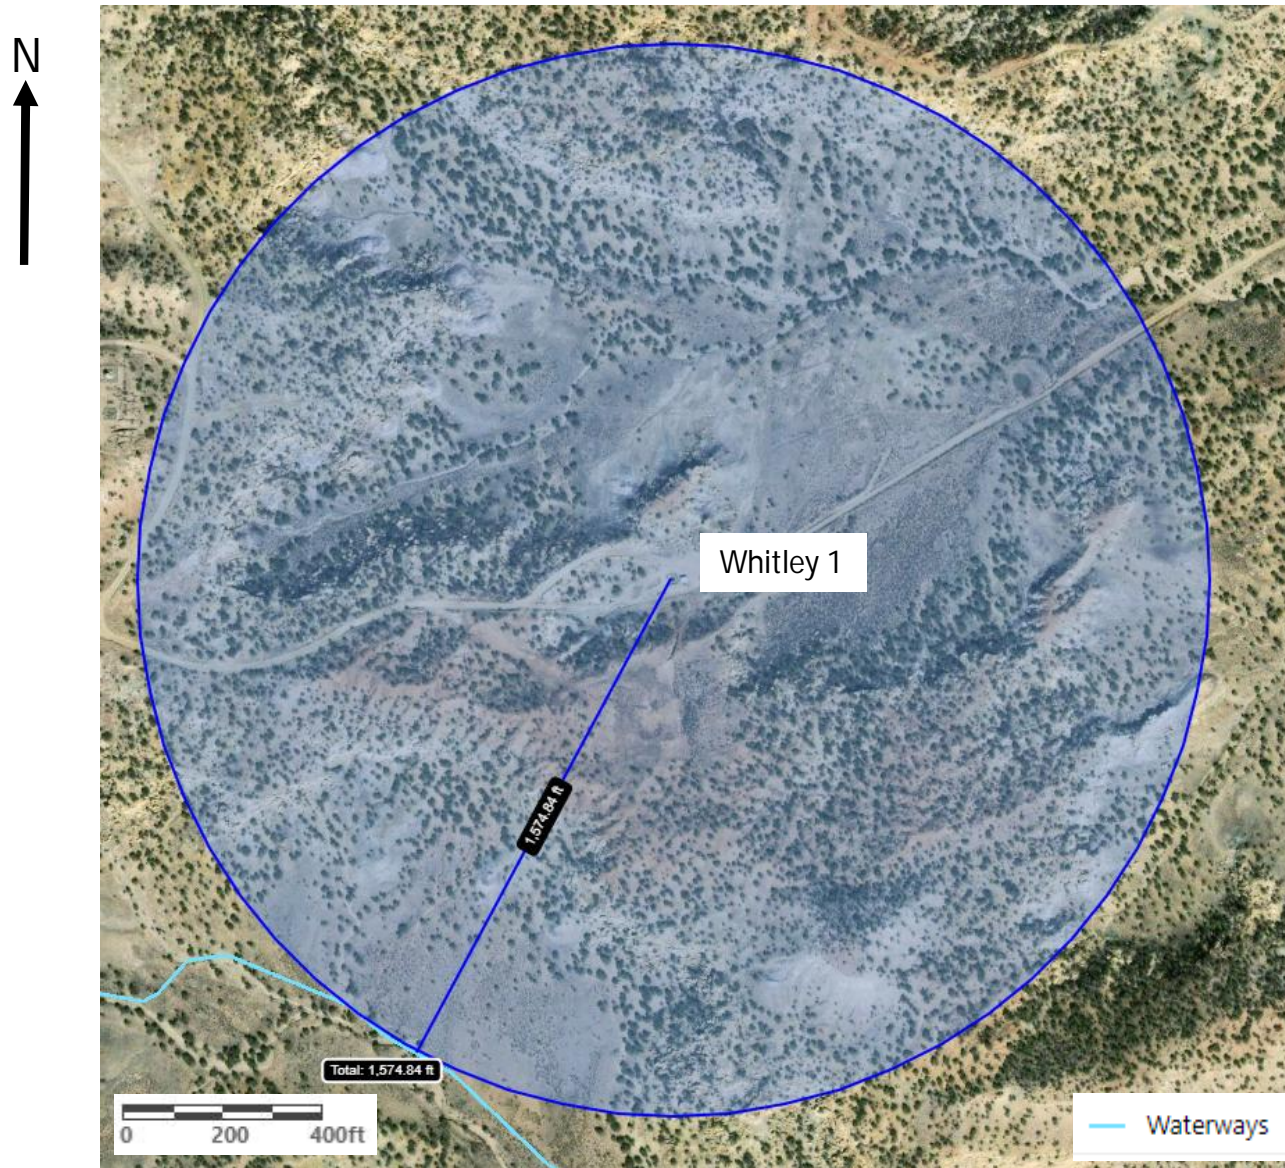
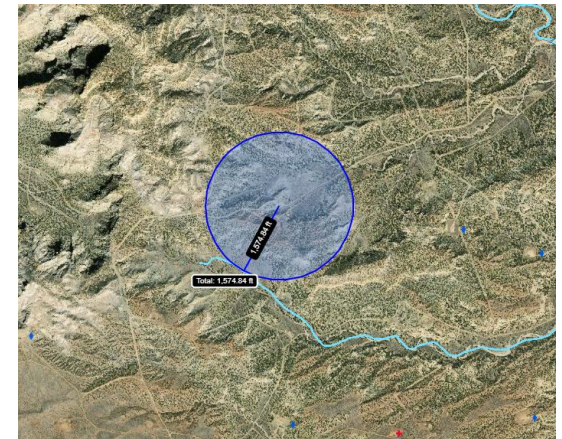
## Distance to watercourse

Distance to watercourse approximately 1,575 ft

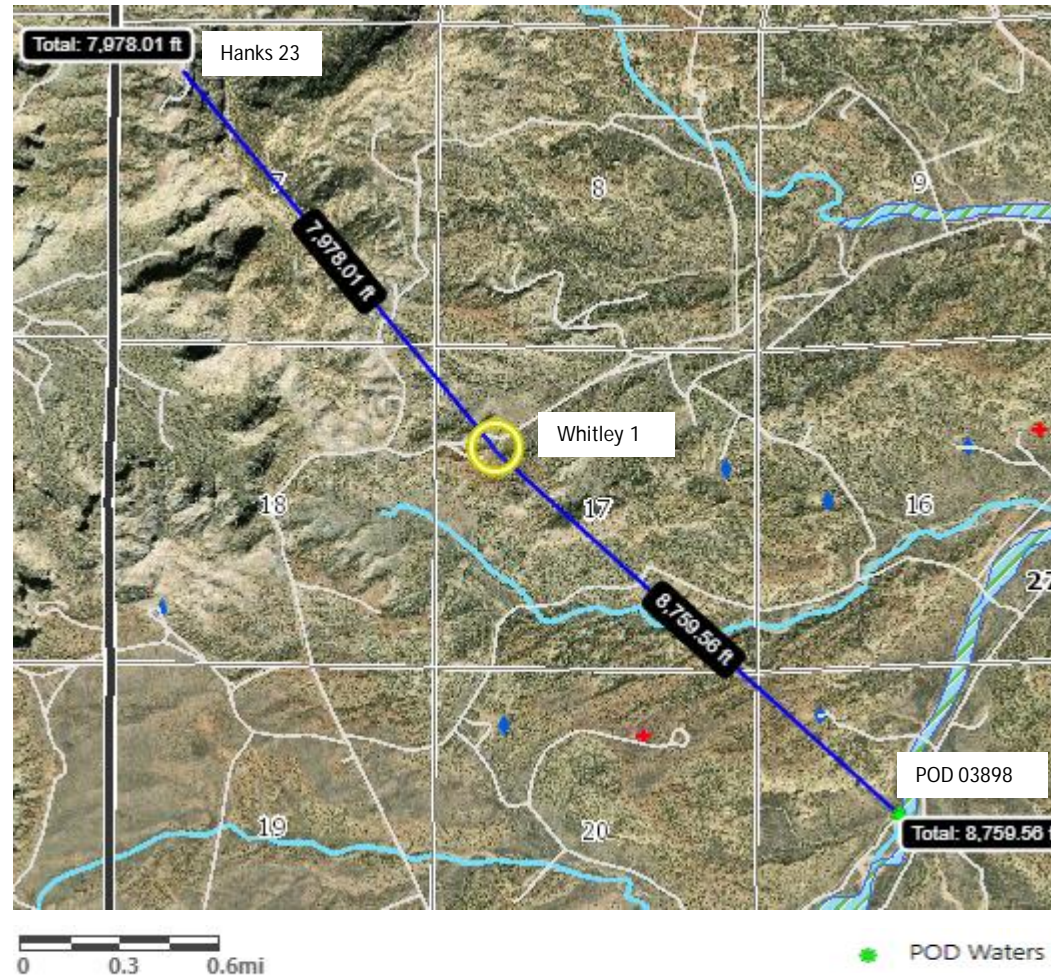
# Depth to groundwater

The nearest water well is POD SJ 03898 POD1 which has a depth to water of 80 ft at an elevation of 6204 ft. The Whitley 1 elevation is 6381 ft estimating groundwater at that facility would be approximately 257 ft. Based on this information and nearby cathodic information groundwater is >100ft.

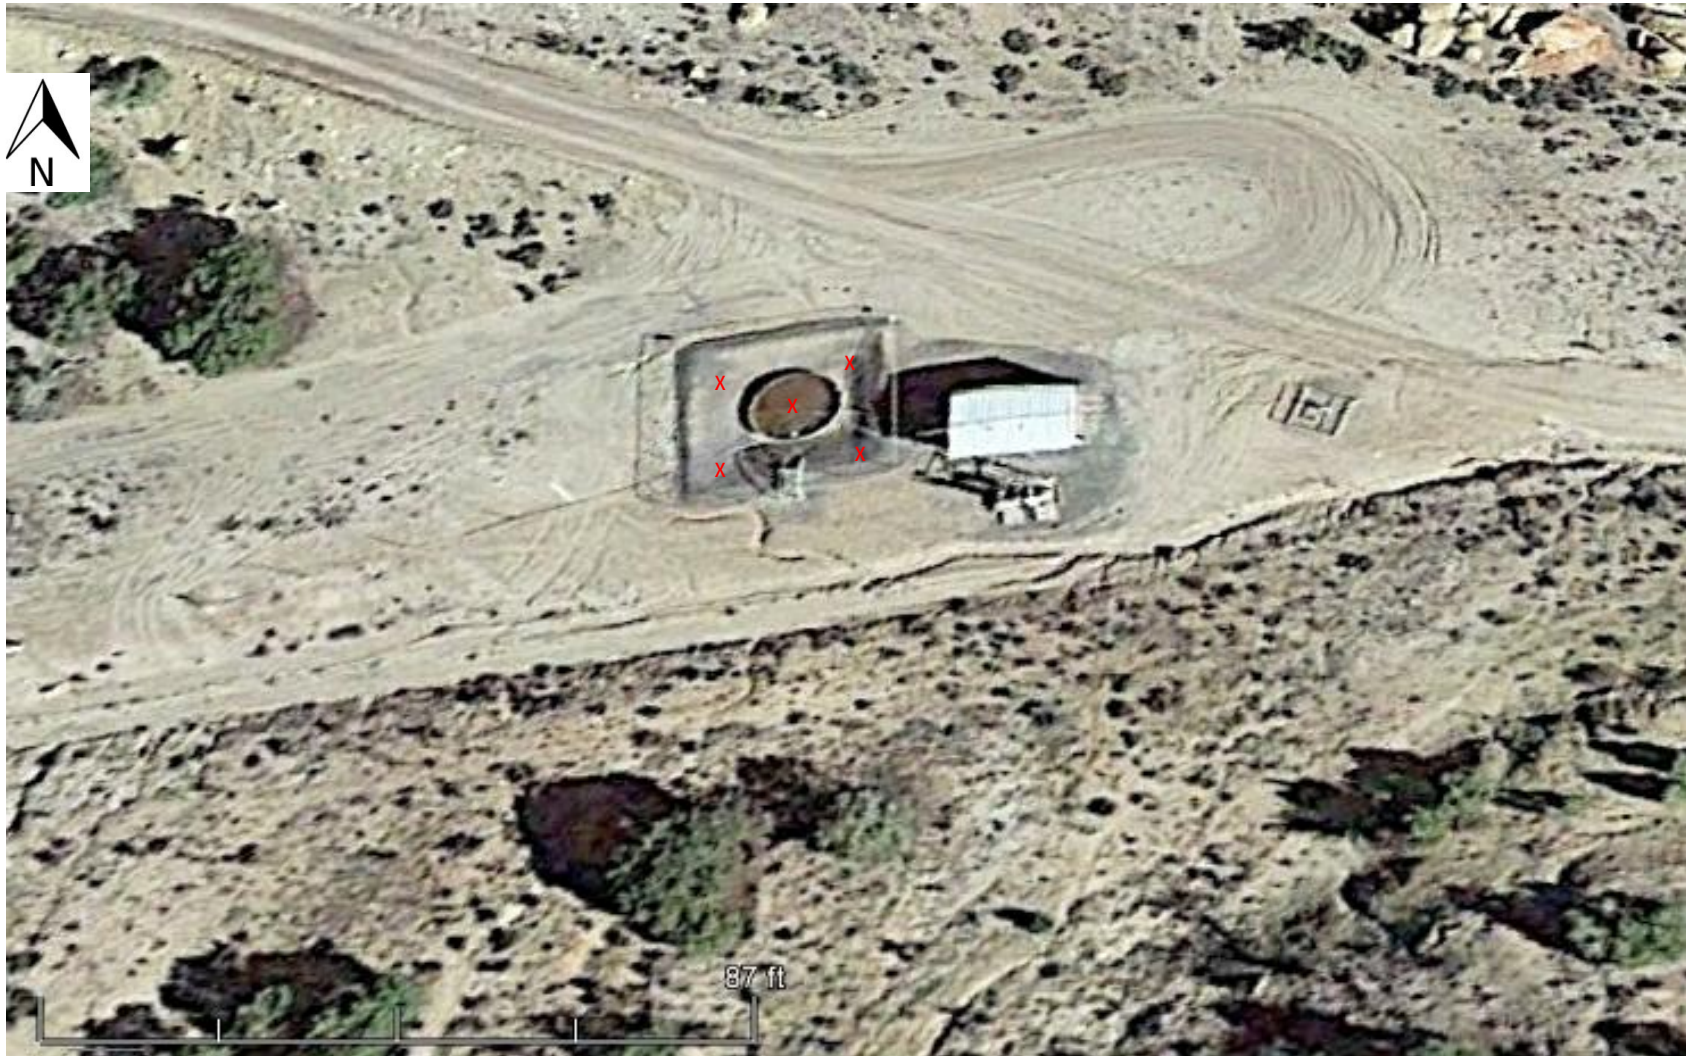
## Sample locations/field notes

X Sample Locations

A five point composite sample was taken on 06/22/2020 in accordance with BGT closure

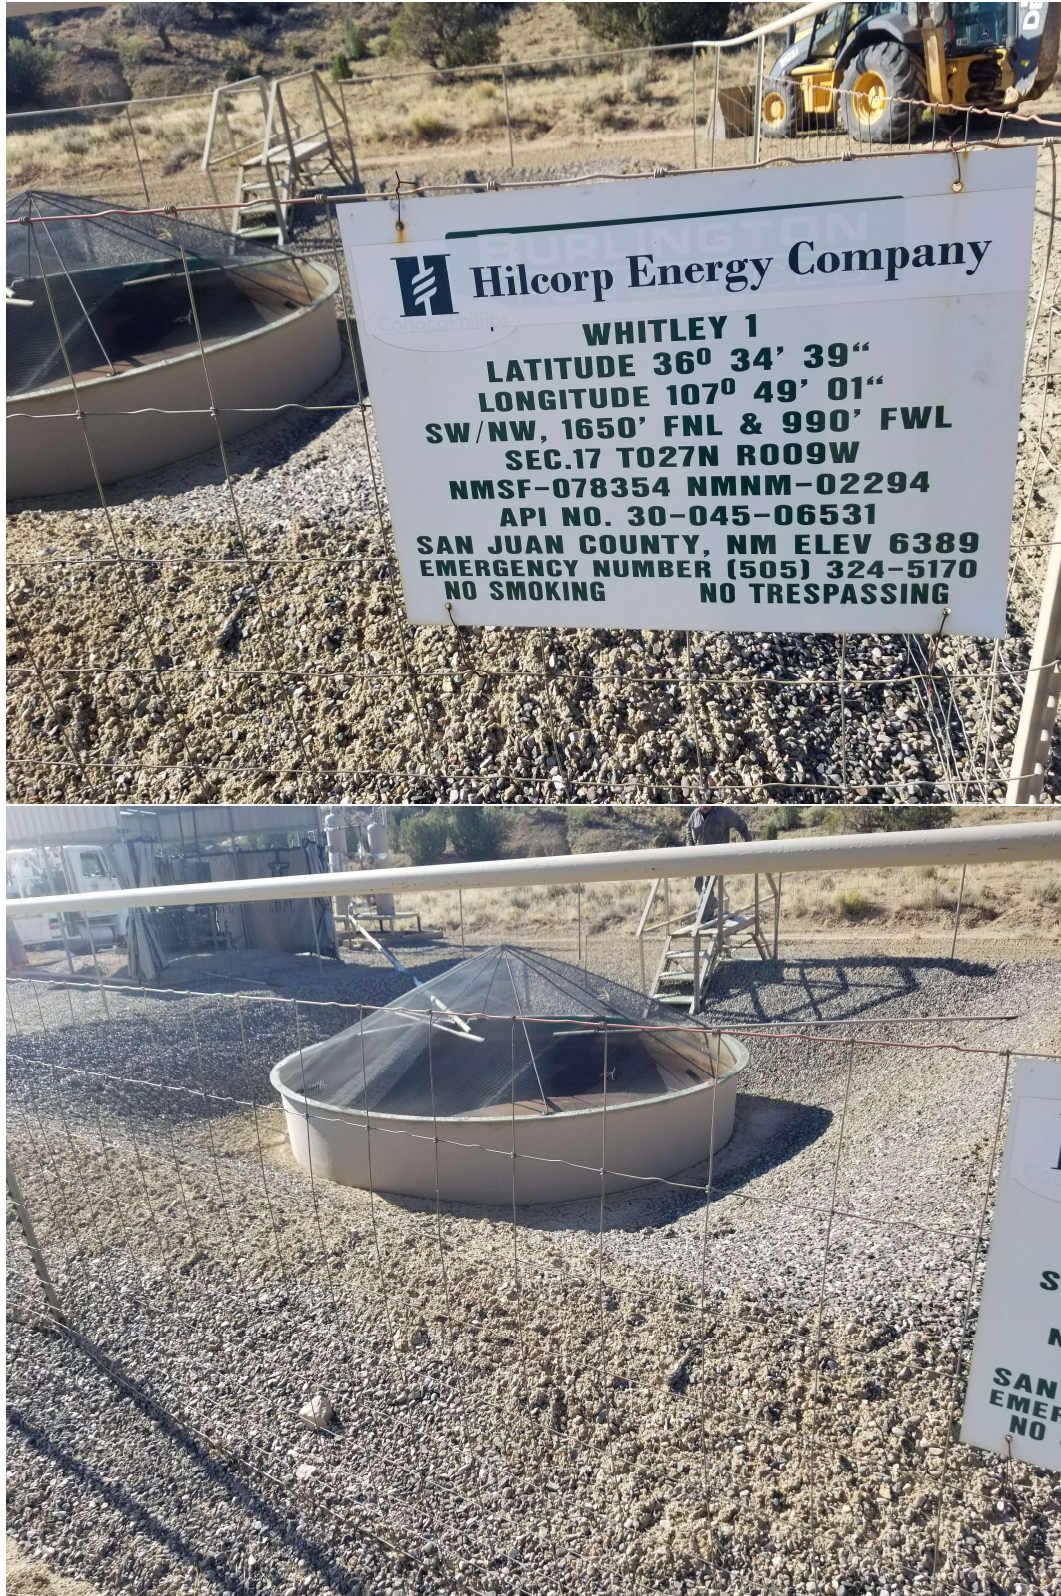
The above well's fiberglass below grade tank was registered as a metal tank in 2008 by the previous Operator. NMOCD requested closure of the BGT permit. The tank was reset above grade.

AFTER - TANK WAS RESET ABOVE GRADE
