Pit, Below-Grade Tank, or
Proposed Alternative Method Permit or Closure Plan Application

1.
Operator: Harvest Midstream OGRID #: 373888
Address: 1111 Travis Street, Houston, TX 77002
Facility or well name: Schalk 29-4 #17
API Number: 30-039-21743 OCD Permit Number: _____
U/L or Qtr/Qtr I Section 25 Township 29N Range 4W County: Rio Arriba
Center of Proposed Design: Latitude 36.69285 Longitude -107.20019 NAD83
Surface Owner: ☒ Federal ☐ State ☐ Private ☐ Tribal Trust or Indian Allotment

Harvest Midstream
Schalk 29-4 #14
BGT Closure

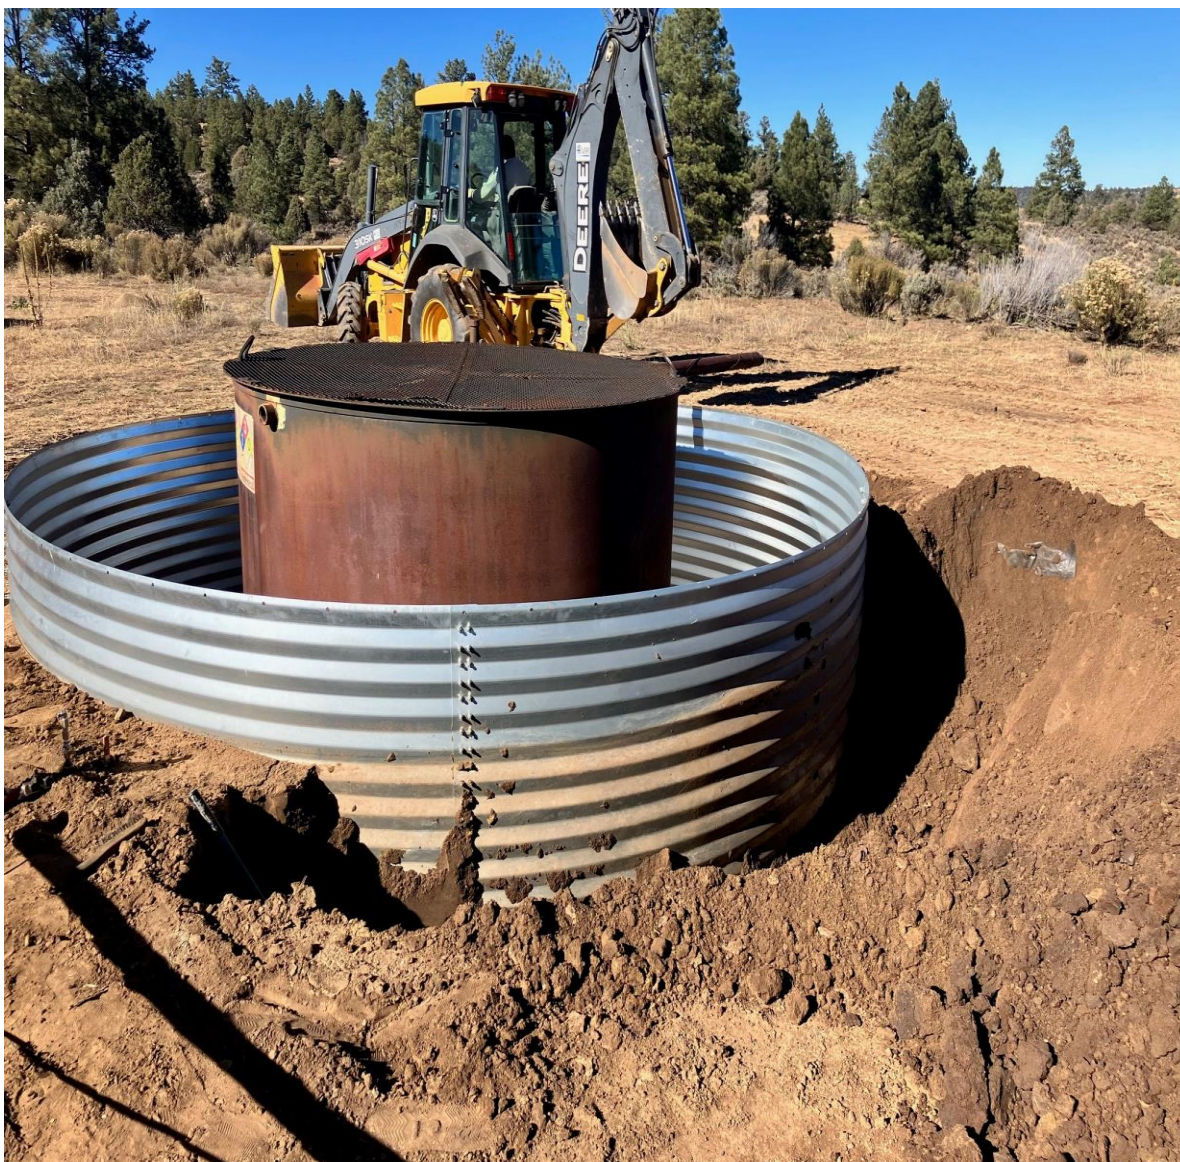
Photo 1: BGT Before Removal

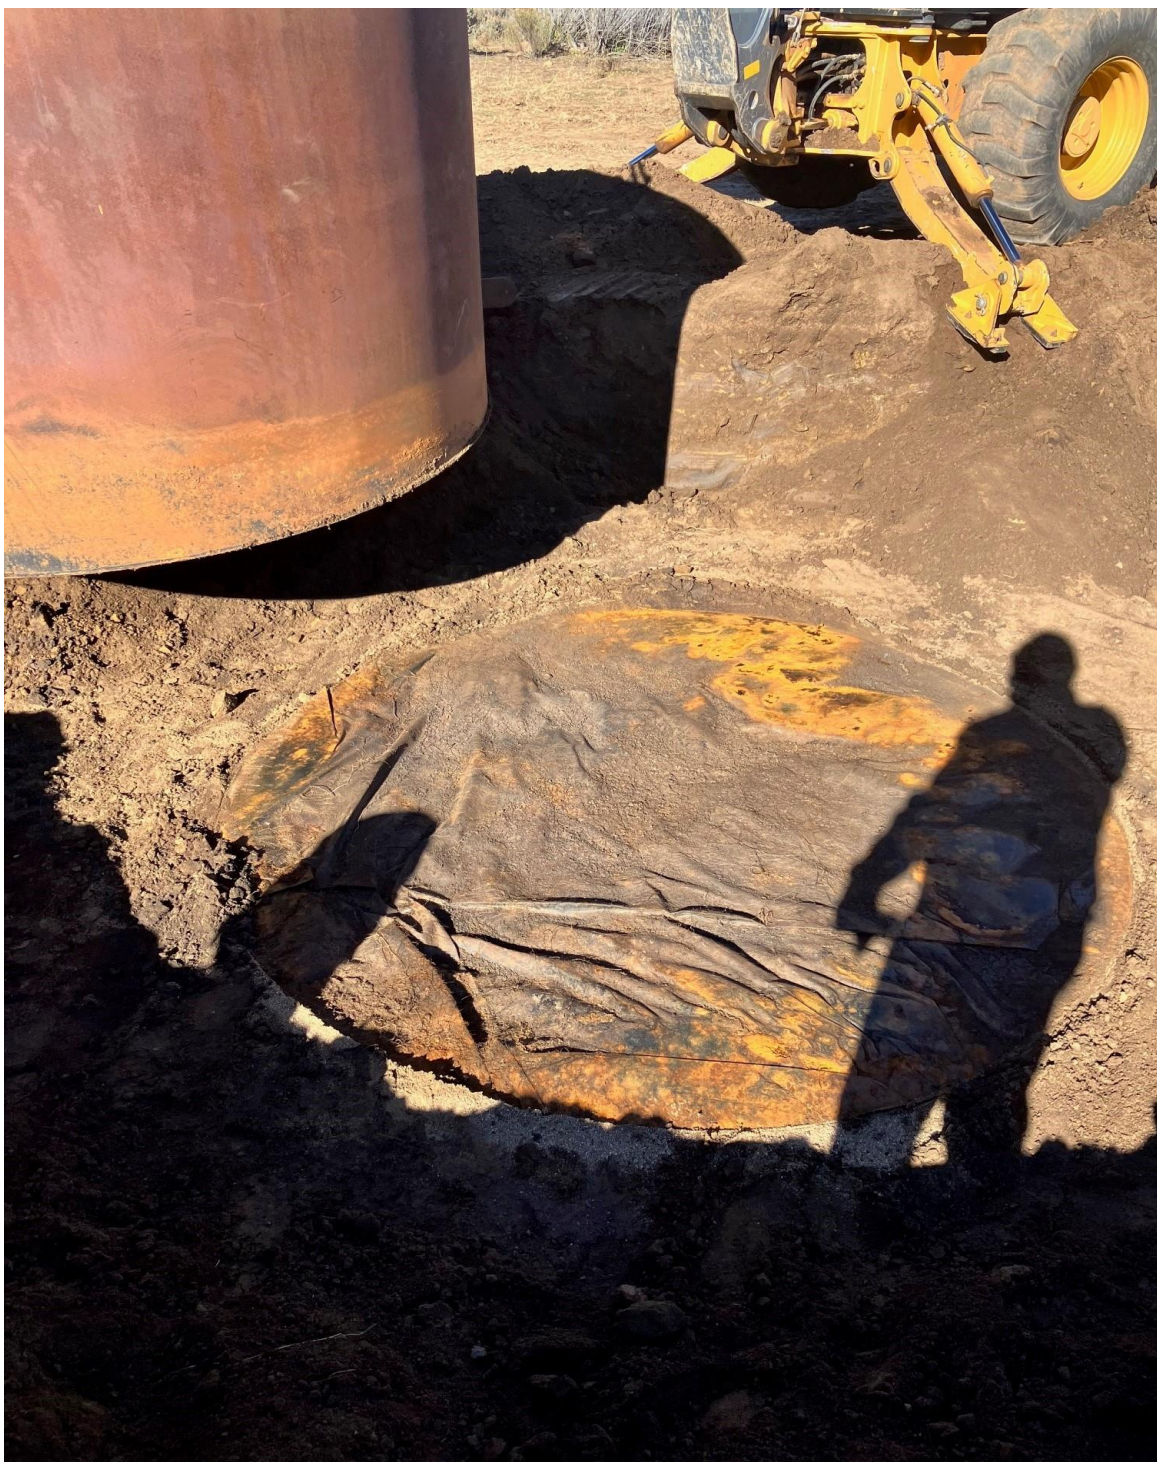
Photo 2: BGT Being Removed with Liner in Bottom of Cellar

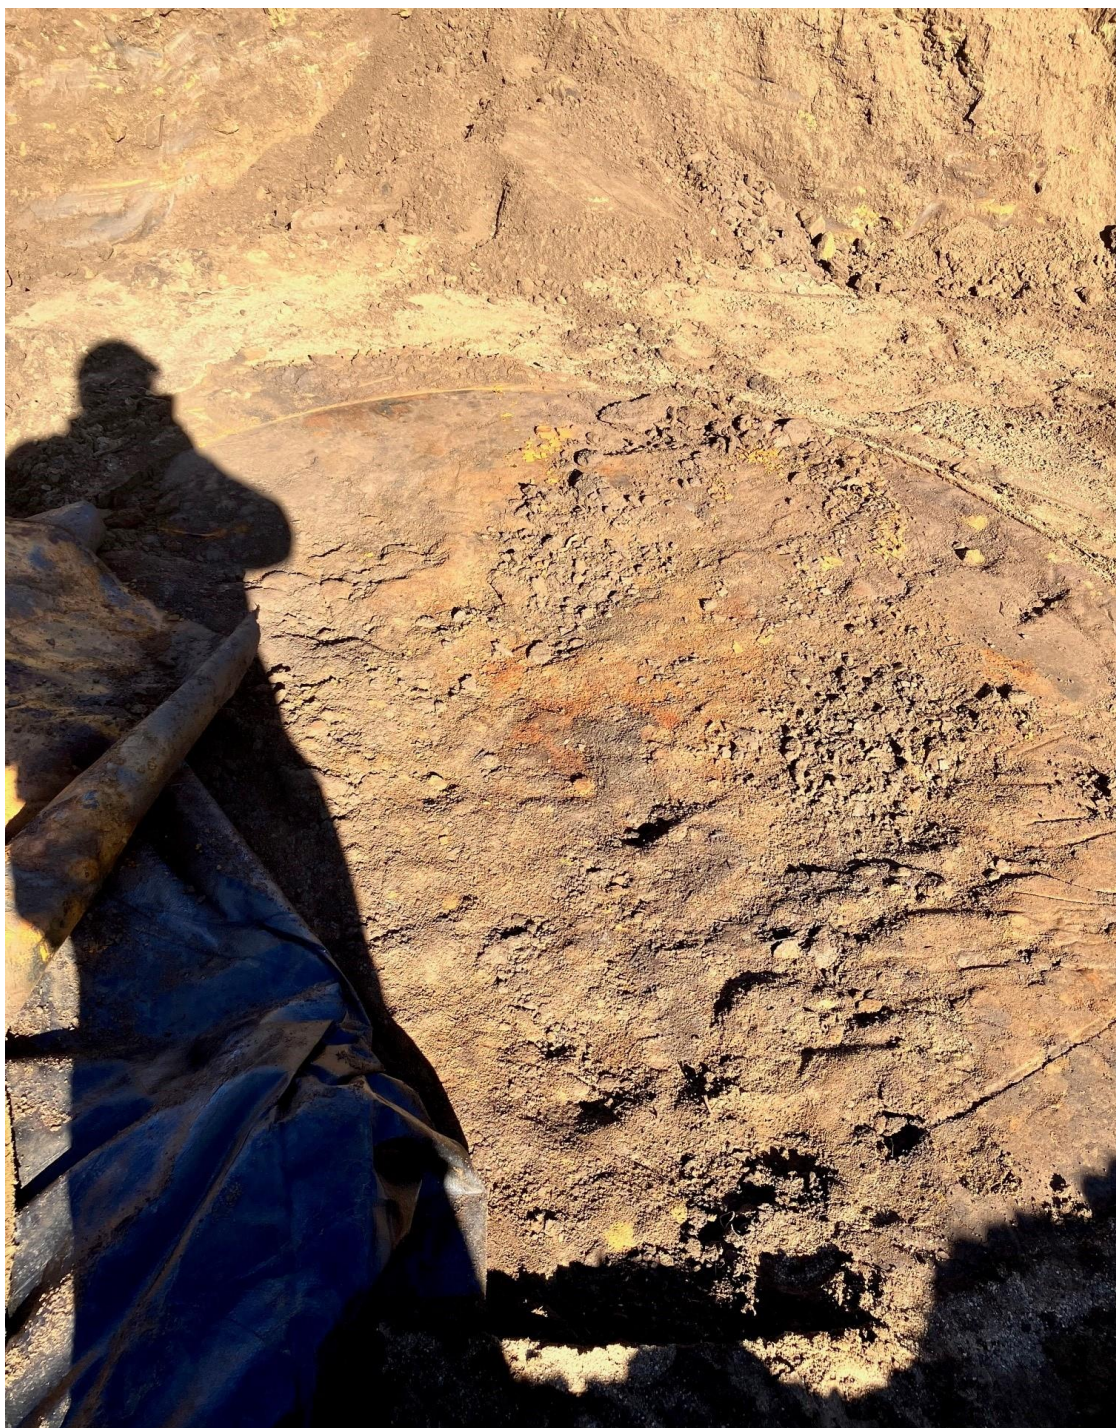
Photo 3: BGT Cellar After Removal with Liner Pulled Back

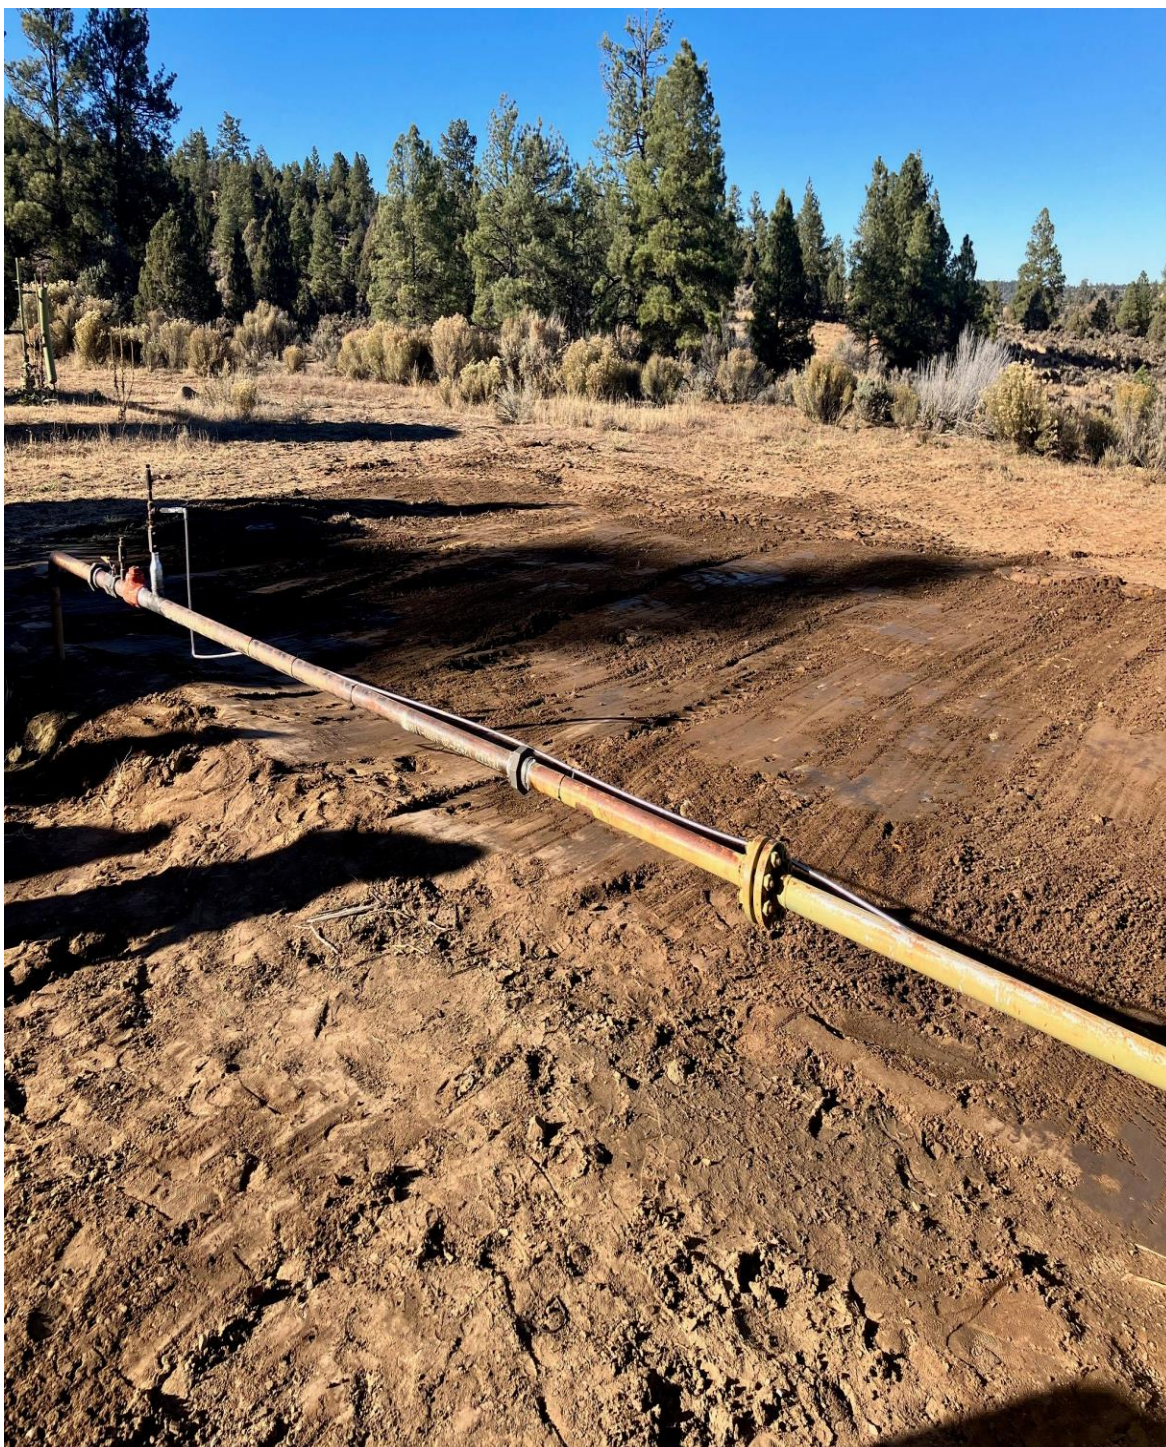
Photo 4: Cellar After Backfill
