**BURNHAM GC 001**  
DK  
API # 30-045-08456  
Unit M - Sec. 012 - T029N - R013W  
870' FSL 1180' FWL  
San Juan, NM

| | Action Type:<br>[UF-WBS] Wellbore Schematic (WELLBORE SCHEMATICS) |

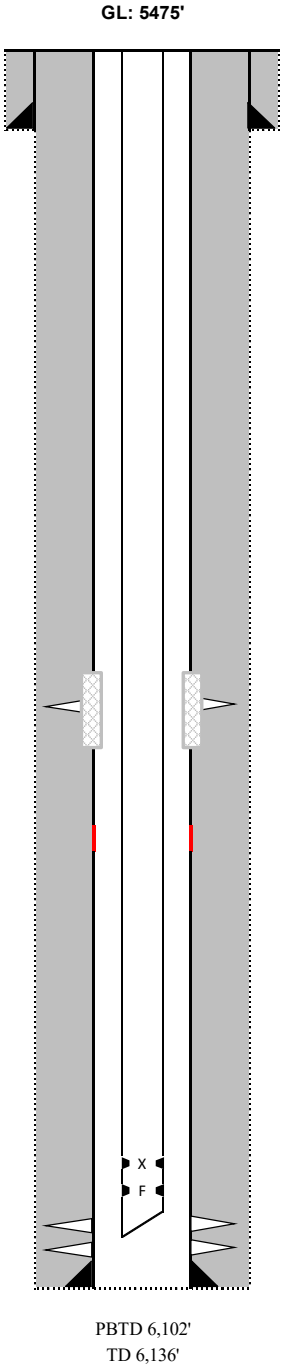
6045-57', 5996-6018' 2 spf  
5982-86' 4 spf  
Frac w/ 50,000 gals wtr & 50,000# snd

5907-23' 4 spf  
Did not frac

8-5/8" 24# @ 402'  
12-1/4" @ 402'  
200 sx cmt circ to surface

Sqz w/ 20 sx & 50 sx cmt  
Perf 2 sqz holes @ 3560'

2nd stage 1000 sx 6% gel cmt; Circ to surface  
DV tool @ 4239'

2' - mule shoe  
.93' - f-nipple  
4' - 2-3/8" tbg sub  
.93' - x-nipple  
192 jts 2-3/8" 4.7# J55 eue

FSV @ 5986'  
2-3/8" tbg @ 6006'

4-1/2" 10.5# @ 6136'  
7-7/8" @ 6136'

1st stage w/ 500 sx 6% gel & 2# tuf plug per sx plus neat cmt

PBTD 6,102'  
TD 6,136'
