**From:** Hansen, Edward J., EMNRD  
**Sent:** Wednesday, April 11, 2012 1:37 PM  
**To:** Hack Conder  
**Cc:** Leking, Geoffrey R, EMNRD; 'Katie Jones'; Laura Pena; 'Scott Curtis'  
**Subject:** Remediation Plan (1R425-15) Termination - ROC Vacuum Jct C-36 Site

RE: Termination Request  
Vacuum Jct. C-36 (1R425-15): UL/C, Sec. 36, T17S, R34E  
RICE Operating Company – Vacuum SWD System

RICE OPERATING COMPANY  
JUNCTION BOX FINAL REPORT

# Vacuum jct. C-36

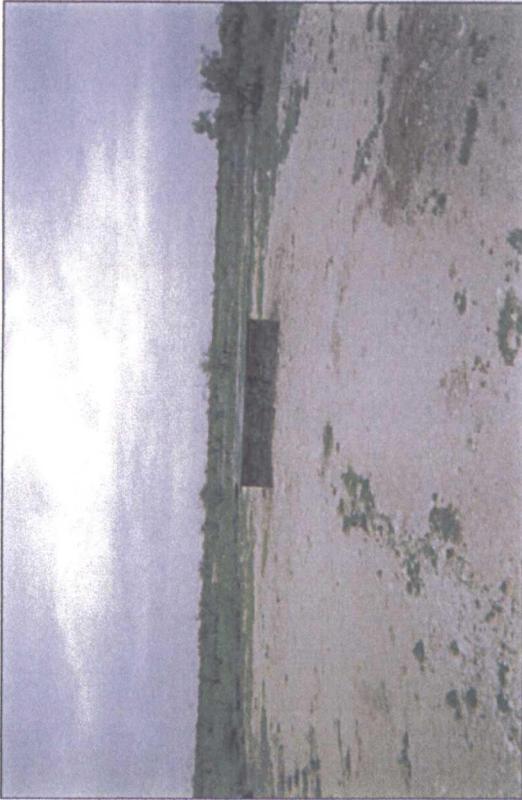
6/13/2005

undisturbed junction box

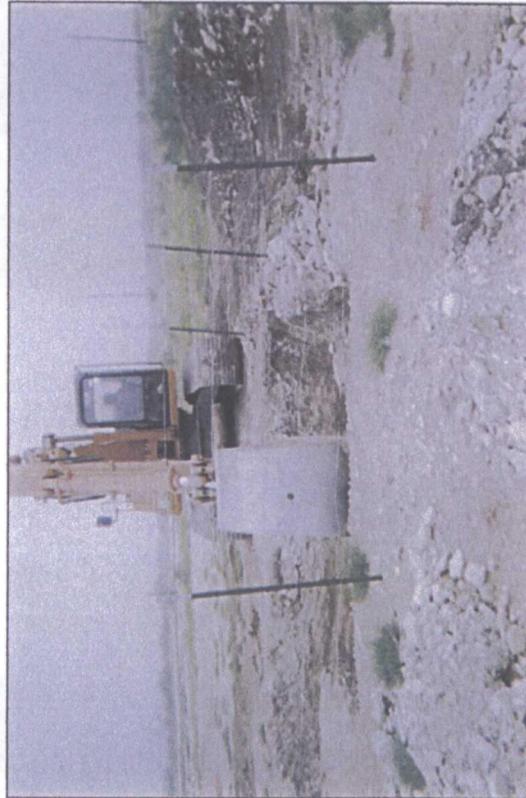
9/16/2005

delineation & excavation

the Vacuum SWD System Abandonment. After removing the box materials, a delineation trench was made at the junction while soil samples were collected at regular intervals to 9 ft BGS. Chloride field tests performed on the samples yielded low concentrations. PID screenings were also low and were less than 100 ppm from 5 to 9 ft BGS. A grab sample at 9 ft BGS was analyzed at a laboratory for confirmation of field tests. NMOCD TPH guidelines were met. There were no physical indications of adverse impact from this junction box. The excavated soil was blended on site and then backfilled into the trench and contoured to the surrounding terrain. Clean additional fill dirt was imported to level the surface. The disturbed surface was seeded with a blend of native vegetation and is expected to return to productive capacity at a normal rate. Since the SWD System is no longer in service, a new junction box is not required.

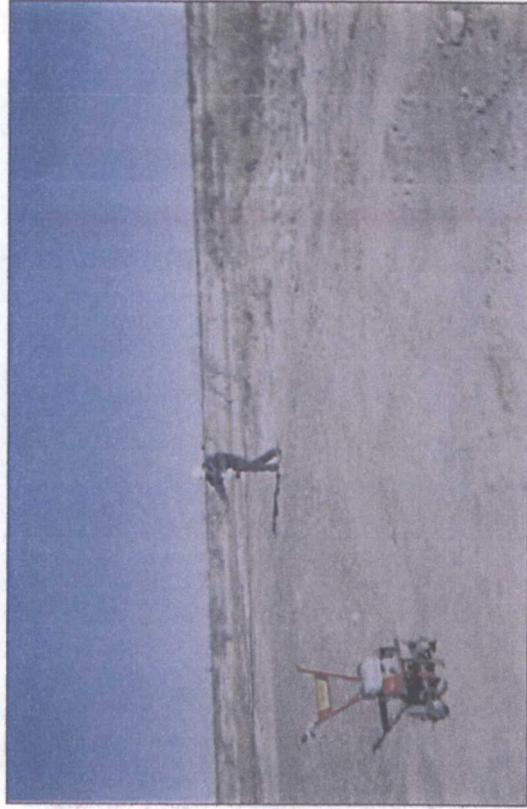
12/19/2005

seeding disturbed surface
