From: Hansen, Edward J., EMNRD
Sent: Tuesday, May 08, 2012 2:39 PM
To: Hack Conder (hconder@riceswd.com)
Cc: Leking, Geoffrey R, EMNRD; Katie Jones <kjones@riceswd.com> (kjones@riceswd.com); Laura Pena (lpena@riceswd.com); Scott Curtis (scurtis@riceswd.com)
Subject: Remediation Plan (1R425-16) Termination - ROC Vacuum F-30 Site

RE: Termination Request
Vacuum F-30 (1R425-16): UL/F, Sec. 30, T17S, R35E
RICE Operating Company – Vacuum SWD System

**RICE OPERATING COMPANY
JUNCTION BOX FINAL REPORT**

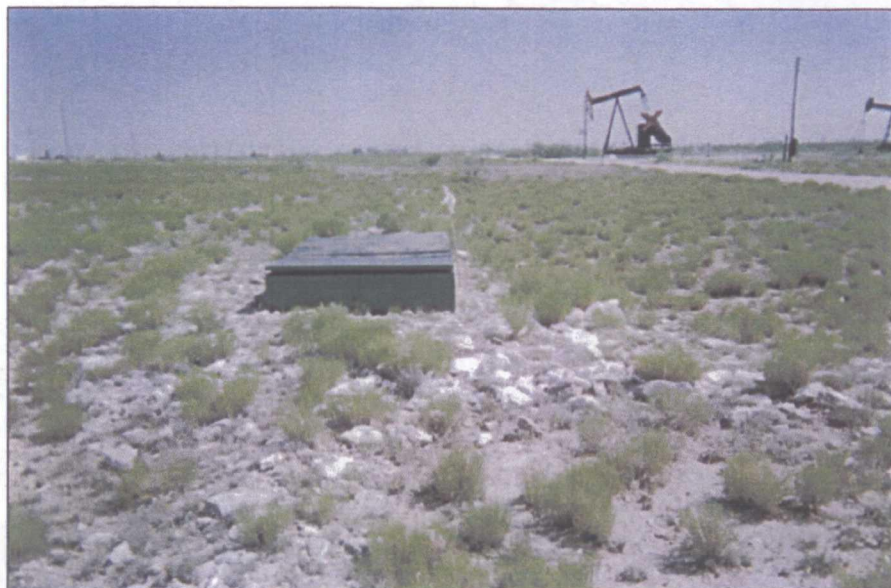
undisturbed junction box

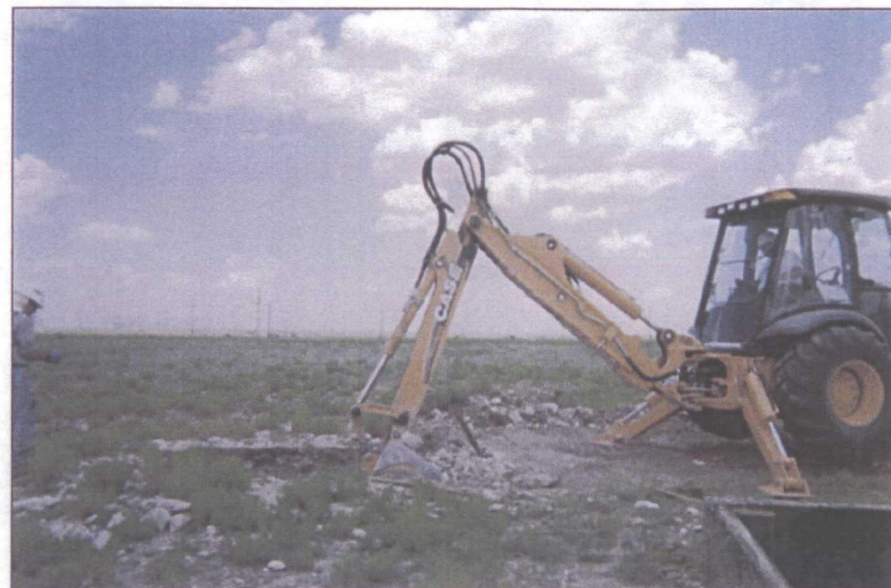
delineation trench at former box site

Vacuum SWD System Abandonment. The box was removed and the location was delineated using a backhoe to excavate an 8-ft-deep trench at the junction site. Chloride field tests and PID

screenings were performed on every vertical foot of soil samples from 2-8 ft. Chloride concentrations were all very low, peaking at 231 ppm on the 6-ft sample. All PID screenings were also low and TPH concentrations from the laboratory were non-detect (10.0 ppm). The soil samples did not exhibit any physical indications of hydrocarbon or salt impact and the location was surrounded by healthy native vegetation. The excavated soils were backfilled into the trench and contoured to the surrounding surface.

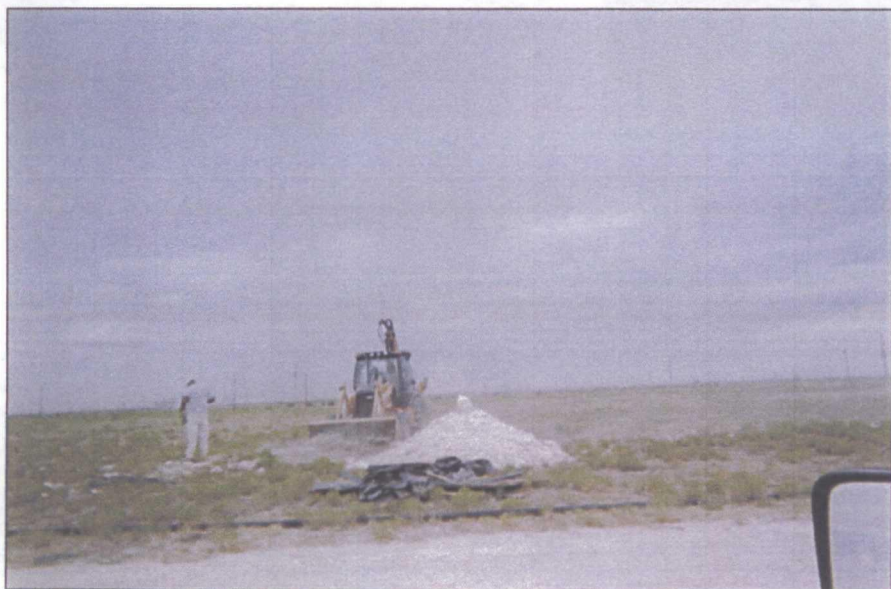
backfilling trench

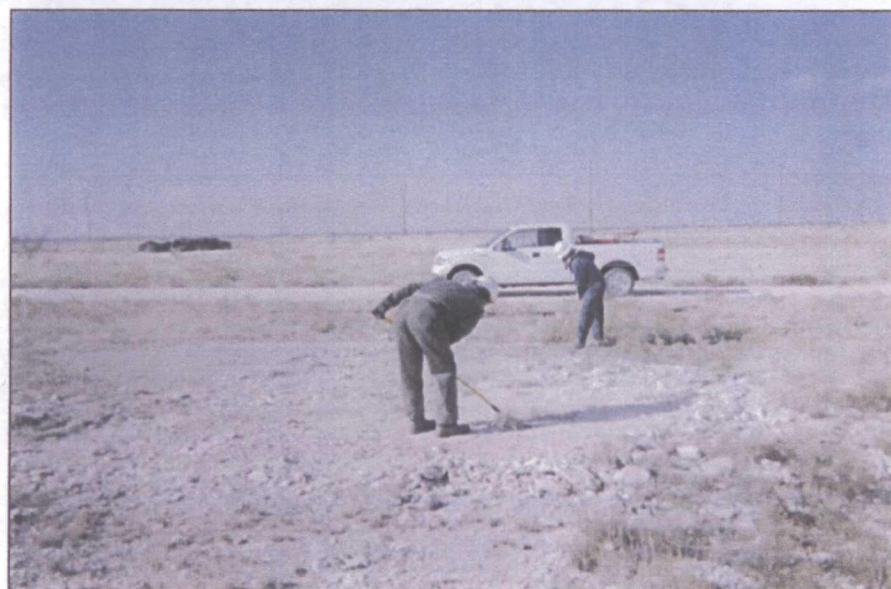
seeding backfilled site
