**RE: Termination Request
for the Rice Operating Company's
Vacuum OXY Permian 'N' EOL Site
Unit Letter B, Section 28, T17S, R35E, NMPM, Lea County, New Mexico
Remediation Plan (1R425-41) Termination**

RE: Termination Request
Vacuum Oxy Permian 'N' EOL (1R425-41): UL/B, Sec. 28, T17S, R35E
RICE Operating Company – Vacuum SWD System

**RICE OPERATING COMPANY
JUNCTION BOX FINAL REPORT**

Vacuum Oxy Permian 'N' EOL

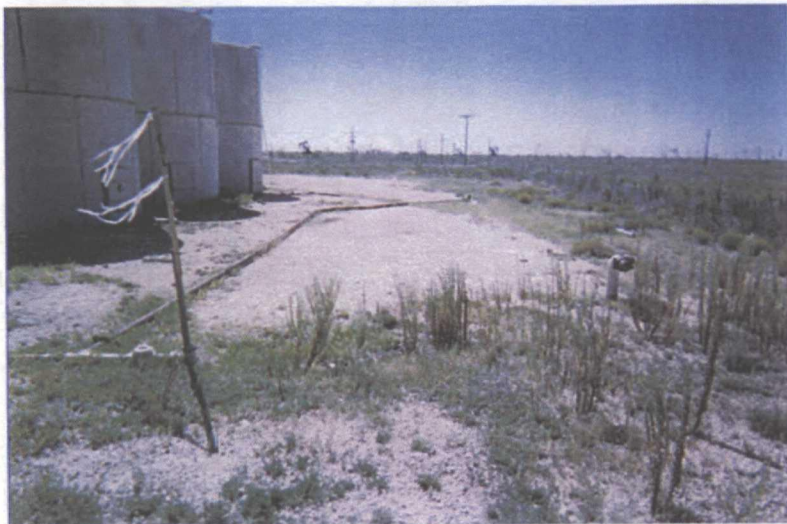
Stake at former box location

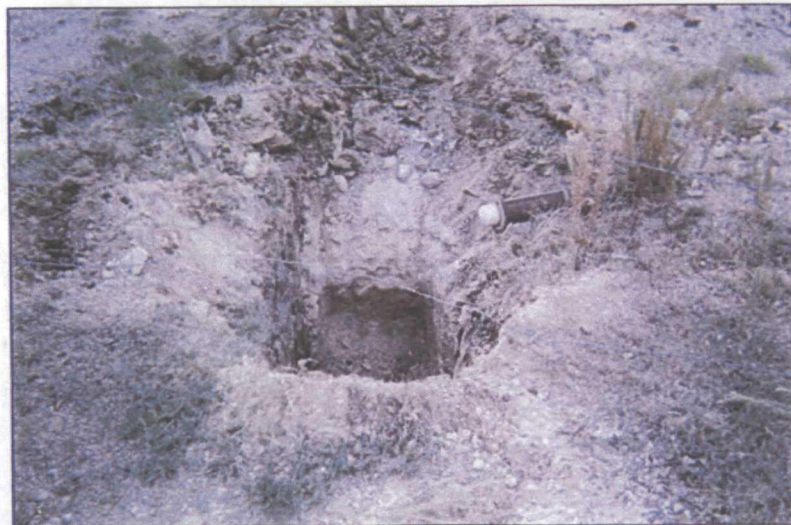
delineation trench 6 ft deep

This junction box located within a production facility site was addressed as part of the Vacuum SWD System abandonment. After the box was removed and the site was cleared of NORM contamination, a delineation trench was made at the former junction site using a backhoe to collect samples to 6 ft BGS. Chloride field tests performed on the samples yielded very low concentrations. Organic vapors were measured using a PID and also yielded very low concentrations in each sample. The deepest (6 ft) sample was sent to a certified laboratory for confirmation. TPH levels were not present within the laboratory's detection limits, meeting NMOCD guidelines. The trench was backfilled and the remaining hole from the box was filled with clean, imported soil and contoured to the surrounding terrain.

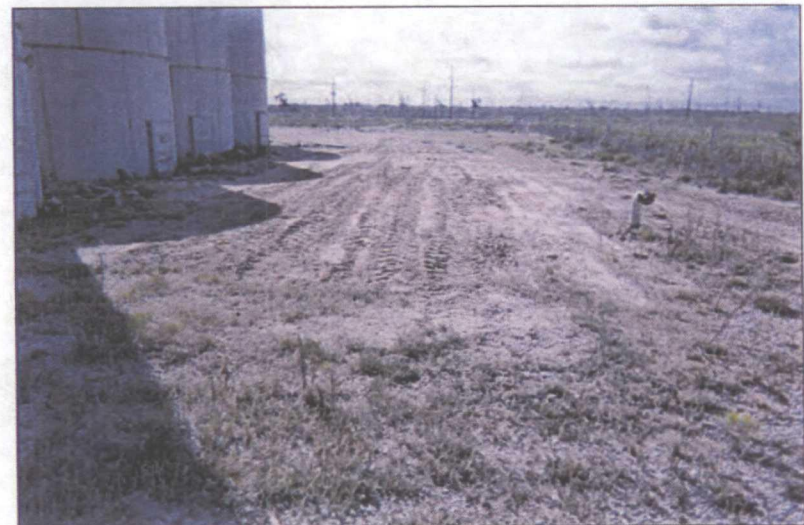
site backfilled with 12 yds³ imported fill
