**RE: Termination Request
for the Rice Operating Company's
Vacuum Exxon 'K' EOL Site
Unit Letter I, Section 32, T17S, R35E, NMPM, Lea County, New Mexico
Remediation Plan (1R425-50) Termination**

RE: Termination Request
Vacuum Exxon 'K' EOL (1R425-50): UL/I, Sec. 32, T17S, R35E
RICE Operating Company – Vacuum SWD System

**RICE OPERATING COMPANY
JUNCTION BOX FINAL REPORT**

Vacuum Exxon 'K' EOL

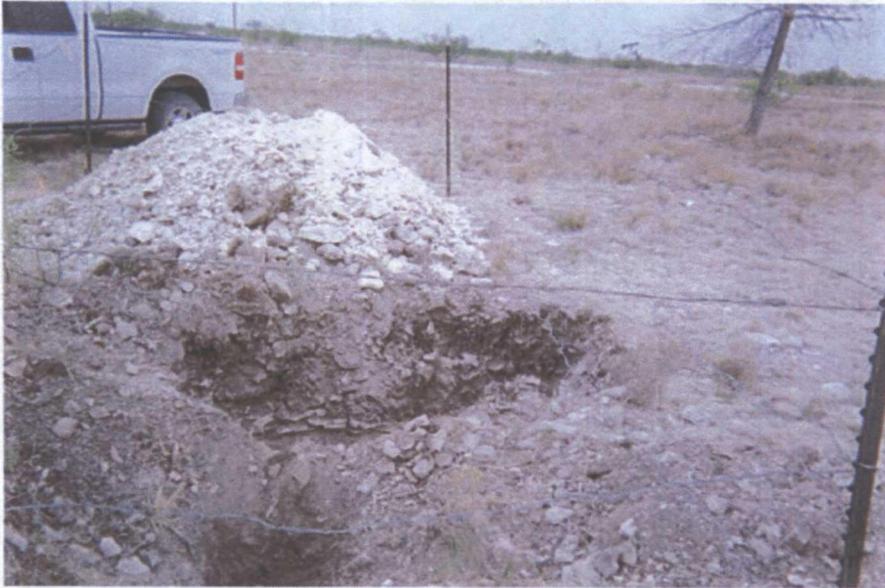
delineation trench at former junction site, facing south 5/5/2008

General Description of Remedial Action: This junction was addressed under the Vacuum SWD System abandonment. After the junction was removed, an investigation was conducted using a backhoe to collect soil samples at regular intervals producing a 5x3x6-ft-deep hole. Chloride field tests were performed on each sample, which yielded low concentrations. Organic vapors were measured using a PID, which also yielded low concentrations. The deepest sample, 6 ft BGS, was sent to a commercial laboratory for analysis of chloride and TPH, confirming low concentrations. The excavated soil was returned to the excavation and clean, imported soil was used as a top cap and to contour to the site to the surrounding area. On 5/22/2008, the site was seeded with a blend of native vegetation and is expected to return to a productive capacity at a normal rate.

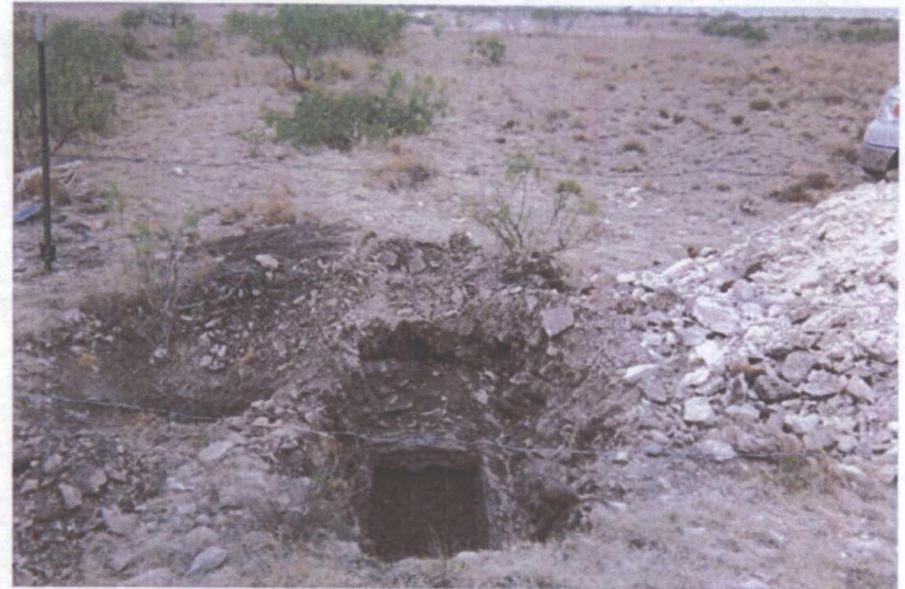
delineation trench at former junction site, facing east 5/5/2008

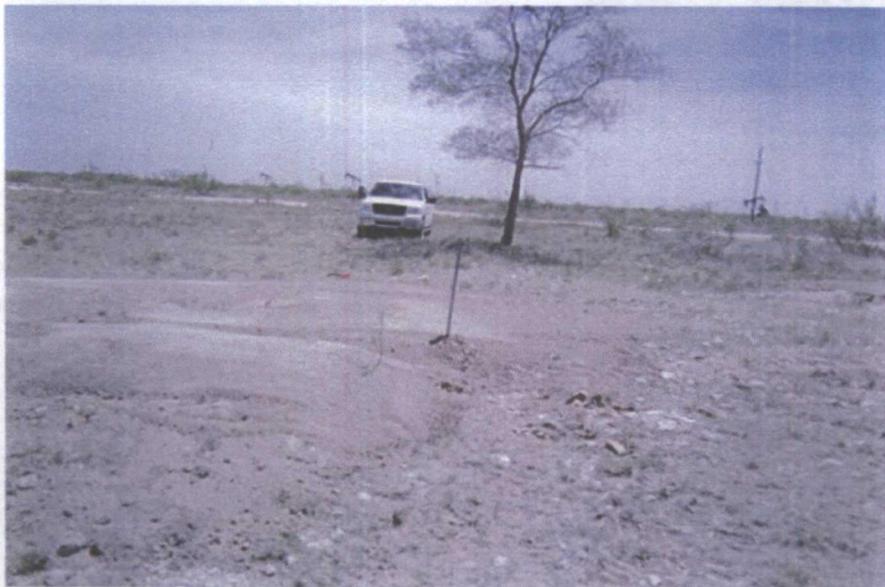
backfilled excavation, facing south 5/21/2008

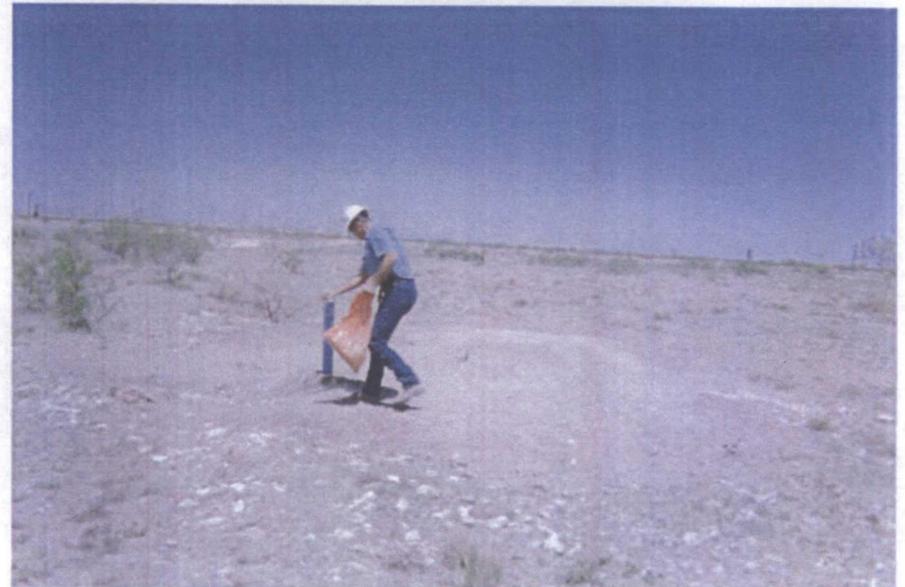
seeding backfilled site, facing east 5/22/2008
