**RE: Termination Request  
for the Rice Operating Company's  
Vacuum Chevron 6-34 EOL Site  
Unit Letter K, Section 34, T17S, R35E, NMPM, Lea County, New Mexico  
Remediation Plan (1R425-59) Termination**

RE: Termination Request  
Vacuum Chevron 6-34 EOL (1R425-59): UL/K, Sec. 34, T17S, R35E  
RICE Operating Company – Vacuum SWD System

**RICE OPERATING COMPANY  
JUNCTION BOX FINAL REPORT**

# Vacuum Chevron 6-34 EOL

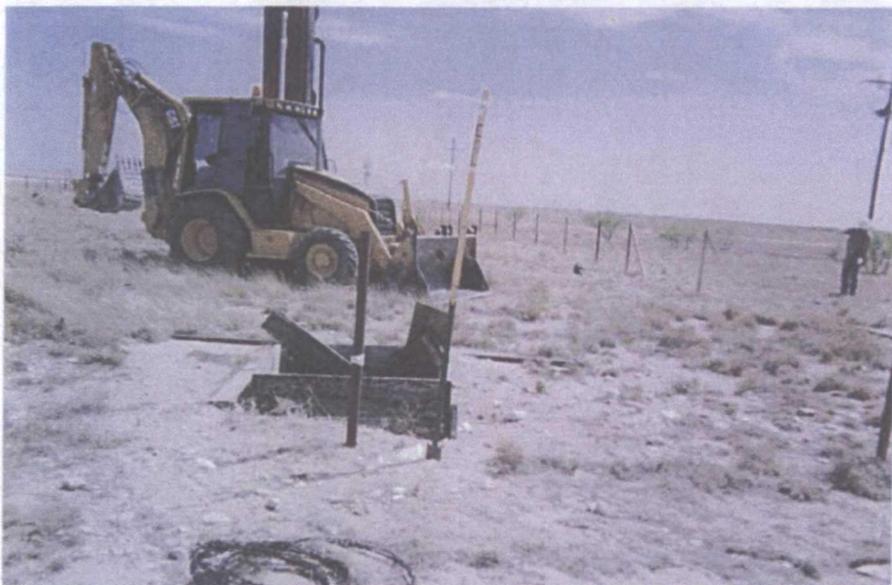
former junction box, facing south

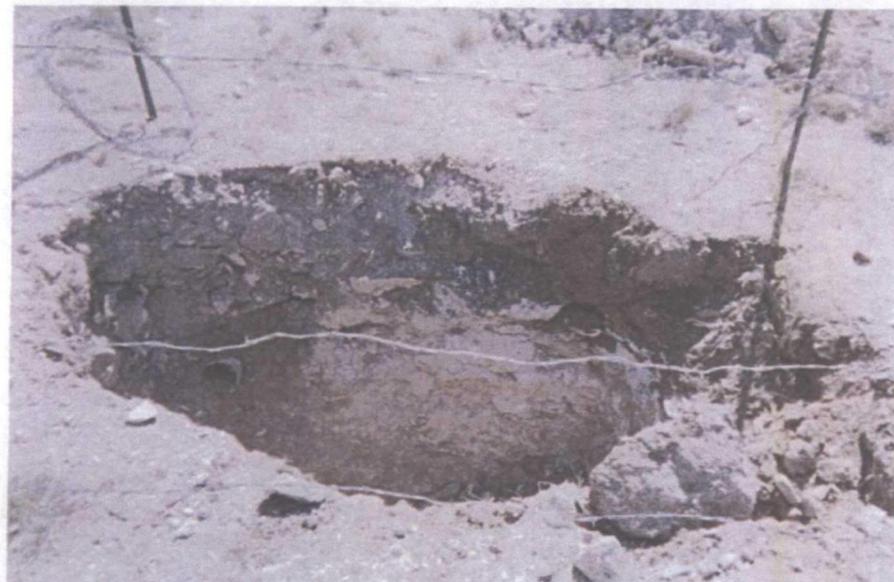
delineation trench at former junction site, facing east

LOCATION	DEPTH	mg/kg
background	6"	110
vertical delineation trench at the junction (source)	2'	137
	3'	117
	4'	98
	5'	135
	6'	163

General Description of Remedial Action: This junction was addressed under the Vacuum SWD System abandonment. After the junction was removed, an investigation was conducted using a backhoe to collect soil samples at regular intervals producing a 5x3x6-ft-deep hole. Chloride field tests were performed on each sample, which yielded low concentrations. Organic vapors were measured using a PID, which also yielded low concentrations. The deepest sample, 6 ft BGS, was sent to a commercial laboratory for analysis of chloride and TPH, confirming low concentrations. The excavated soil was returned to the excavation and clean, imported soil was used as a top cap and to contour the site to the surrounding area. On 5/20/2008, the site was seeded with a blend of native vegetation and is expected to return to a productive capacity at a normal rate.

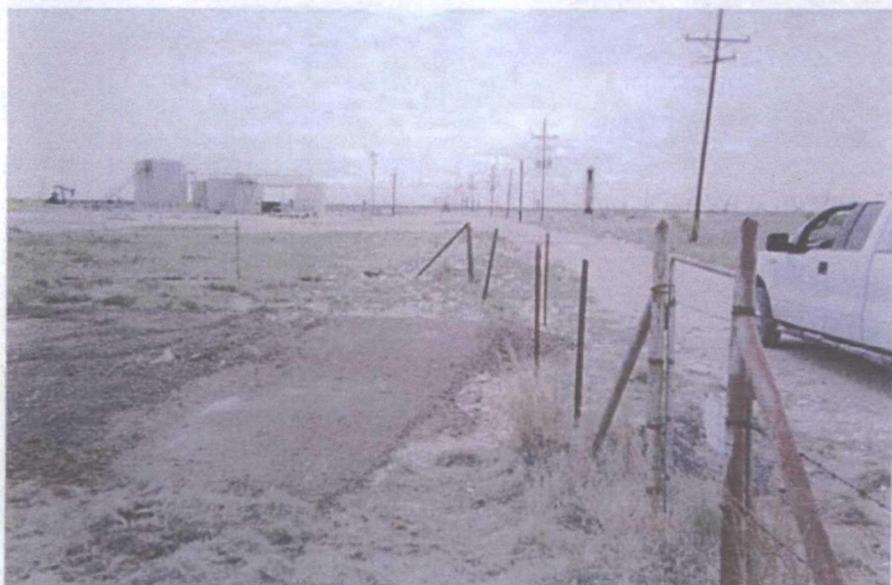
backfilled site, facing west

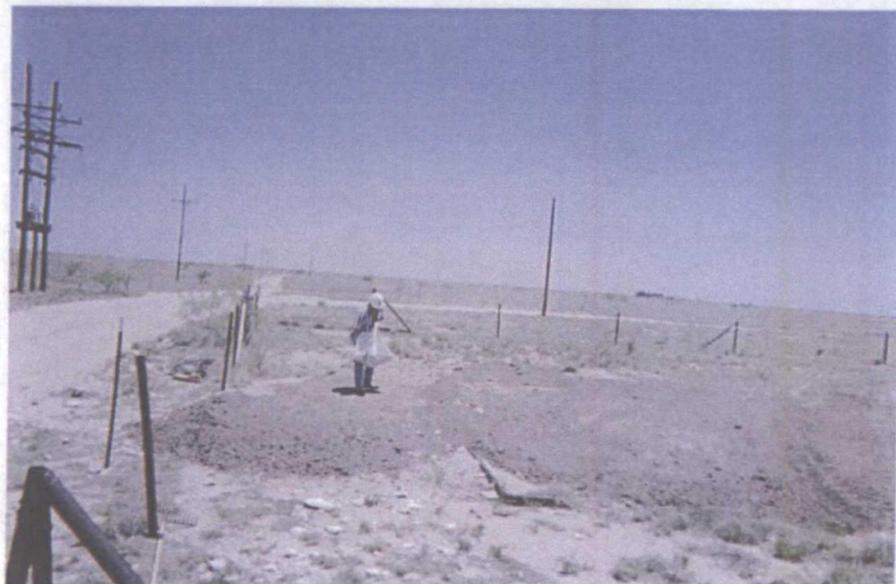
seeding backfilled site, facing east
