Release Notification and Corrective Action

Name of Company Yates Petroleum Corporation	OGRID Number 25575	Contact Amanda Trujillo
Address 104 S. 4 <sup>TH</sup> Street		Telephone No. 575-748-1471
Facility Name Johnston BE	API Number 30-015-26824	Facility Type Battery
		Order Number 2RP- <i>1201</i>

*2RP-1201*

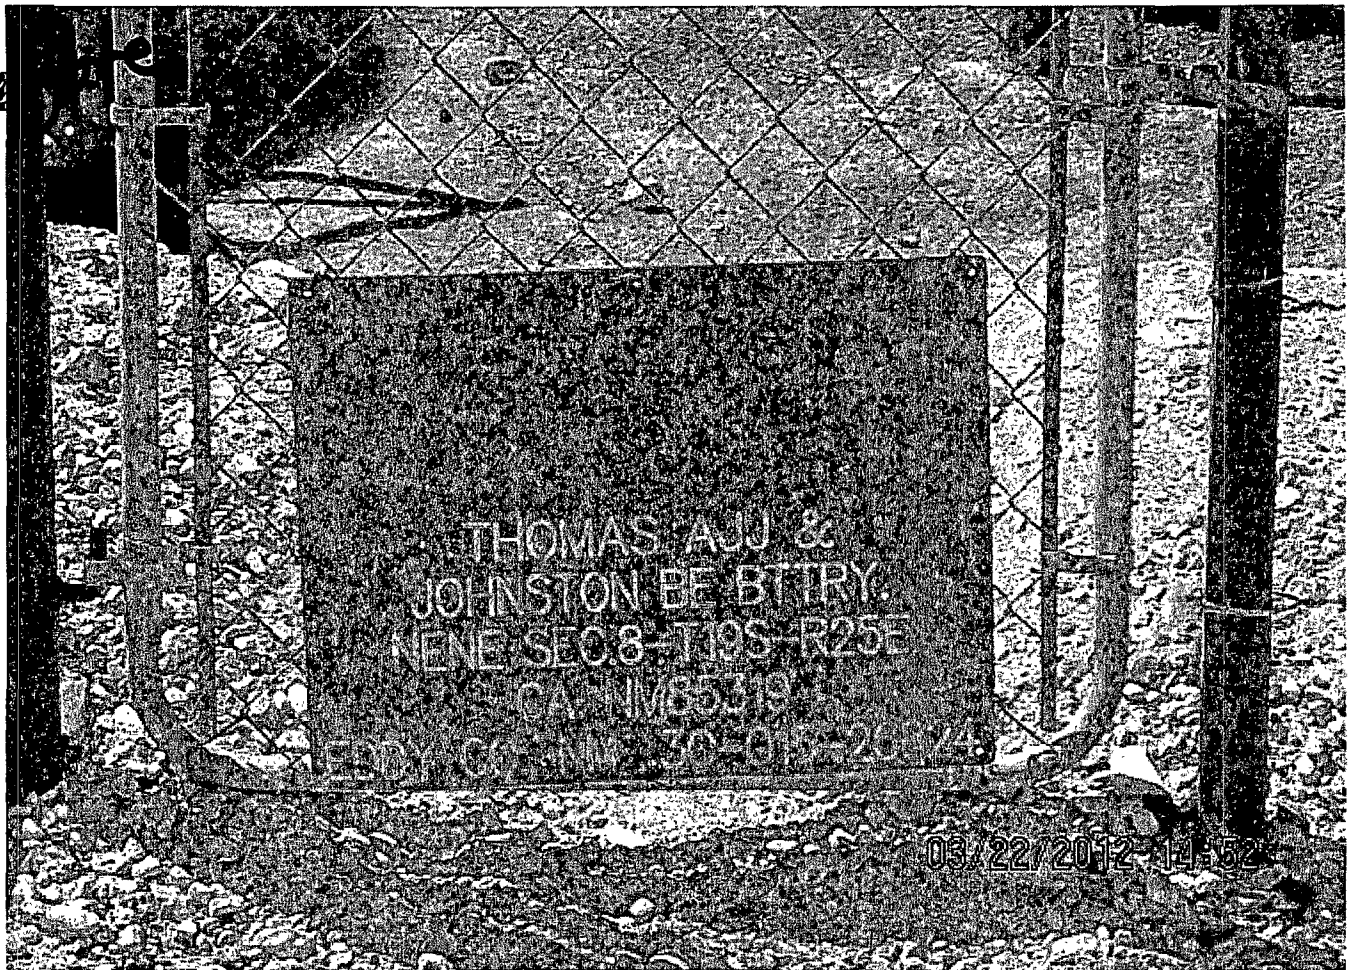
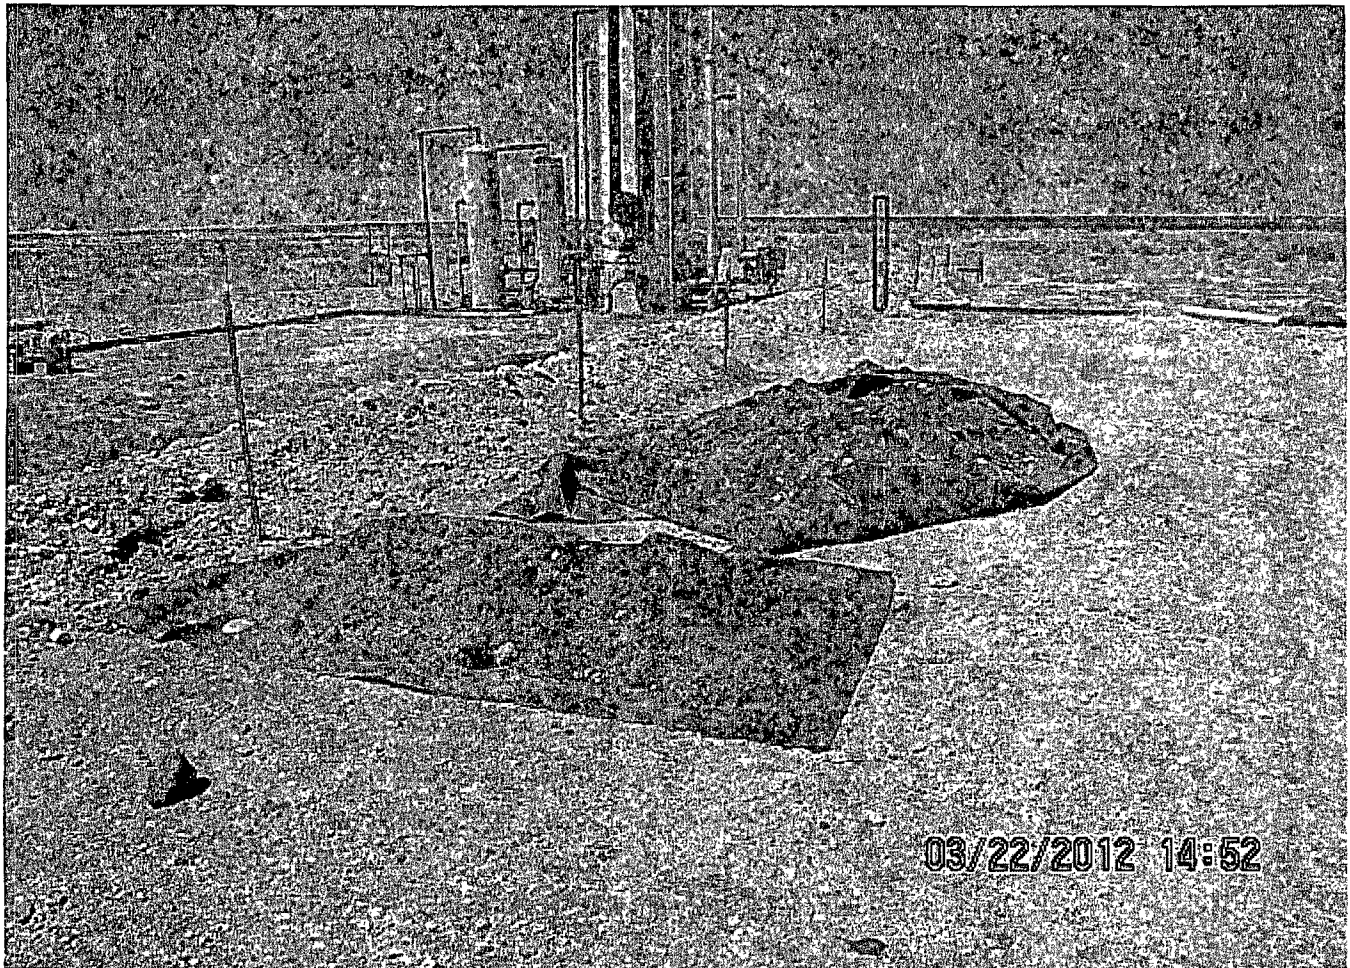
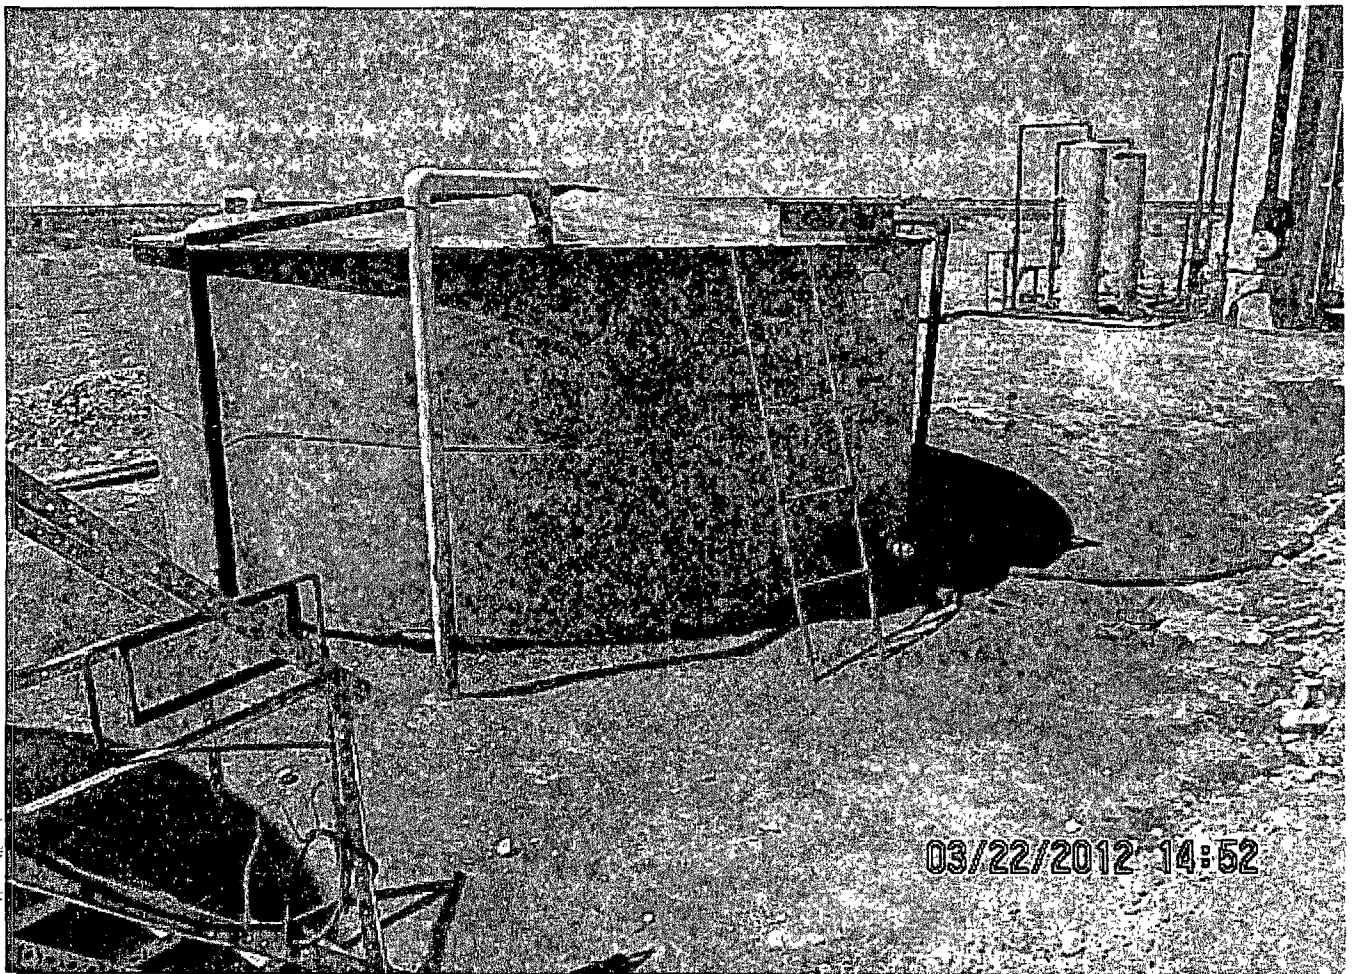
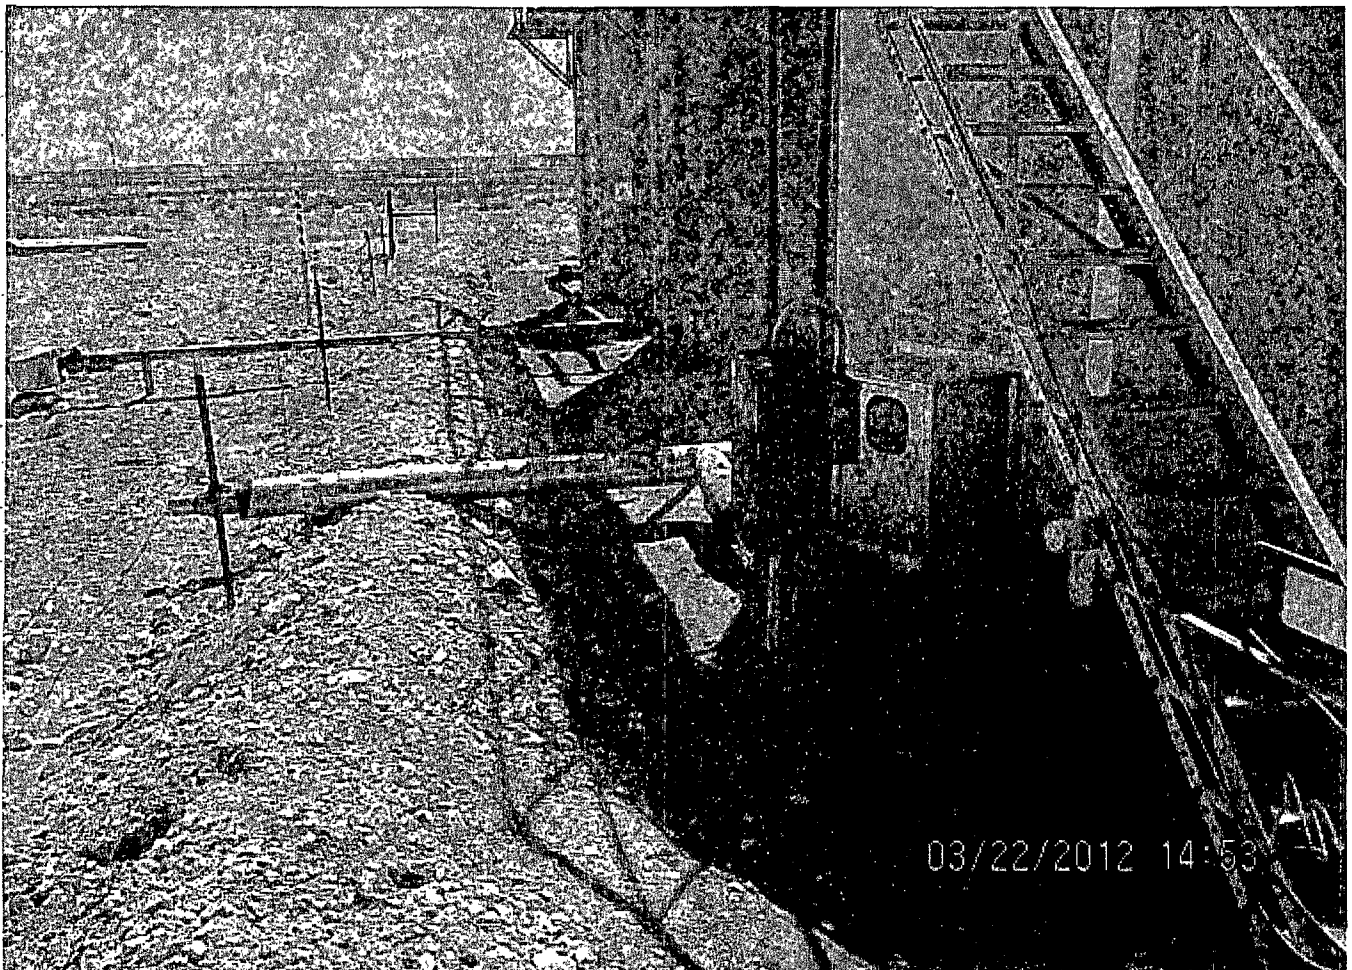
BEFORE EXC

An approximate size of 15' x 45' was impacted. The impacted area is located around the slop tank and in front of the production tanks. Soil from the pooling areas was excavated and disposed of at an NMOCD approved facility. Vertical and horizontal delineation samples will taken and analysis ran for TPH and BTEX once all contaminated material has been removed. **Depth to Ground Water: >100' (approx. 260', per New Mexico ChevronTexaco Trend Map); Wellhead Protection Area: No; Distance to Surface Water Body: >1000'; SITE RANKING IS 0.**

Before

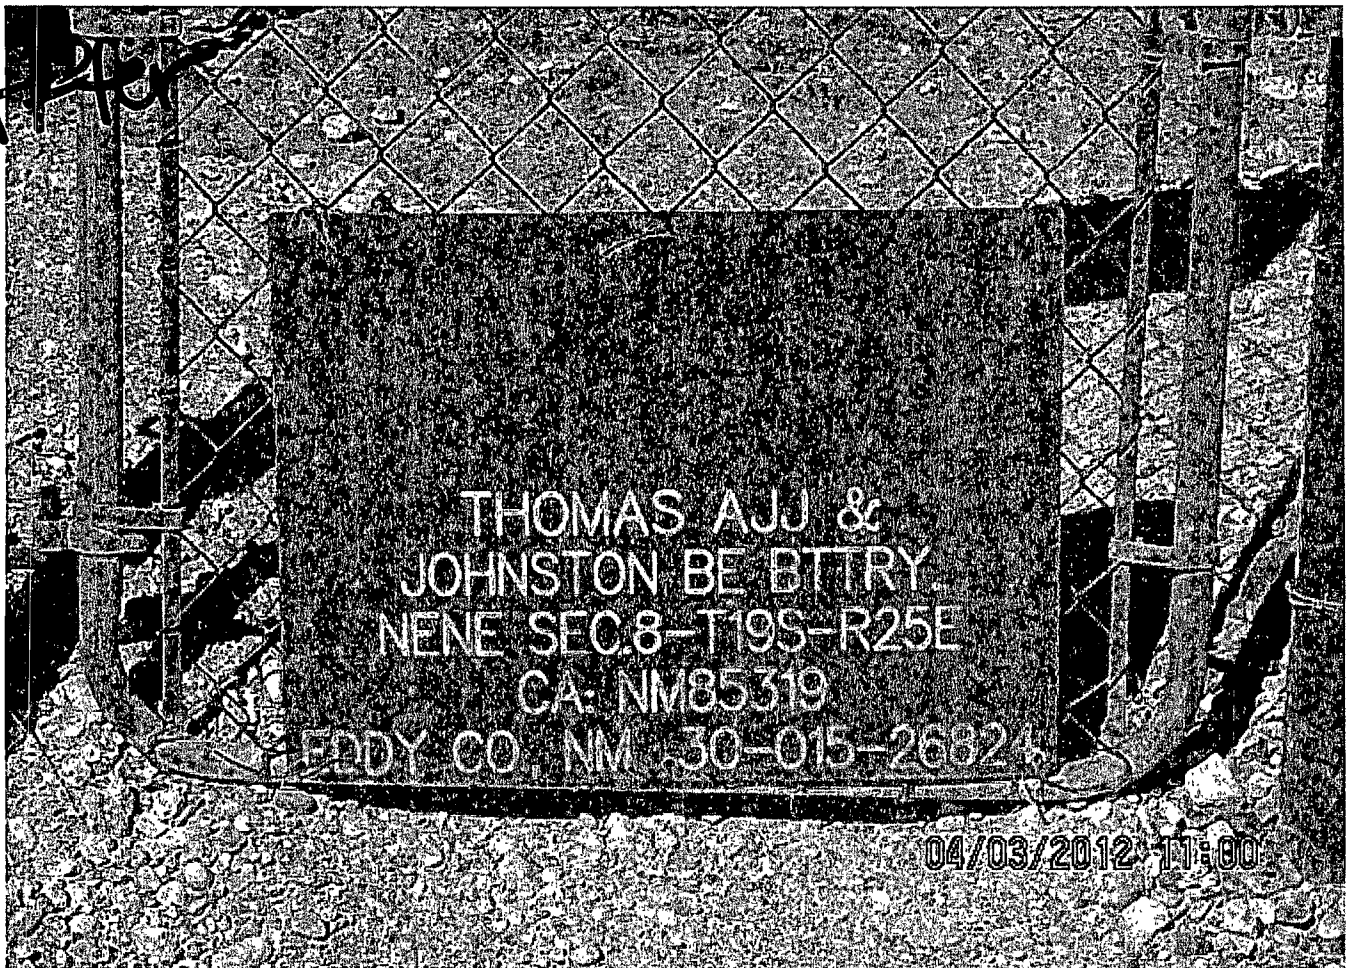
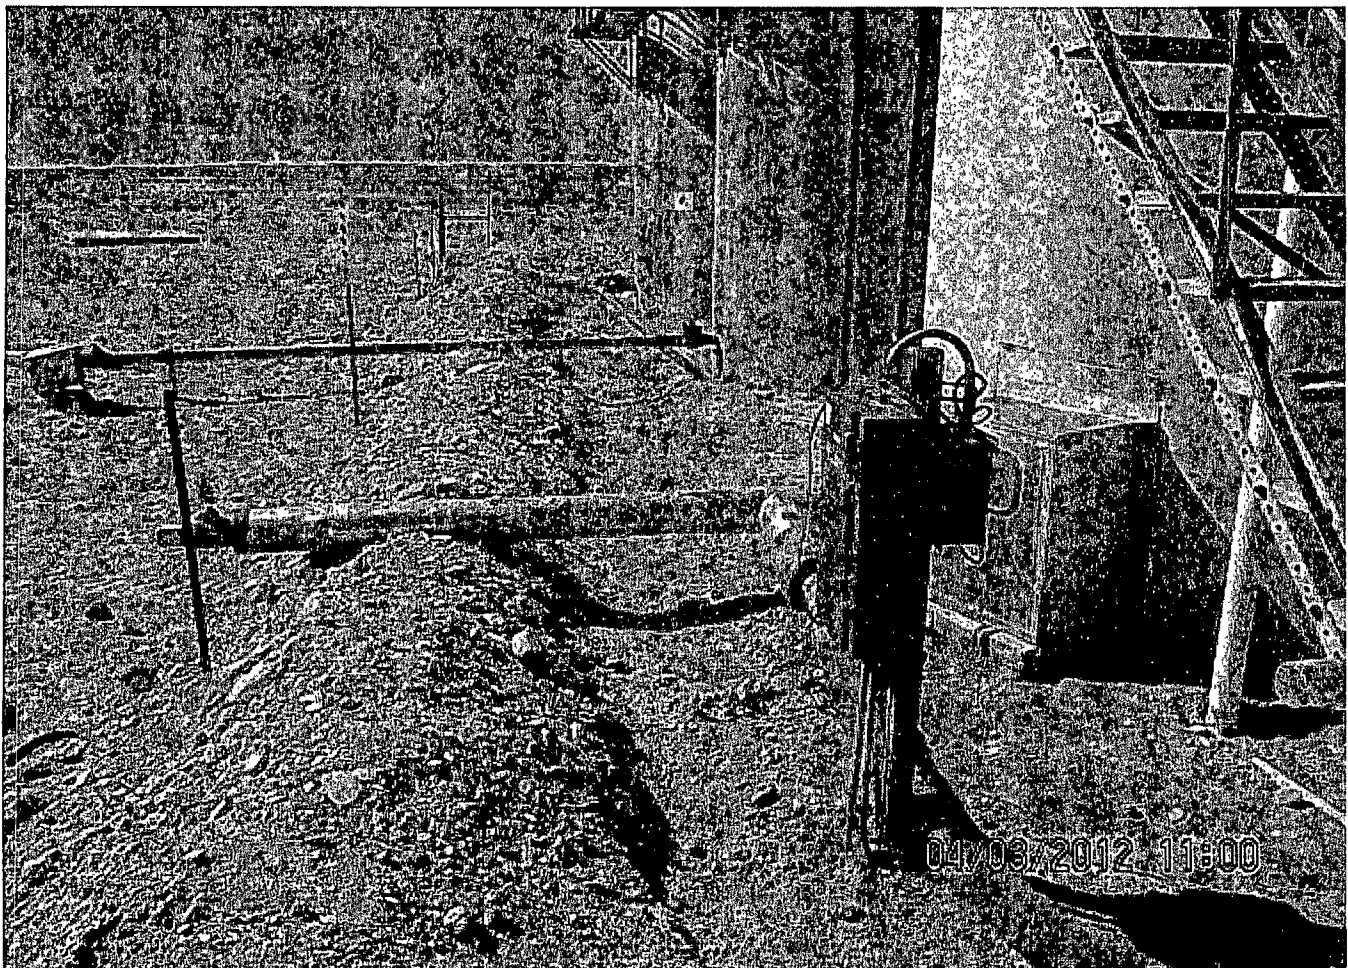
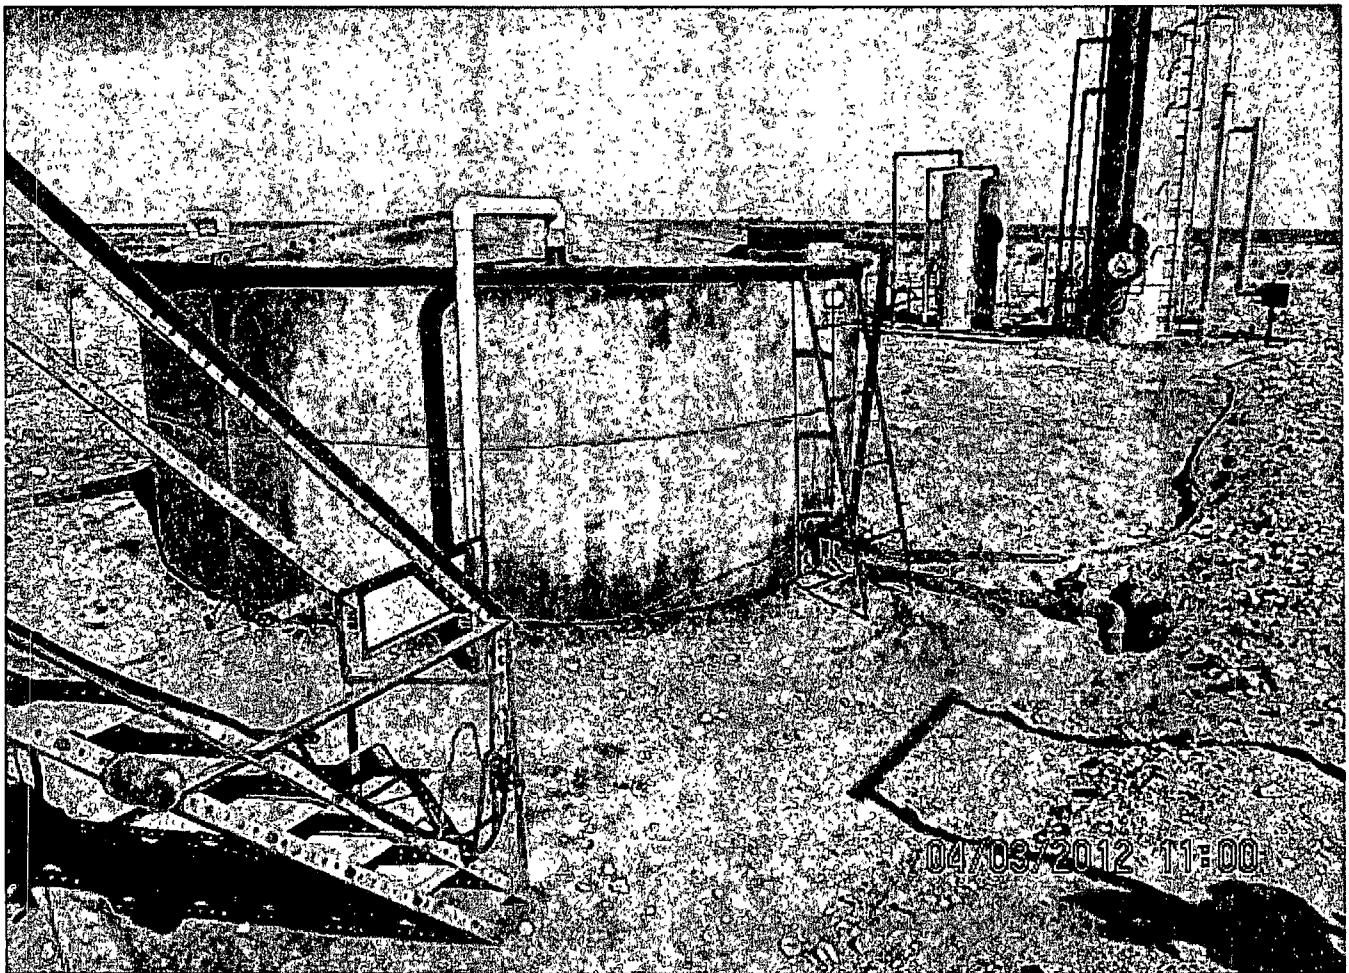
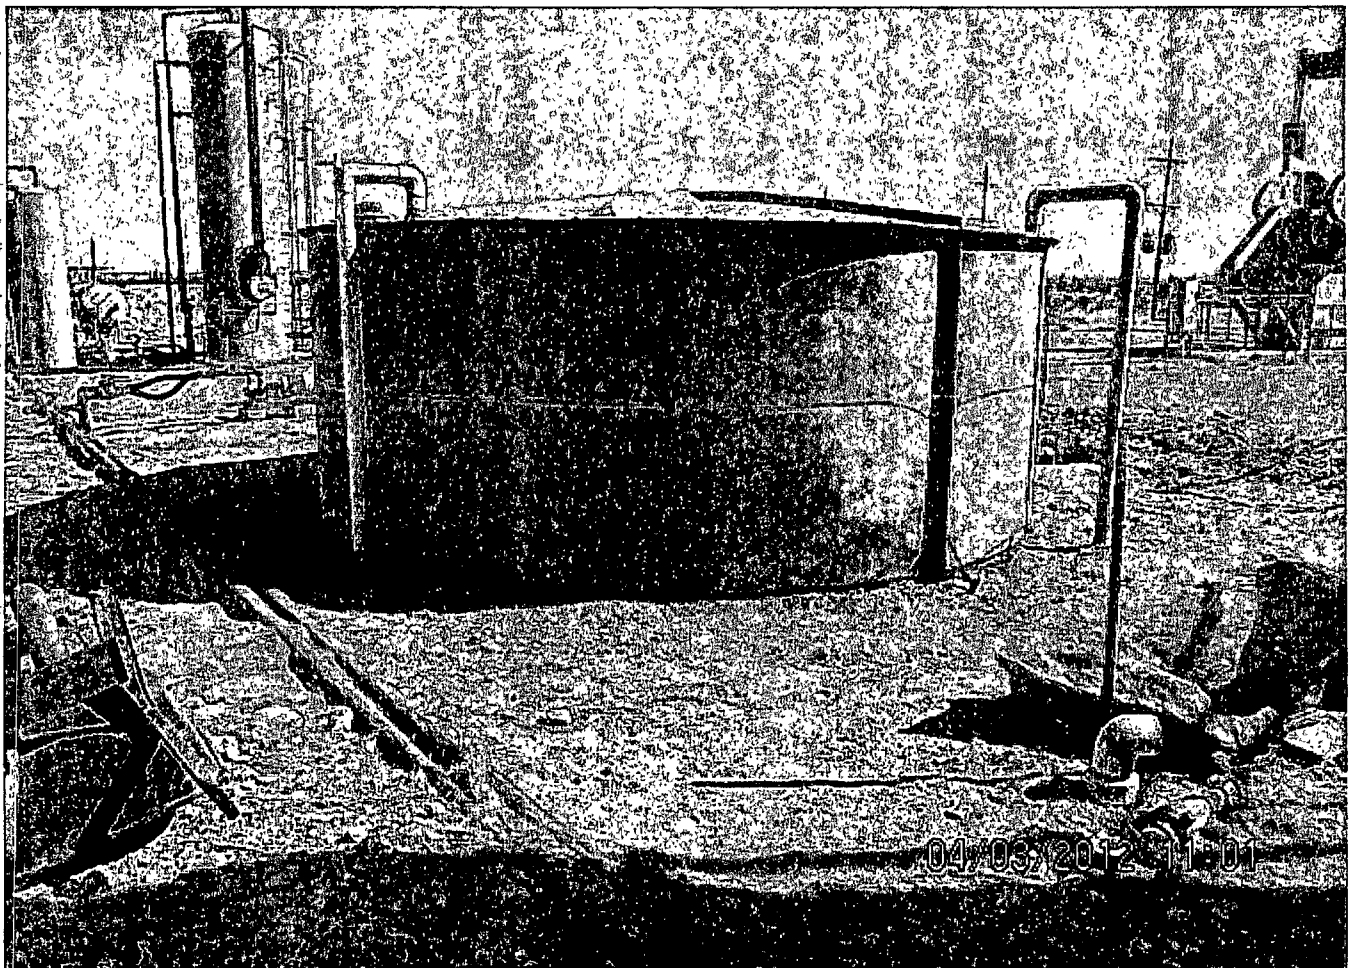
6.  
AFTER EXC

AFTER
