Release Notification and Corrective Action

Name of Company: BOPCO, L.P. <i>260737</i>	Contact: Tony Savoie
Address: 522 W. Mermod, Suite 704 Carlsbad, N.M. 88220	Telephone No. 575-887-7329
Facility Name: PLU-JV-CVX-Big Sinks #017H AKA PLU Big Sinks 7-25-31 USA #1H	Facility Type: Exploration and Production

FIELD SPILL REPORT

LOCATION OF SPILL SITE: PLU CVX JV BS #017H (aka PLU Big Sinks 7-25-31)

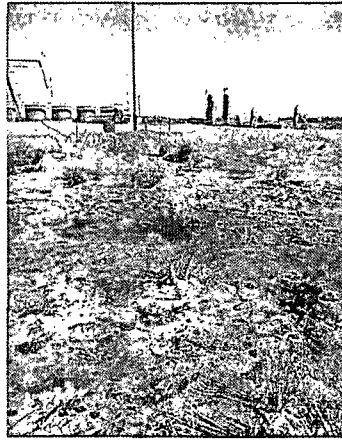
11/17/2014

The spill impacted approximately 2550 sq.ft. of pasture land that had been recently disturbed during a pipeline construction job. The release also misted approximately 4760 sq.ft. of pasture area. All of the free standing fluid was recovered; the stained area was left as is pending remediation. The spill area will be cleaned up in accordance to the NMOCD and BLM remediation guidelines.

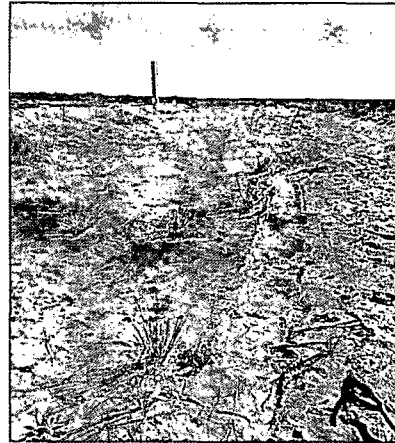
PLU-CVX-JV-BS-017H4

Puddled area

Mixed area
