# Occidental Permian Limited Partnership

RE: Final Closure Plan  
North Hobbs Unit Well #32-111  
UL 'D', Sec. 32, T-18-S, R-38-E  
API # 30025075280000

# SPILL MAP

8/11/06 NHu 32-111 Flowline LEAK

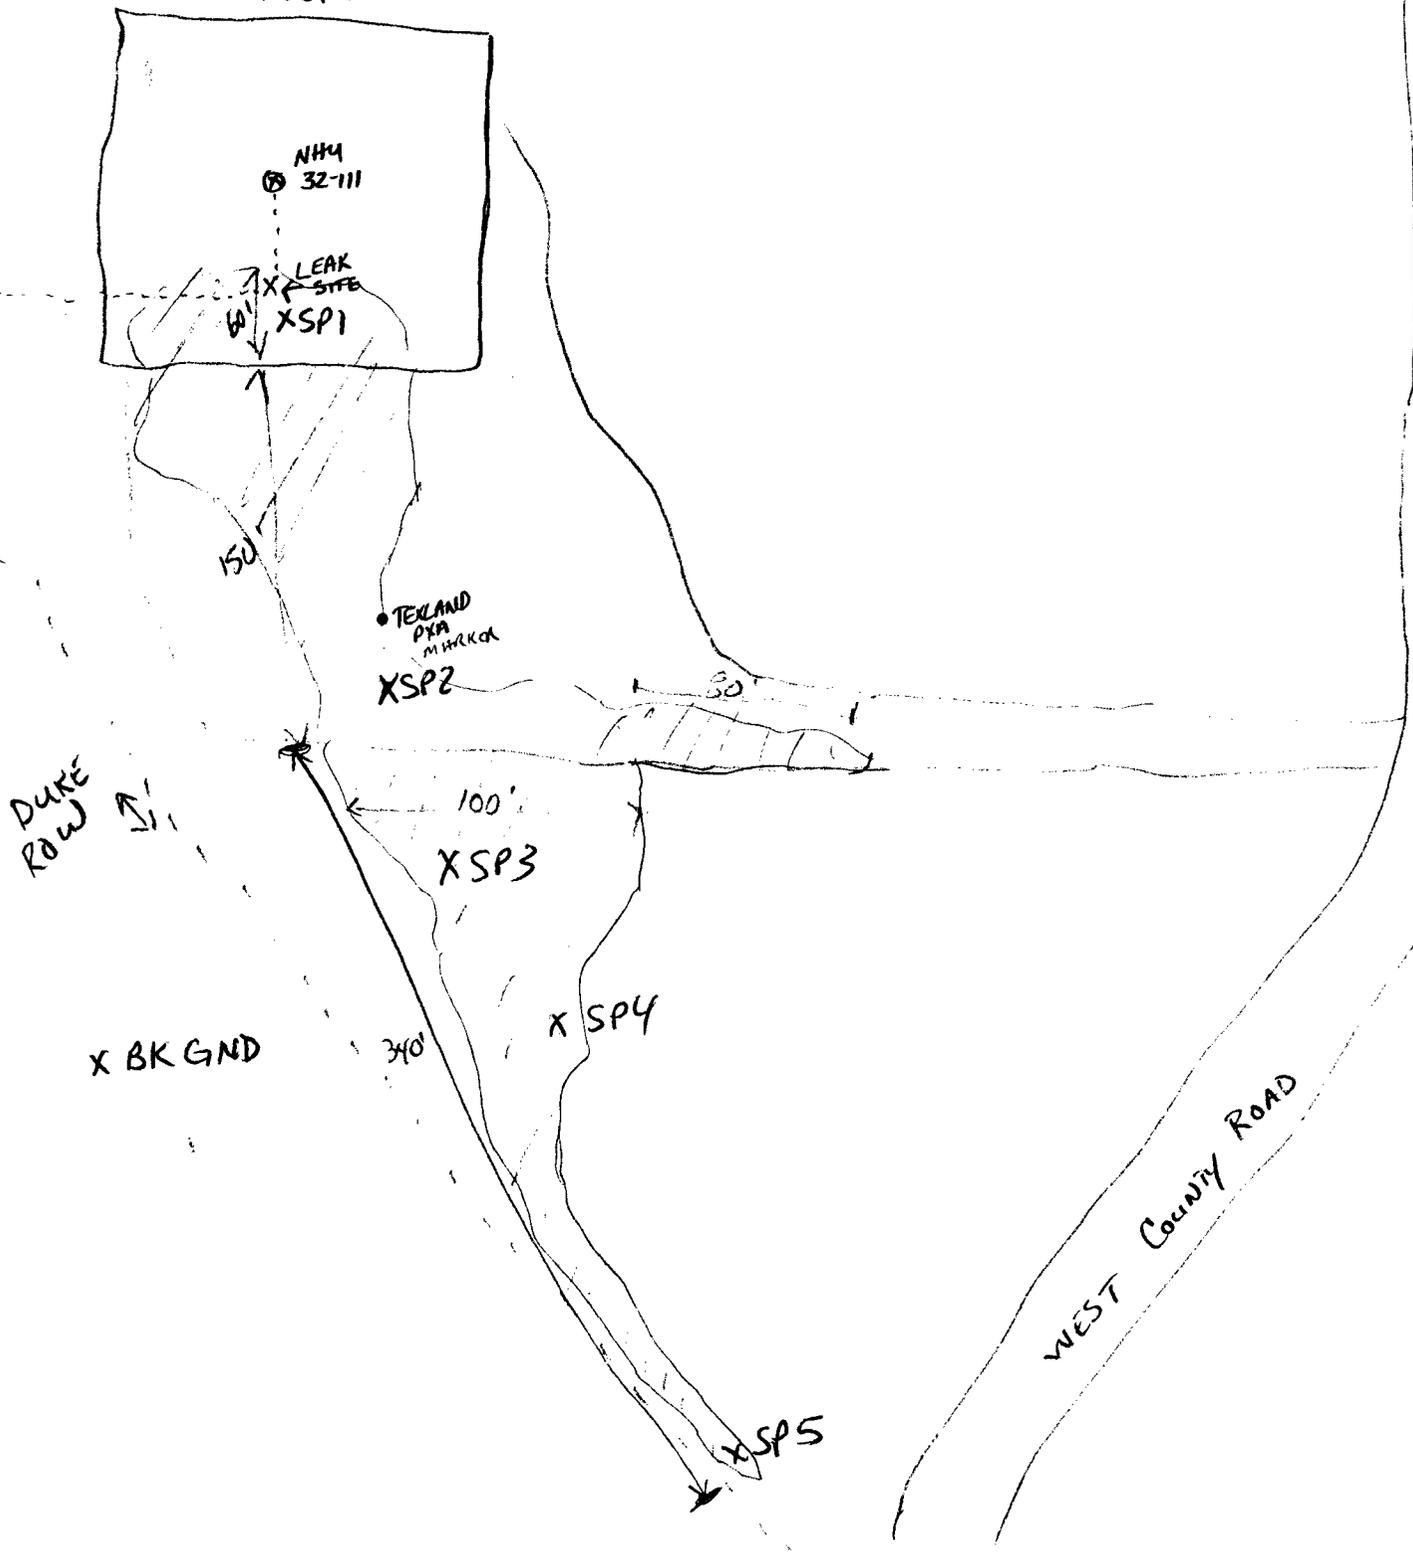
N 32° 42' 38.00" W 193° 10' 37.70" LLD Sec 32, T-18-S, R-39E

1580 x 20 BW EST. LOSS Gary W. AK 10:30 AM 8/12/06  
REC. 130719 BW mostly rain water.
